RELATIONSHIP BETWEEN GEOLOGICAL STRUCTURES AND SHORTWALL MINING AT MATLA COLLIERIES, MPUMALANGA

**Thesis submitted in fulfillment of the
requirements for the degree of**

MASTER OF SCIENCE

May 2006

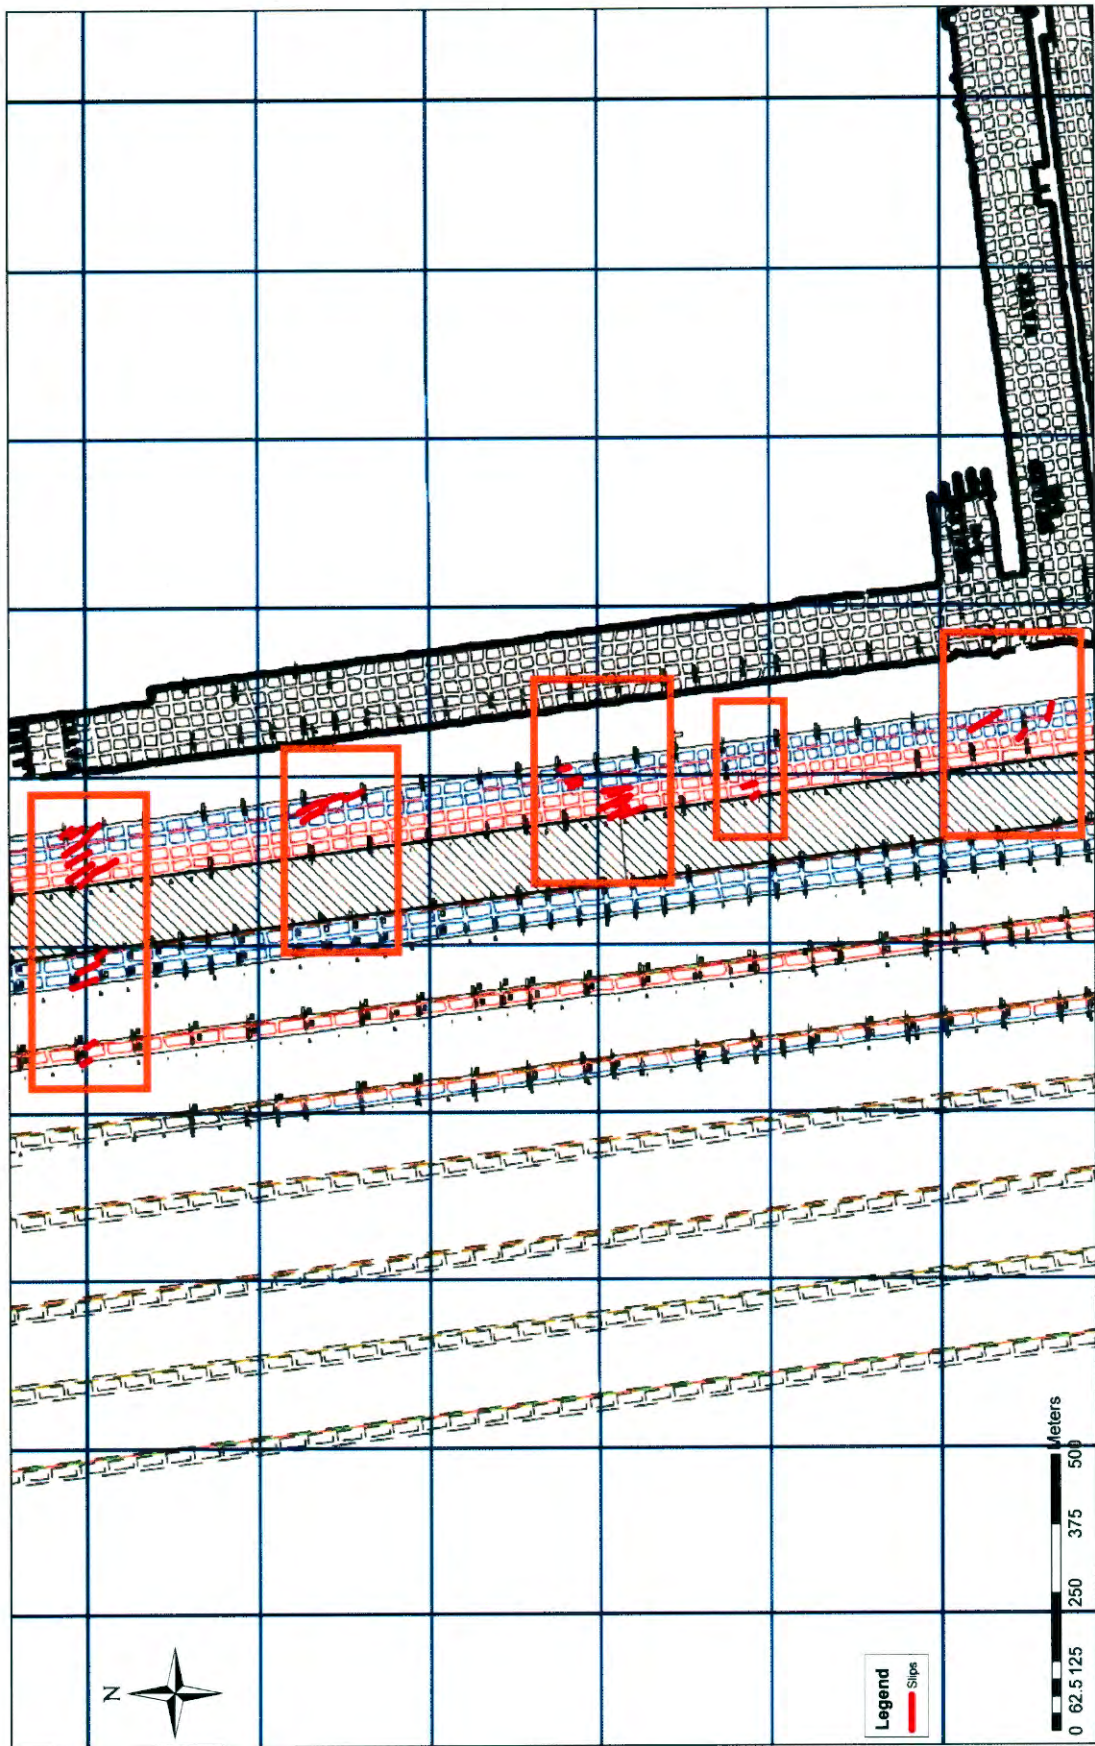
Figure 19: Slip zones at Matla Coal Ltd. No. 2 Mine.

Slips are openings that are caused by stresses. When movement occurs in a slip after it was formed it is renamed as a slickenside. The movement is caused when the stress in the surrounding area is disturbed. A number of slips were found and surveyed at Matla Coal Ltd. No. 2 mine (Figure 19). The origin of the slips relate to the depositional environment of the coal layers and the redistribution of the stresses by the mining activities.

The slips at Matla Coal Ltd. No. 2 Mine could be the reason for roof failures. However, slips have only been surveyed in the operational areas. The fact remains that slips can only be surveyed in the development roads and not in the direct roof of the panel which implies that more slips may be present. The presence of slips remains a problem and when magnified by a slow rate of advance, roof failure is imminent.

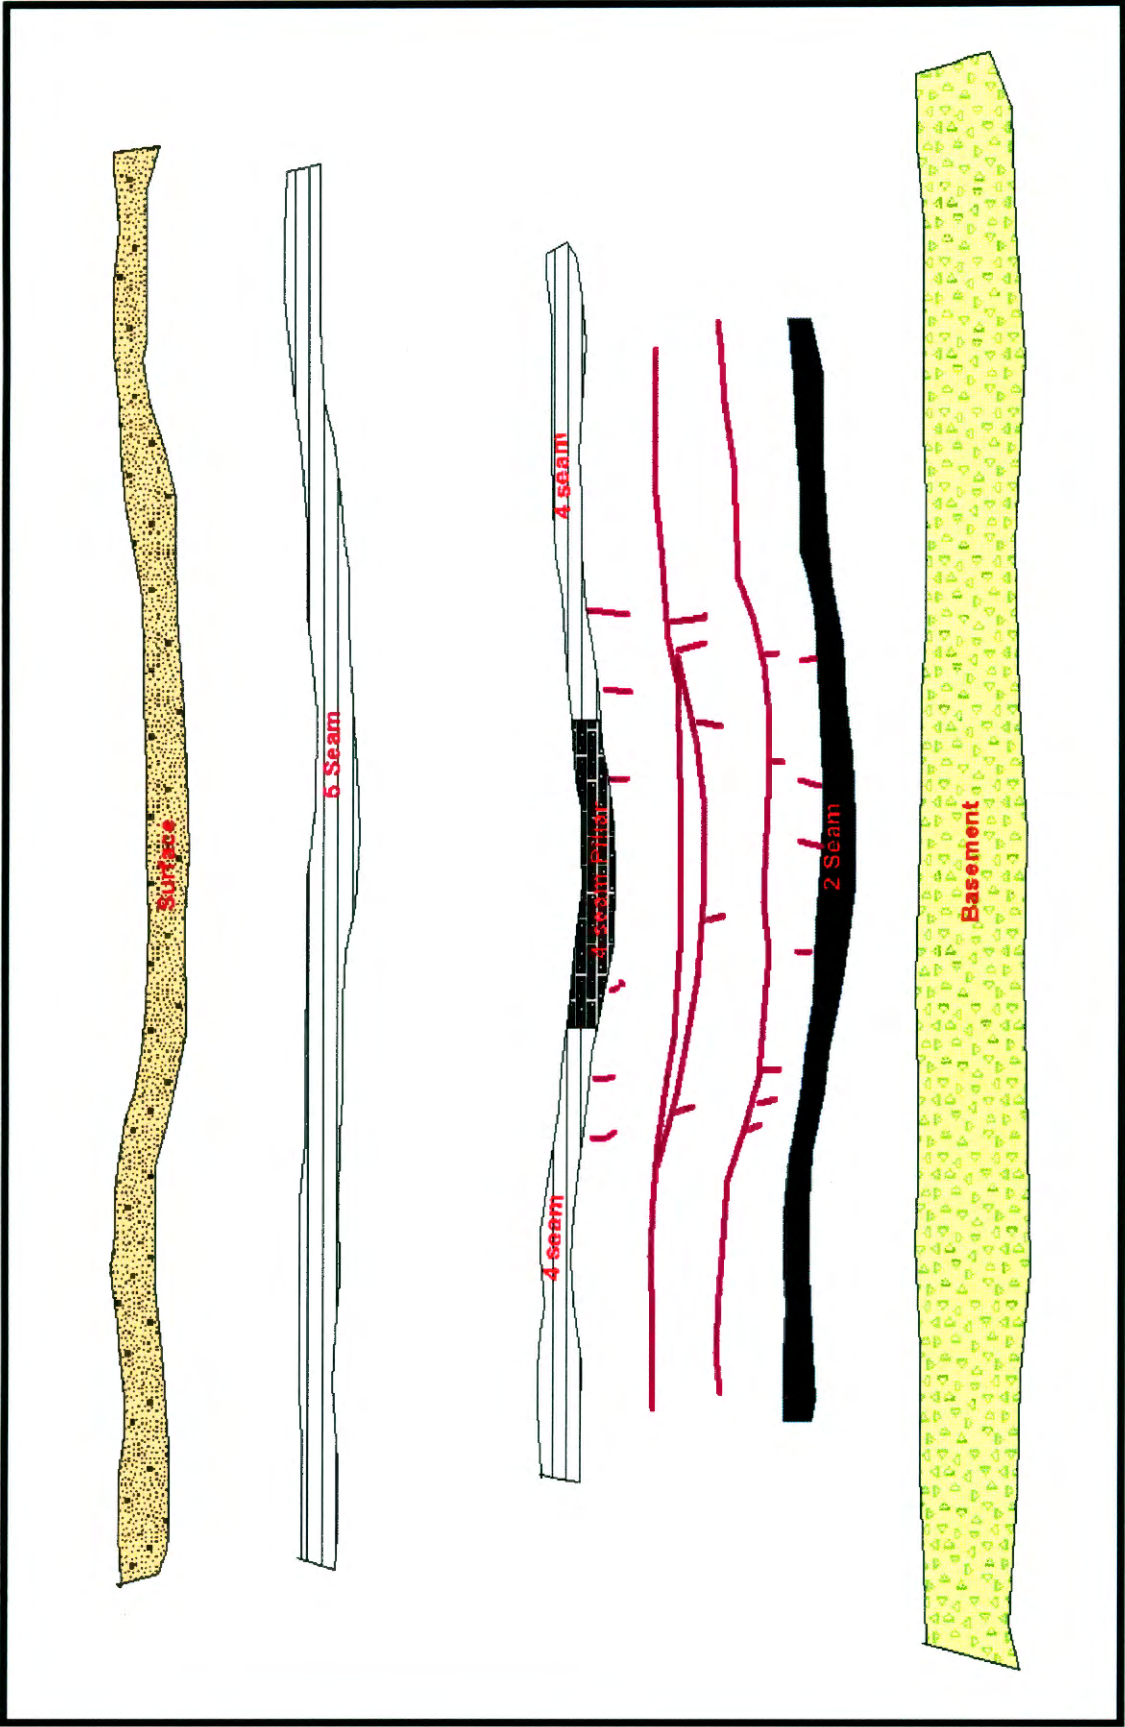
Figure 23: Origin of the vertical slips at Matla Coal Ltd. No. 2 Mine.

2. The slip zones were found to correlate with the floor rolls. This differential correlation confirms the existing theory that the slips result from compaction of the No. 2 Coal Seam after deposition.

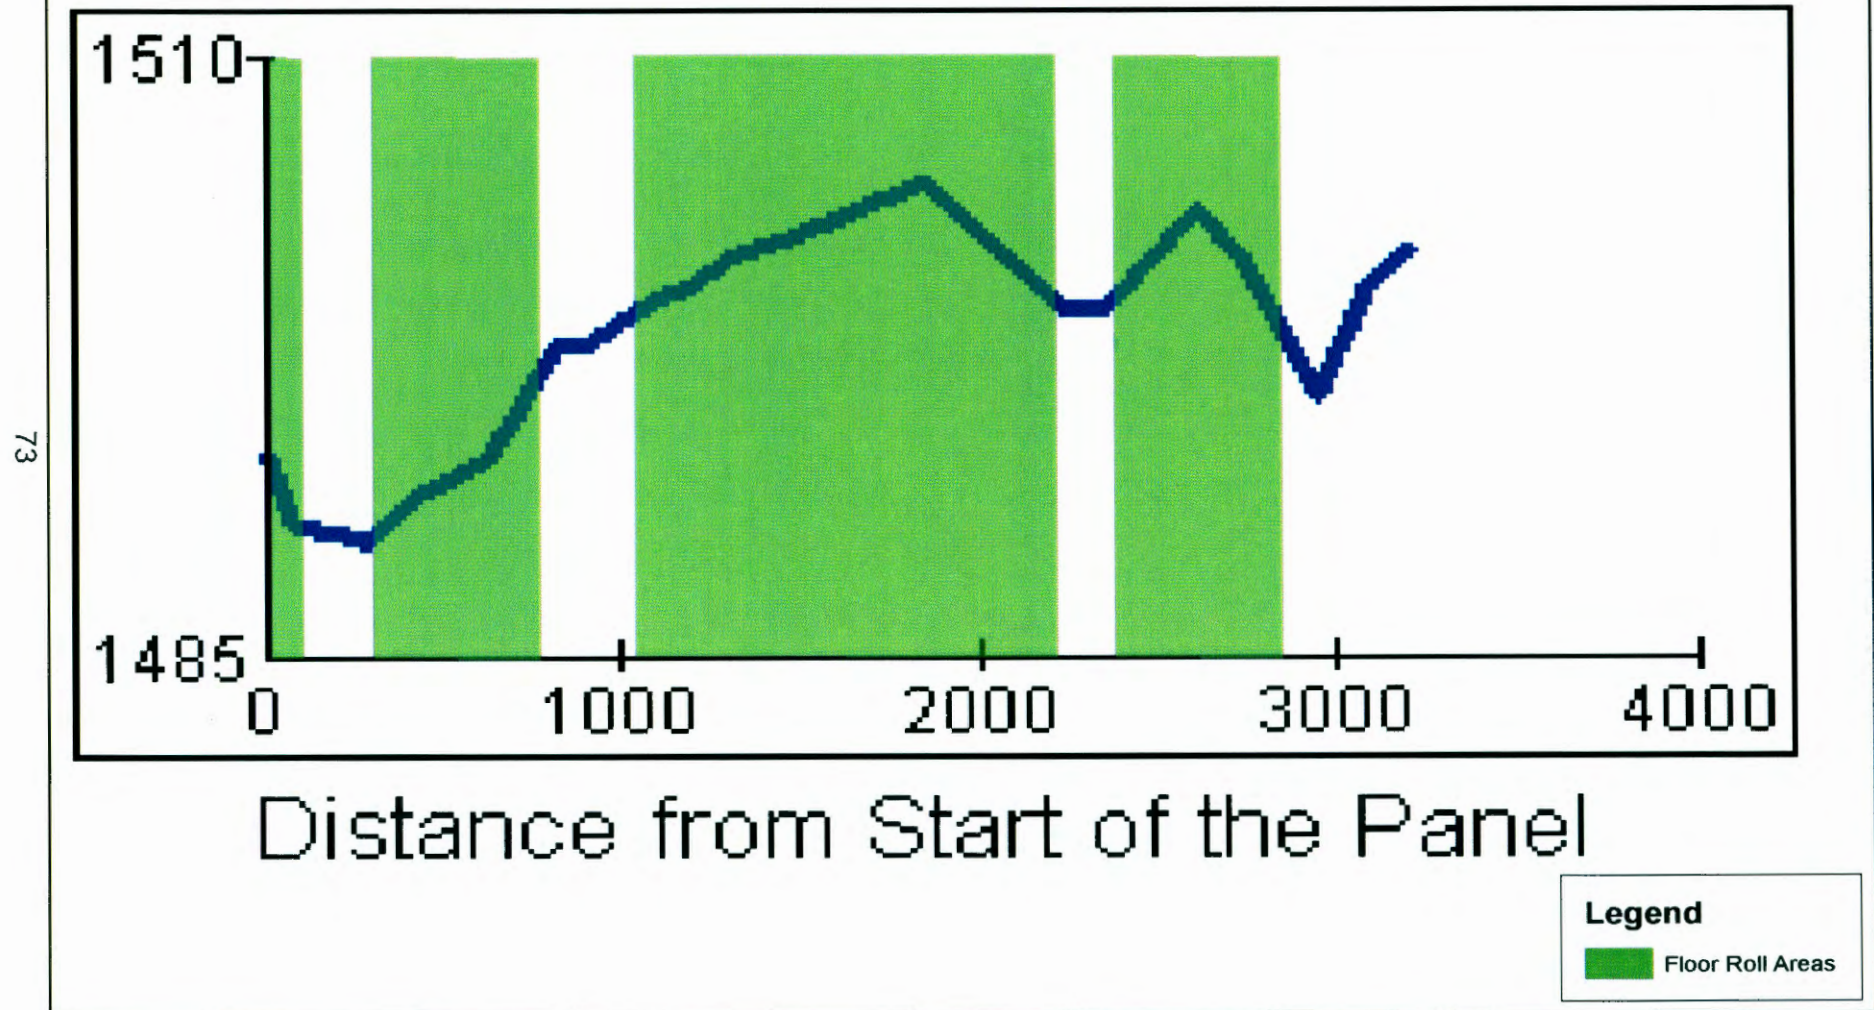
Figure 30: Floor Roll areas in Panel 1

A large number of elevated areas are found in the floor of No. 2 Mine (Table 25). The origin of these structures can be found in the depositional history of the area. The research results indicate that the floor rolls have caused or have been instrumental in causing most of the roof failures at Matla Coal Ltd. No. 2 Mine due to the relationship between the floor rolls and the slips. In order to illustrate the impact of floor rolls on the mining conditions at Matla Coal Ltd. No. 2 Mine, the areas where floor rolls are present were correlated with the areas where roof failures occurred. In the first panel 100% of the roof failures occurred in areas where floor rolls are present; in the second panel 88% of the face breaks occurred in these areas and in the third panel 83%.
