THE ENVIRONMENTAL IMPACTS OF THE GROUNDWATER ON THE ST. LUCIA WETLAND

A dissertation submitted to meet the requirements for the degree of
Magister Scientiae

In the Faculty of Natural and Agricultural Sciences
Institute for Groundwater Studies

April 2013

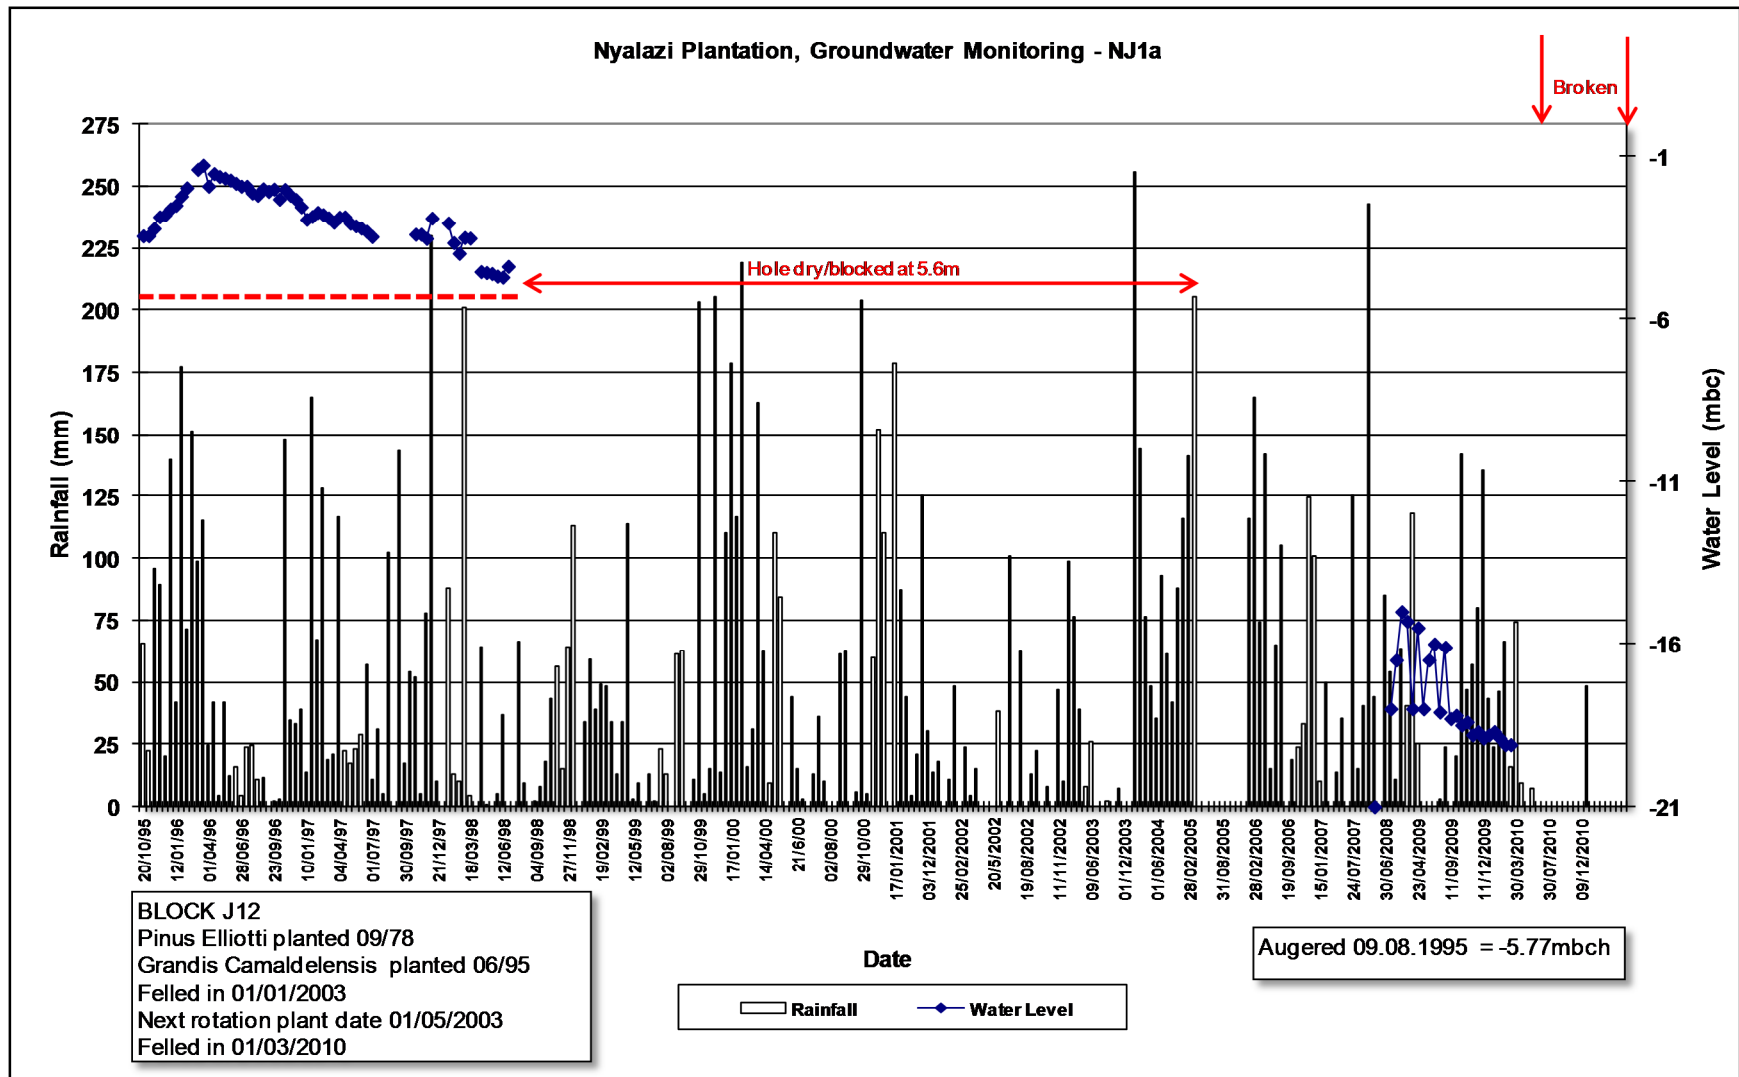
Figure 22: NJ1a Water Level Trends - 1995-2010

For NJ1a, a decline of on average 1.65 metres per annum was observed, calculated from the time the water level started to decline (after the initial rise), to the point where the monitoring point ran dry (March 1996 - June 1998). For a period of approximately 10 years, no data was obtained as the water level had declined below the depth of the piezometer and the piezometer was blocked at 5.6 metres. This was later deepened between 2005 and 2008 (no records of this was available) and data was once again recorded from March 2008 until February 2010. The piezometer is currently blocked at 7.1 metres although water level data was recorded up to a depth of 19 metres in 2010, indicating a minimum depth of 19 metres after the redrilling in 2008, however no information regarding the redrilling was available. It has been recommended in Section 9.1.1 that NJ1a is rehabilitated. The total drop in water level over the period of 15 years which was monitored (1995 to 2010) was 15.66, based on an initial water level of 3.44 mbch and a final water level of 19.1. Therefore the average annual decline in water level was calculated by using the total drop of 15.66 metres divided by the 15 years of monitoring which results in an average decline of 1.04 metres per year.

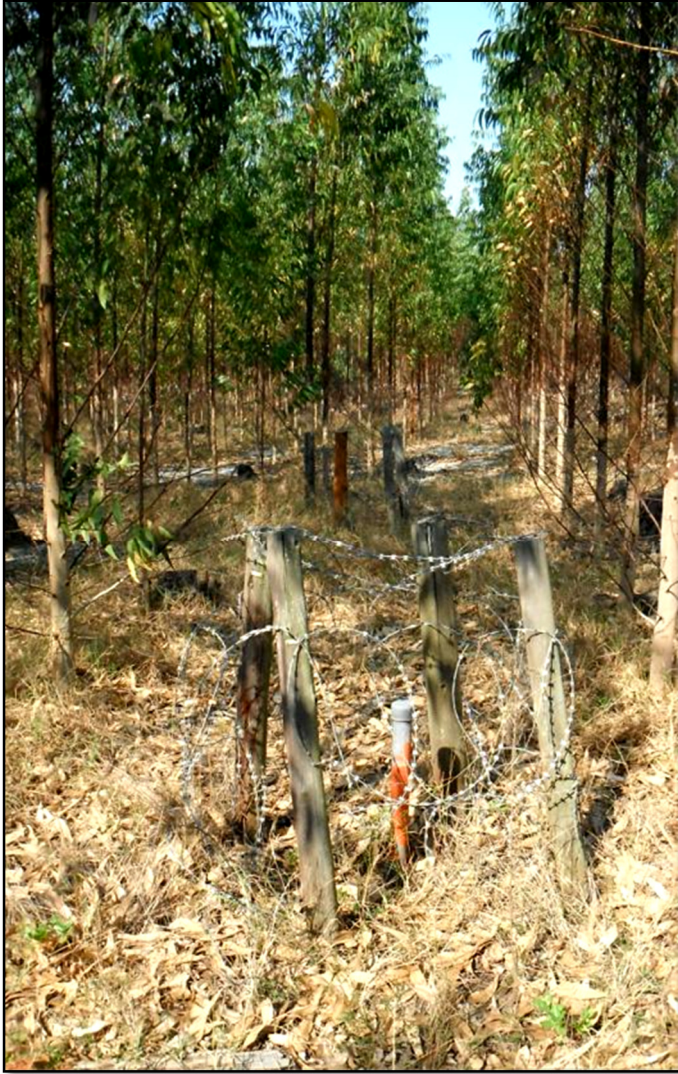
Figure 23: Monitoring point NJ1a (front) and NJ1b (back)

The *Pinus elliottii* compartment was established in 1978. Piezometer NJ1a and borehole NJ1b (photographed in Figure 23) are located 30 metres apart and were installed in August 1995 to monitor the *Eucalyptus grandis Camaldulensis* plantation which was planted in June 1995. Monitoring of the water level commenced mid October 1995. From October 1995 to March 1996, the water level rose 1.98 metres in monitoring point NJ1a and 2.19 metres in NJ1b over this period (Figure 22 and Figure 24).

Borehole NJ1b indicated comparable results to NJ1a, when comparing the initial trends from 1995 to 1998 and indicates similar water levels between 2008 and 2010. The water level dropped at a rate of 1.1 metres per annum, based on data collected over 14.5 years and the depth of the borehole being 21.54 metres, which allowed for a larger data set (Figure 24).

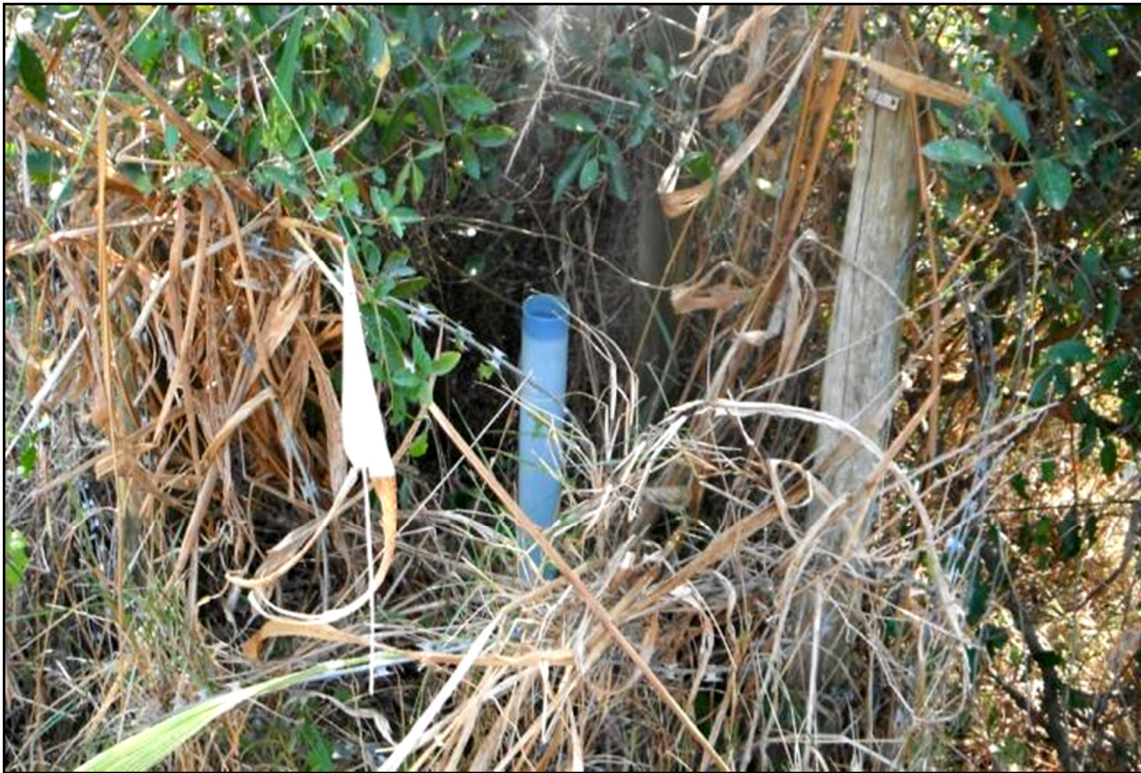
Figure 26: Monitoring point NJ2a located within the indigenous area

This monitoring point was installed within the indigenous vegetation (Figure 26) located adjacent to the *Pinus occulapia* plantation. The trendline is relatively stable compared to monitoring points located within the plantations (Figure 27).

There was a slight decline in the water level during the drier periods of 1998 and 1999 due to the low rainfall figures for that period, which then rebounded after the high rainfall during the wet season of 2000/2001. No water level measurements were recorded during 2009 and part of 2010, as the monitoring point was blocked during this time. The latest water level measured in February 2011, was 11.2 metres in comparison to the initial water level 10.04 metres, resulting in a drop of 1.16 metres over a period of 16 years. During the August 2012 site visit, the monitoring point was measured as dry with a depth of 10.65 mbgl.

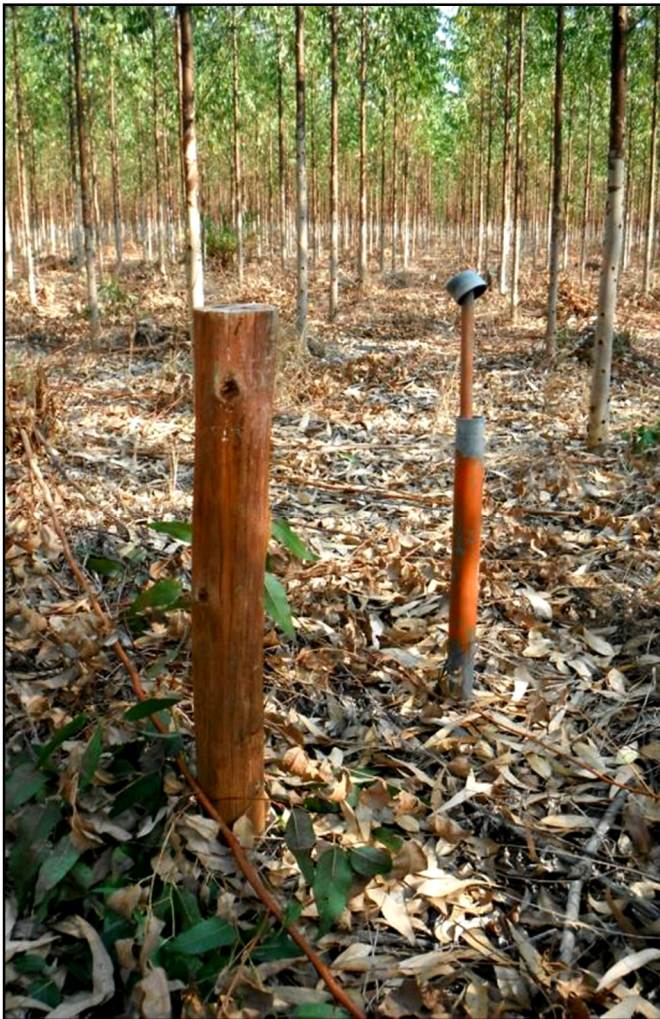
Figure 29: Monitoring point NJ4a located within the indigenous area

NJ4a was visited during the site visit conducted in August 2012 and illustrated in Figure 29 below. The current depth was measured as 5.59 mbch (metres below collar height), with the monitoring point being dry. The monitoring of NJ4a over the period from late 1995 to late 2002 indicated a slight increase in the water level from 5.5 to 4.5 metres (Figure 30).

However, after a 5 year hiatus, the water level had declined to 18.2 metres indicating a significant decrease (this refers to a drop or decline in the water level) over this period. The drop in water level over this interval was similar to the trend observed in NJ3a.

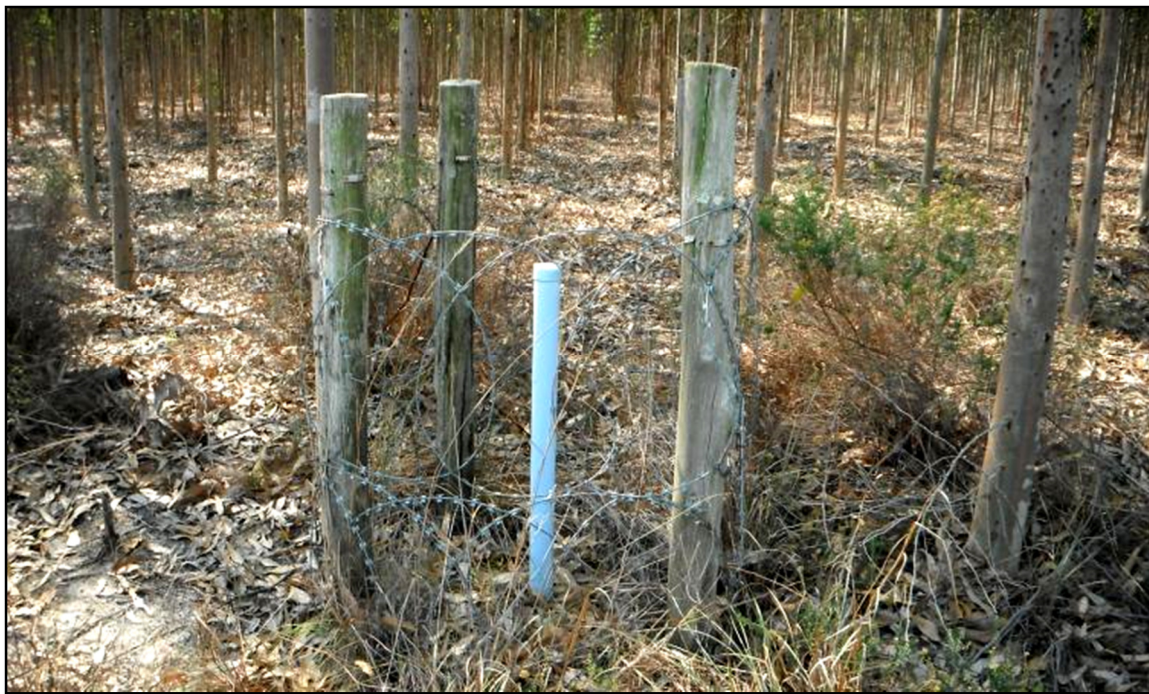
Figure 32: Monitoring point NO1a

A small area of *Pinus elliottii* and *Eucalyptus grandis Camaldulensis* species were planted in compartment D, adjacent to each other, in October 1986. The two piezometers, NO1a and NO2a (Figure 32 and Figure 34) were installed to determine the impact of the different species on the groundwater level. The localities of the monitoring points and associated compartments monitored are presented in Figure 31.

The *Eucalyptus grandis Camaldulensis* was planted in October 1986 however no information was available regarding the felling dates. The water level measured within this Eucalyptus plantation was lower in comparison to the adjacent Pine plantation, with a difference ranging from 1 to 2.6 metres (refer to Figure 33).

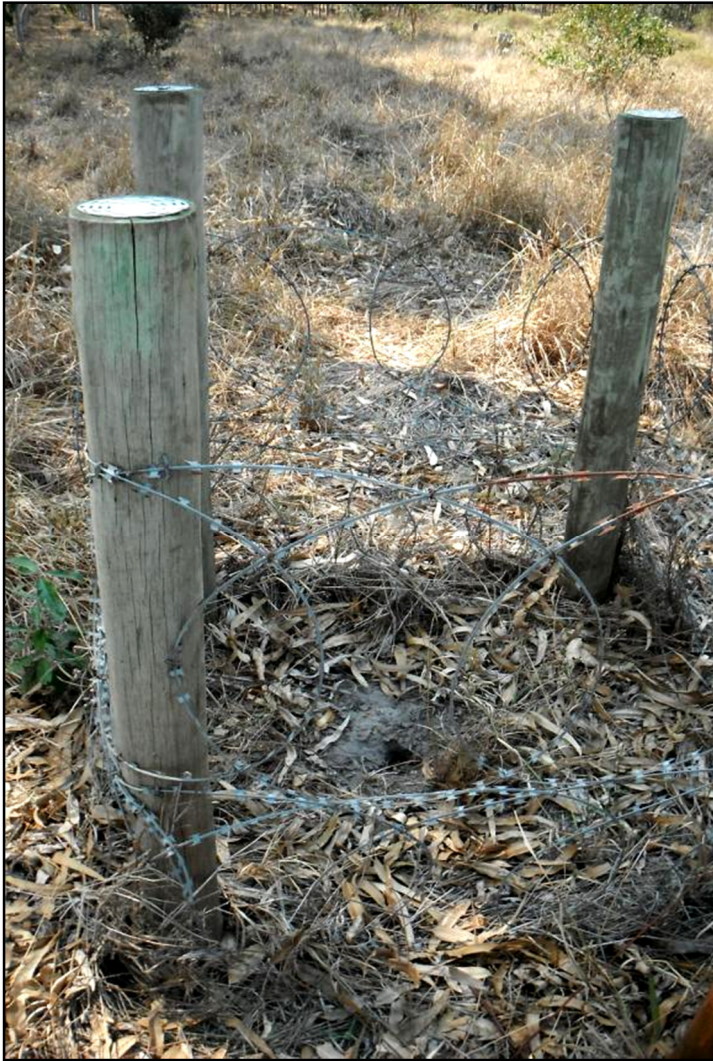
Figure 37: Monitoring point NR2a

Piezometer NR2a (Figure 37), located at the northern tip of the cross sectional line, monitors the adjacent Eucalyptus plantation, planted in 1998 and felled in 2005. The

rotation prior to this, which was planted in November 1988 and felled in November 1997, was the Pine species.

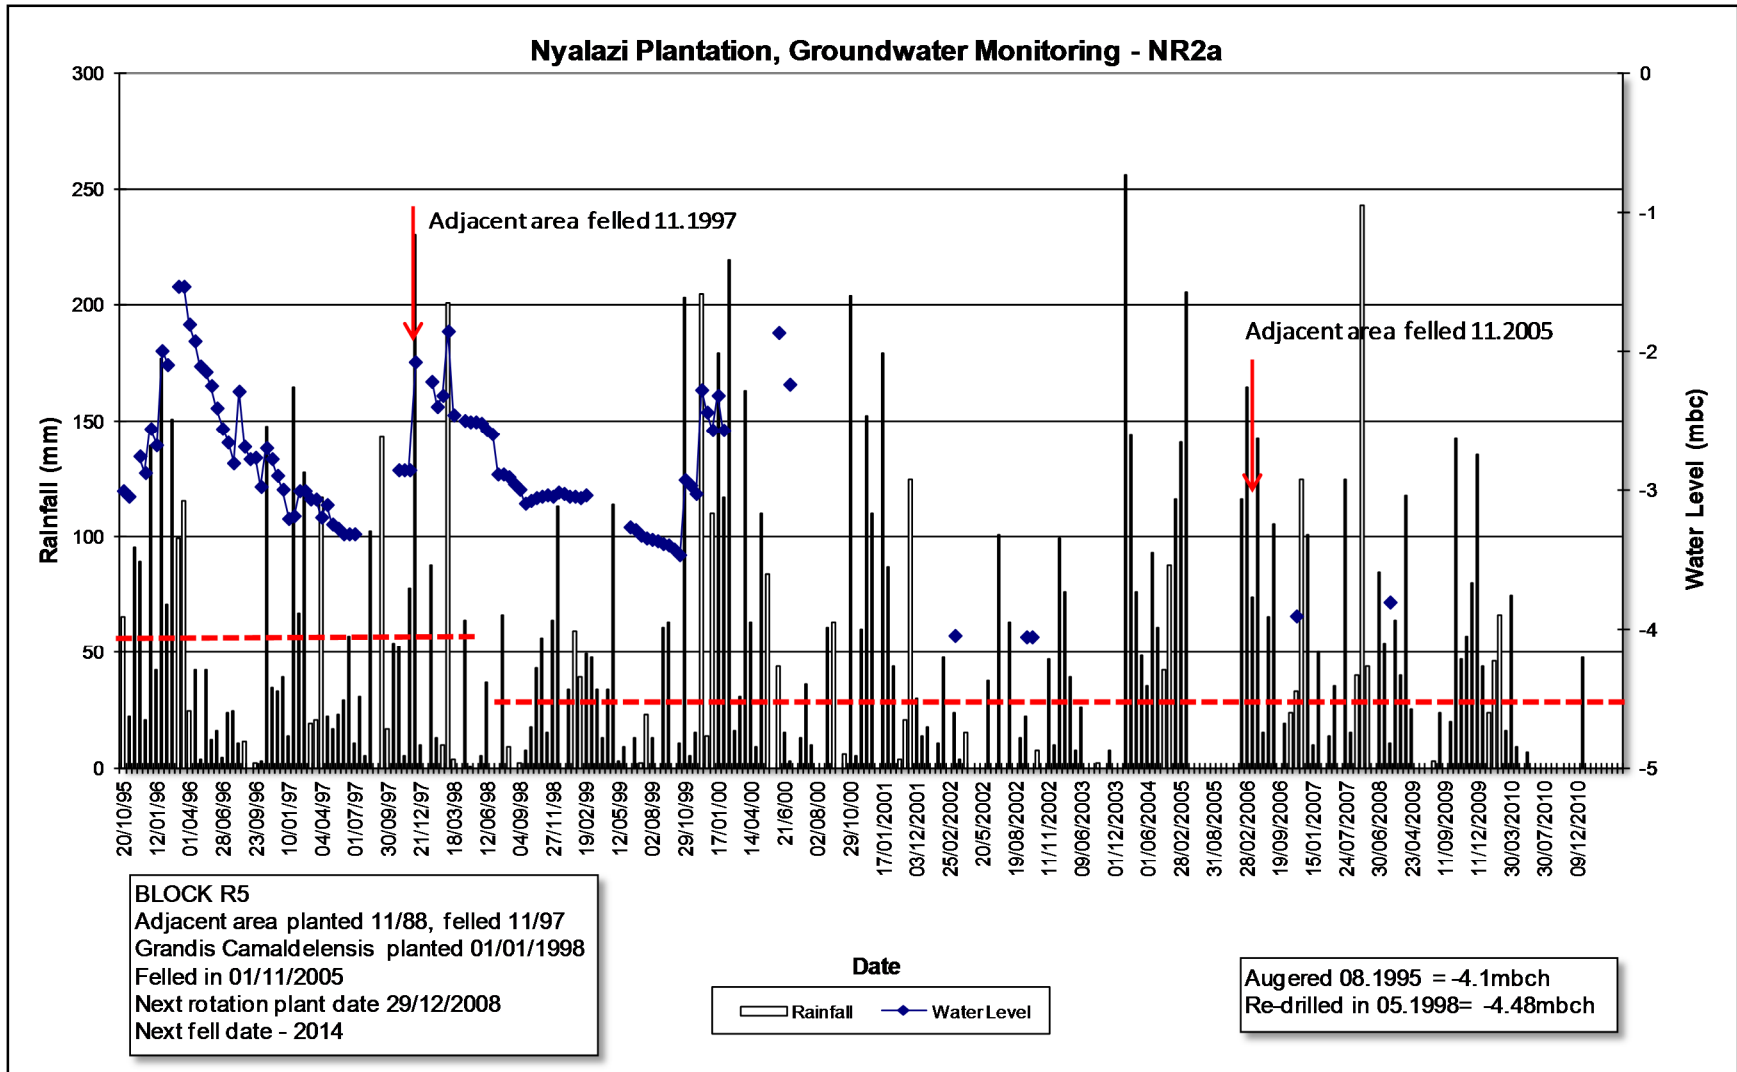
Figure 38: NR2a Water Level Trends - 1995-2010

The data indicates a rise in the water levels (Figure 38) over a period of four months (during late 1995 to early 1996), to the highest water level recorded for this monitoring point followed by a steady decline over the year to follow. The rise in water level may be attributed to the high rainfall recorded in early 1996. The decline coincides with a very low rainfall period of seven months (March 1996 to October 1996). Subsequently, the water level rise in 1997 corresponds to the felling of the adjacent plantation in November 1997 as well as high rainfall figures recorded over this period. The rise in water level is most likely as a result of the high rainfall due to increased recharge to groundwater, as this trend is observed in other monitoring points too.

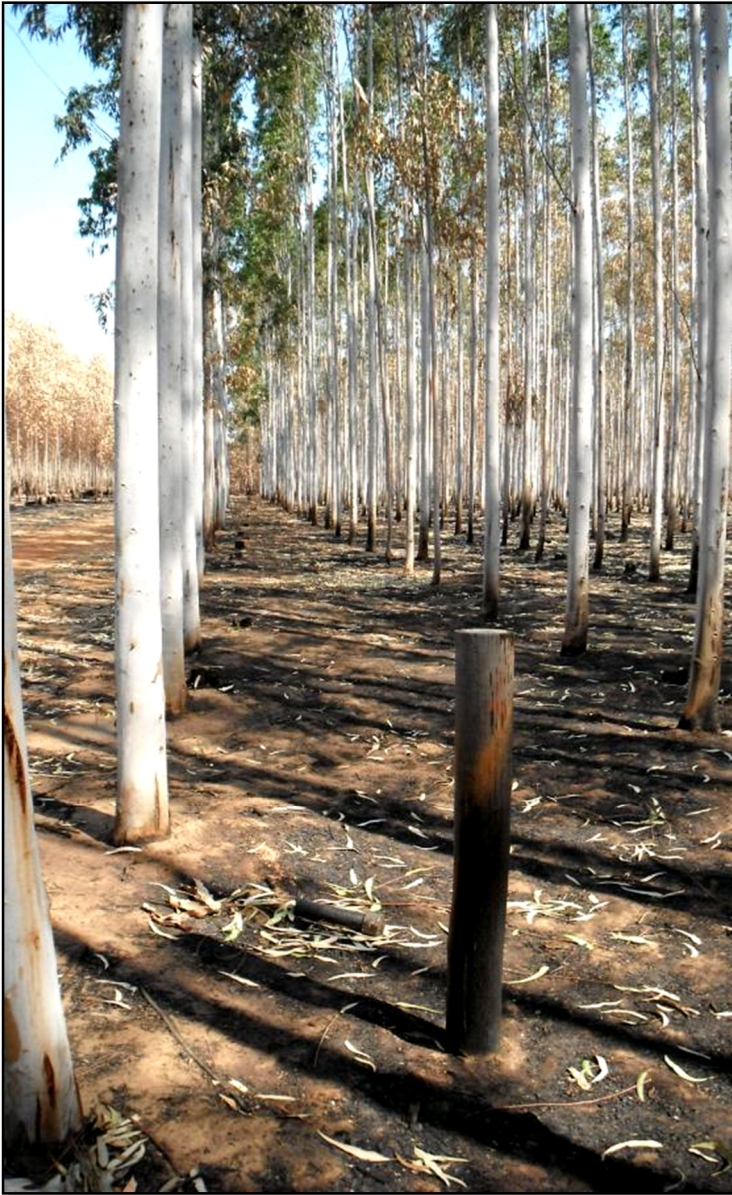
Figure 39: Monitoring point NQ1a

Piezometer NQ1a, located in the Eucalyptus area (Figure 39), indicated similar trends to other boreholes as discussed in Section 7.3.1.2, with the increase occurring in late 1995 to early 1996 followed by a decrease until mid 1997. The monitoring point was measured as dry beyond late 1998 (refer to Figure 40).

The piezometer is currently destroyed as the casing has been removed and the hole is filled up, with only the marker post remaining.

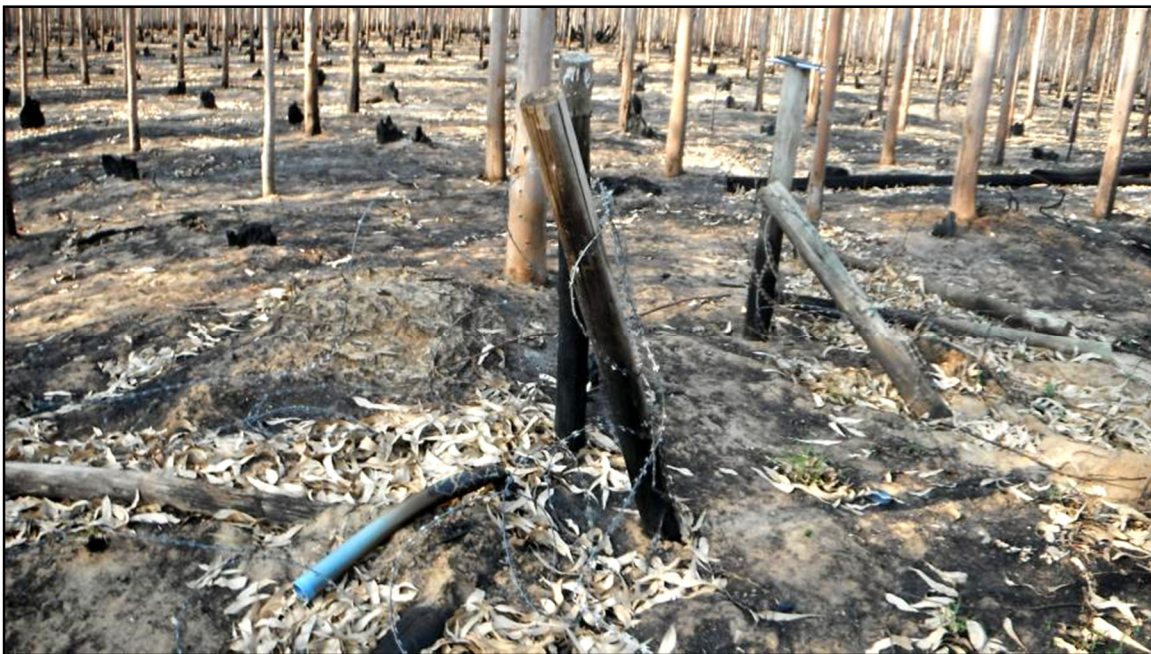
The initial trend observed when monitoring commenced, indicated a rise in water level in late 1995 which then declined and stabilised in 1997. The monitoring point was blocked for an extended period and was therefore deepened in July 2003 and after this deepened monitoring point ran dry, a new borehole was drilled adjacent to the old point in October 2007 (Figure 42). The measurements indicated a steady decline from 2008 until 2012, when the last measurement was recorded. On average, the water level declined by 1.1 metres per annum over the 17 year monitoring period. The rate of decline in water level measured proves to be one of the more rapid trends observed for the area. The current water level measured in August 2012 was measured as 24.92mbgl. The upper casing portion has been removed and the borehole is in a poor condition.

Figure 41: Old NN1a monitoring point - destroyed by fire

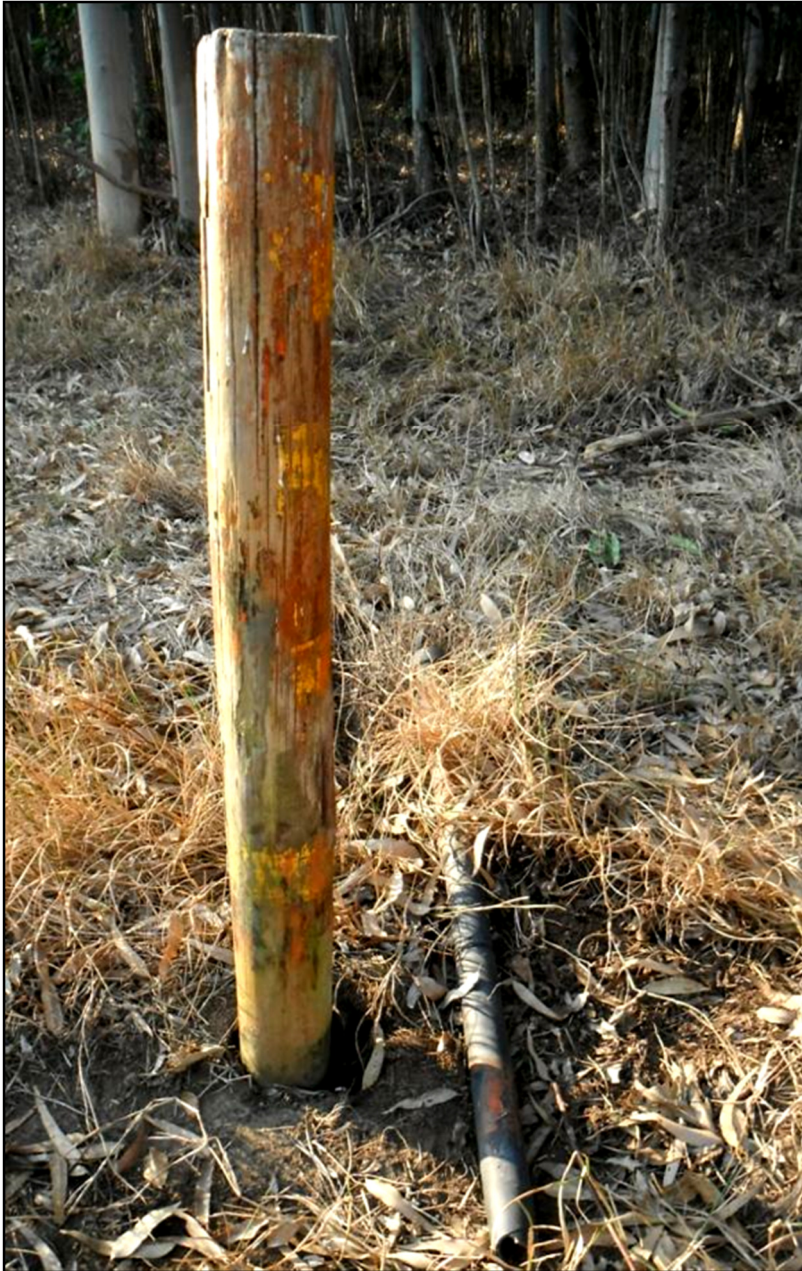
Figure 44: NK1a Monitoring point

During the site visit conducted in August 2012, it was evident that the casing has been removed from the monitoring point NK1a and the monitoring hole has been filled with sand (Figure 44). NK1a indicated comparable trends to other monitoring points in 1995/1996 where the rise and fall of water levels could be attributed to rainfall patterns and ultimate groundwater recharge (Figure 45). No further data was captured beyond 1998 as the monitoring point was dry.

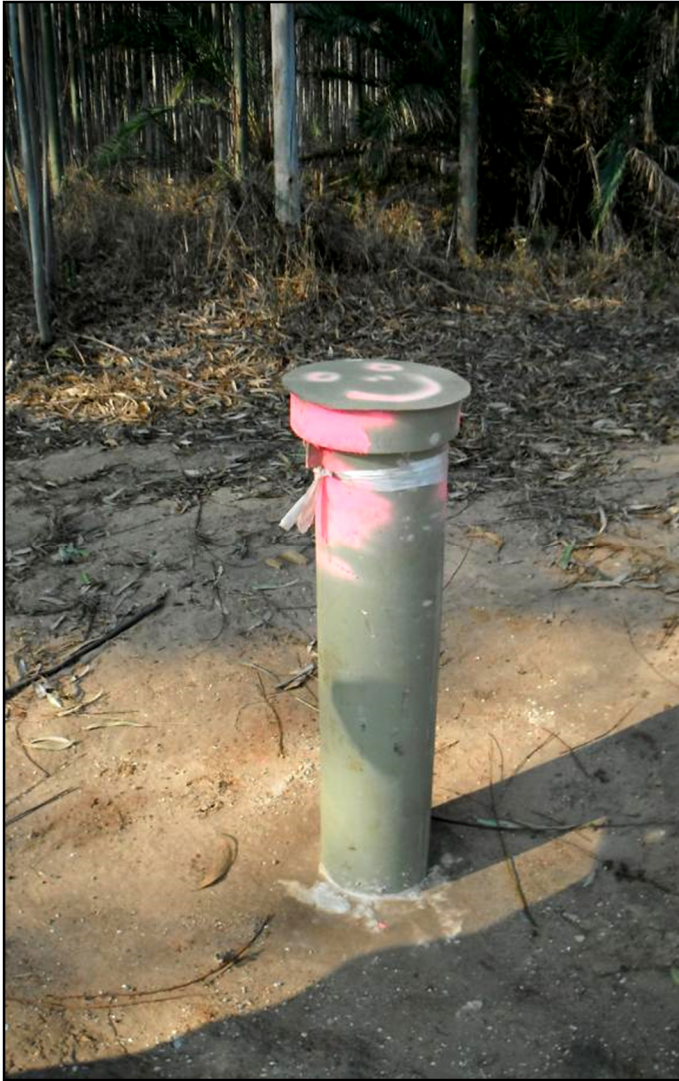
Figure 47: Monitoring borehole WES01

An additional borehole, WES01 was drilled in November 2011 (Figure 47), in close proximity to NM1a. This borehole is located approximately 260 metres south east of NM1a. The water level recorded in WES01 in November 2011 was 24.25 metres below ground level. This level is deeper than the last water level recorded in NM1a of 20 metres, which indicates the water level continues to decline. The borehole was not accessible during the August 2012 site visit and therefore no updated water level was recorded.

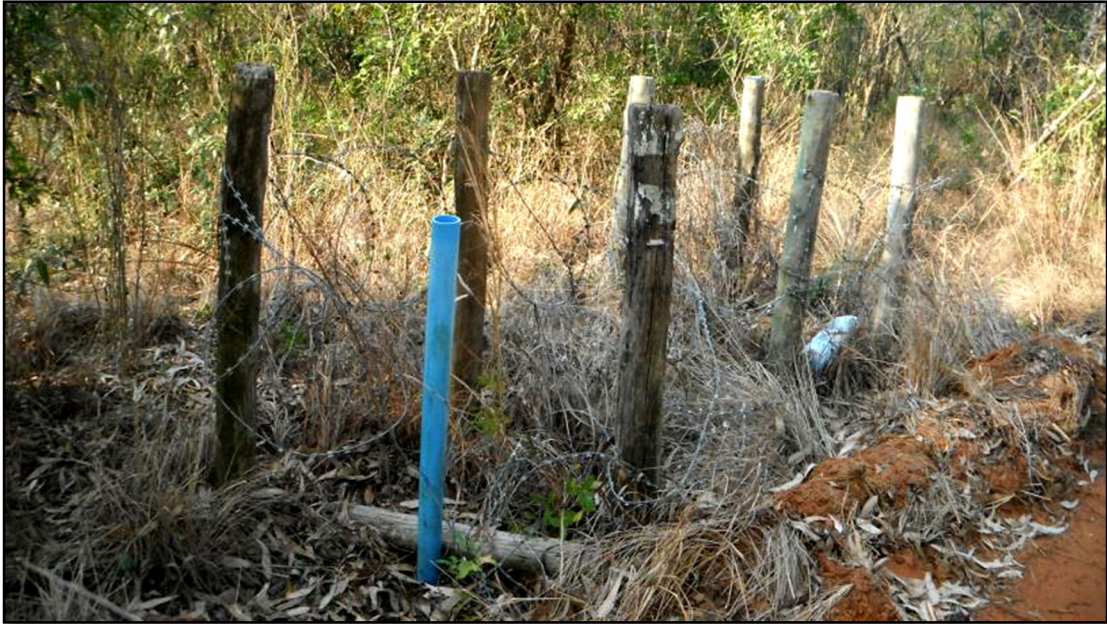
Figure 48: Old monitoring point NM2a

Piezometer NM2a, was installed in May 1995 (Figure 48), situated within the indigenous vegetation on the western boundary of the plantation and has been dry for majority of the monitoring period. A response to the high rainfall during 2000 was evident with an increase in the water level. The monitoring point was re-drilled in July 2002 (Figure 49) which was

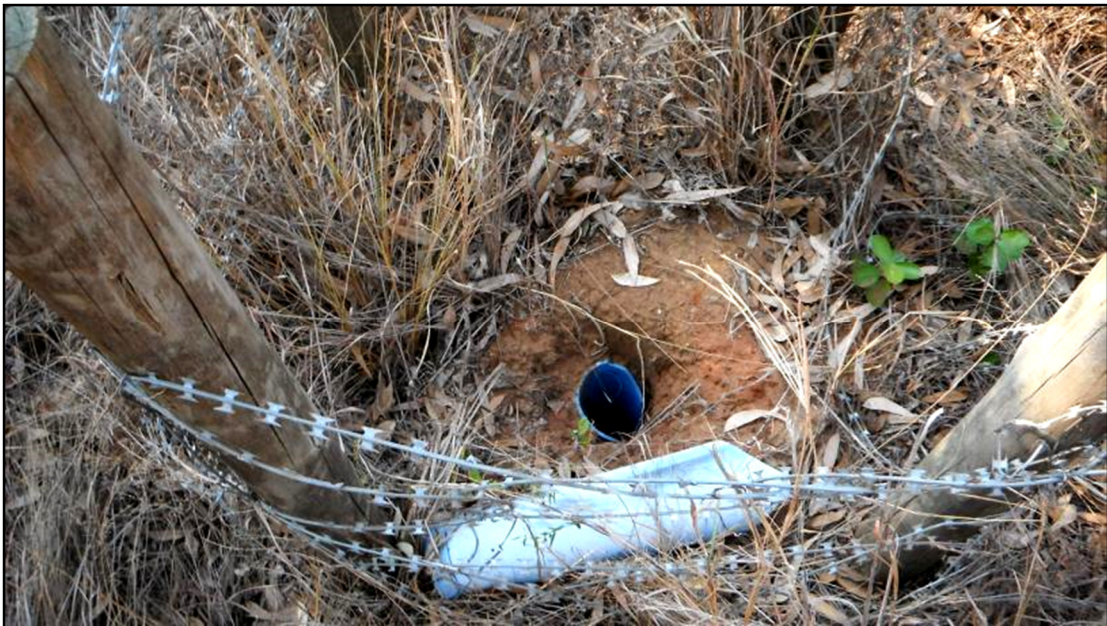
Figure 49: Newly drilled borehole NM2a

measured as dry from 2009 onwards (Figure 50). The current depth measured in August 2012 was 15.13mbgl.

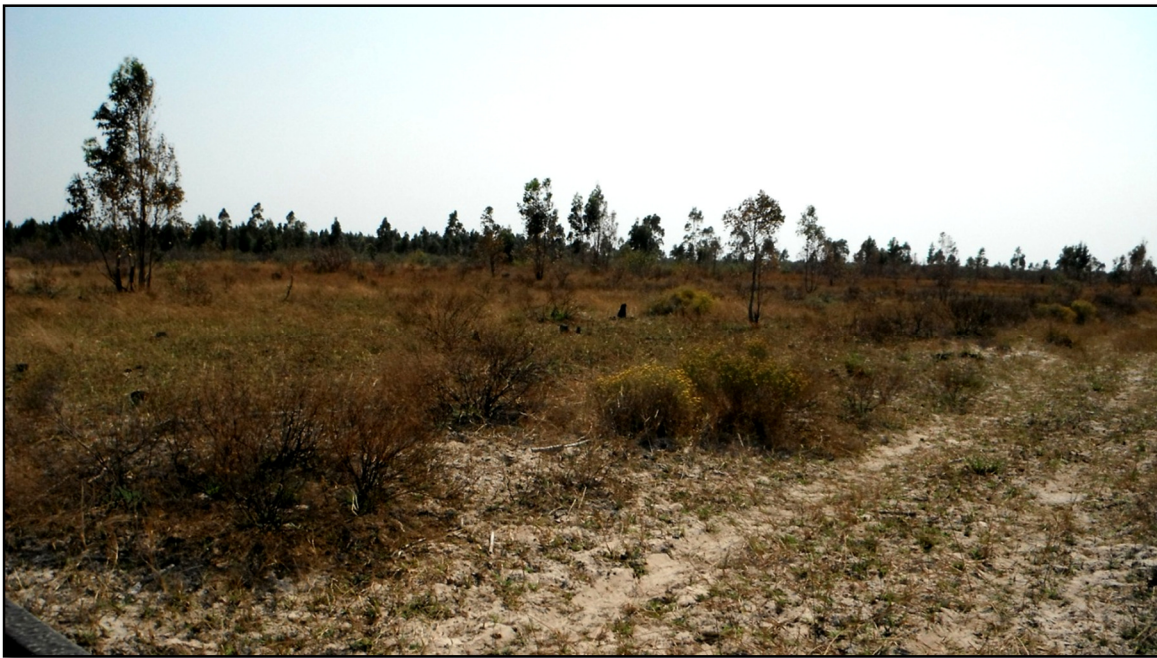
Figure 53: Area where NU2a and NU2b were located

NU2a and NU2b are located near the junction of compartments U28, U29 and U3. During the August 2012 site visit, these monitoring points were not located and therefore it is concluded that the two points have been destroyed, most likely by elephants in the area. The area now consists of indigenous vegetation as illustrated in Figure 53. The two monitoring points were located approximately 10 metres apart and therefore indicate virtually identical trends as indicated in Figure 54 and Figure 55, for NU2a and NU2b, respectively. The trends are also very similar to NU1a, with the exception of a more gradual decline during the period of 1998 in NU2a and NU2b compared to the sharp decrease in NU1a.

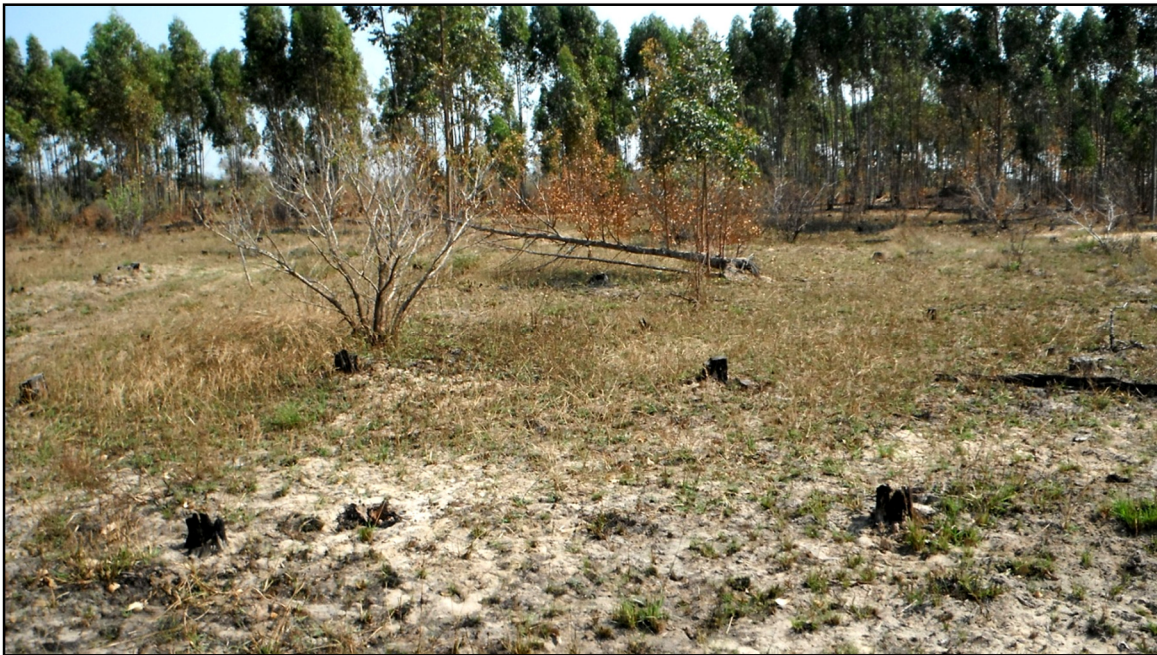
Figure 56: Area where NU3a was located

NU3a was located within compartment U3 along the western portion of the Pine plantations (Figure 56), however, was not located during the August 2012 site visit and has therefore been destroyed. The trend observed from the monitoring data indicates similar observations to the other monitoring points within this plantation (Figure 57).

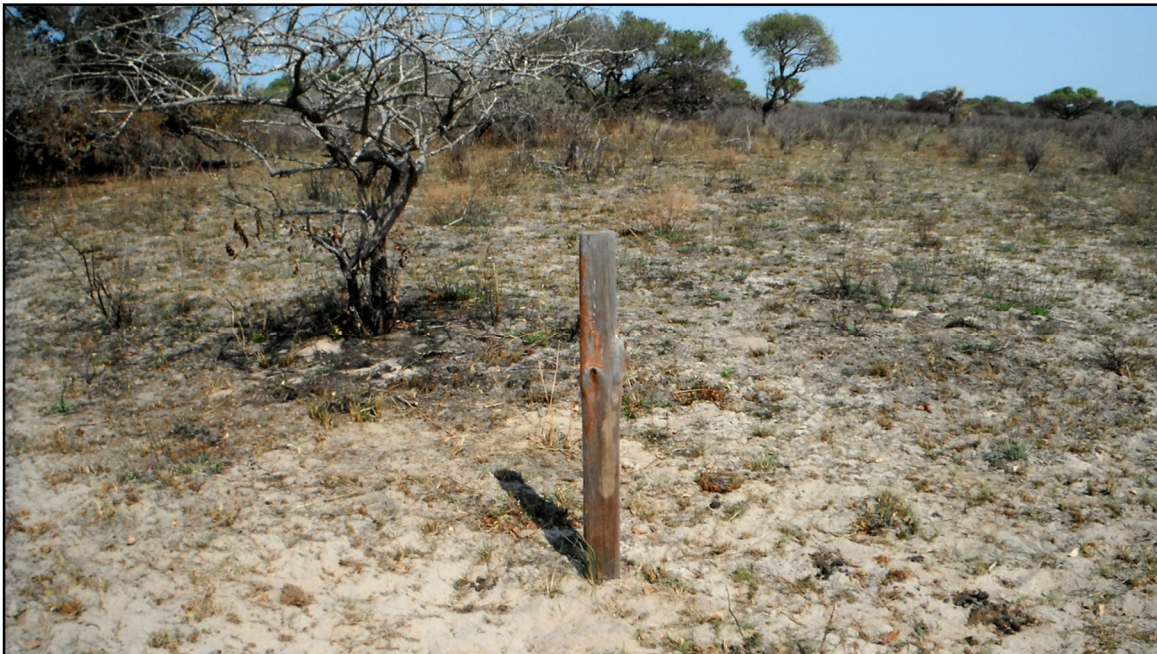
Figure 58: Monitoring point NR1a

Monitoring point NR1a is located approximately 200 metres from the southern boundary of the plantation situated within the indigenous vegetation (Figure 51). The location of the monitoring point was identified during the August 2012 site visit, marked by a wooden pole as presented in Figure 58, however, the casing was found adjacent to the monitoring point and the hole was not identified and is therefore most likely backfilled with sand.

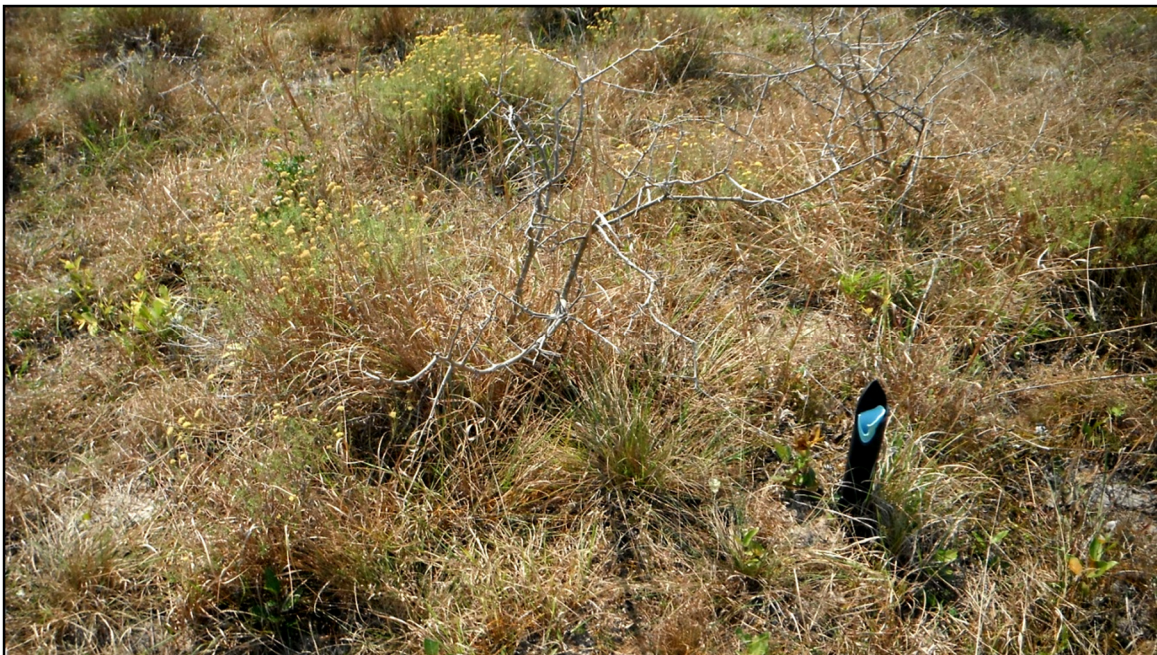
Figure 60: Monitoring point NT1a

NT1a is located approximately 200 metres east of NU1a and the eastern boundary of the Pine plantation, with the purpose of monitoring the indigenous vegetation. Figure 60 displays the current status of the monitoring point, where the casing has been damaged. The water level trends of NT1a (Figure 62) are almost identical to those of NU1a, which is located within the plantation. The exception is that the water level of NT1a is slightly shallower than those measured in NU1a. On average, NT1a indicates a water level which is between 0.5 metres and 1 meter shallower than NU1a. This is most likely due to the fact the NT1a is located within the indigenous vegetated area and NU1a is within the plantation. The depth obtained during the August 2012 site visit, was measured at 4.36mbch, with a collar height of approximately 0.29 metres.

Monitoring point NT1a, located adjacent to the Pine plantation which occupied the area until 1995, which was replaced by Eucalyptus and finally restored back to indigenous land indicated that the water levels had recovered even after the presence of Pines from 1967 to 1998 and Eucalyptus from 1998 to 2001/2002. This most likely as a result of the system reaching equilibrium once the plantation was removed and the area was restored to its natural state.

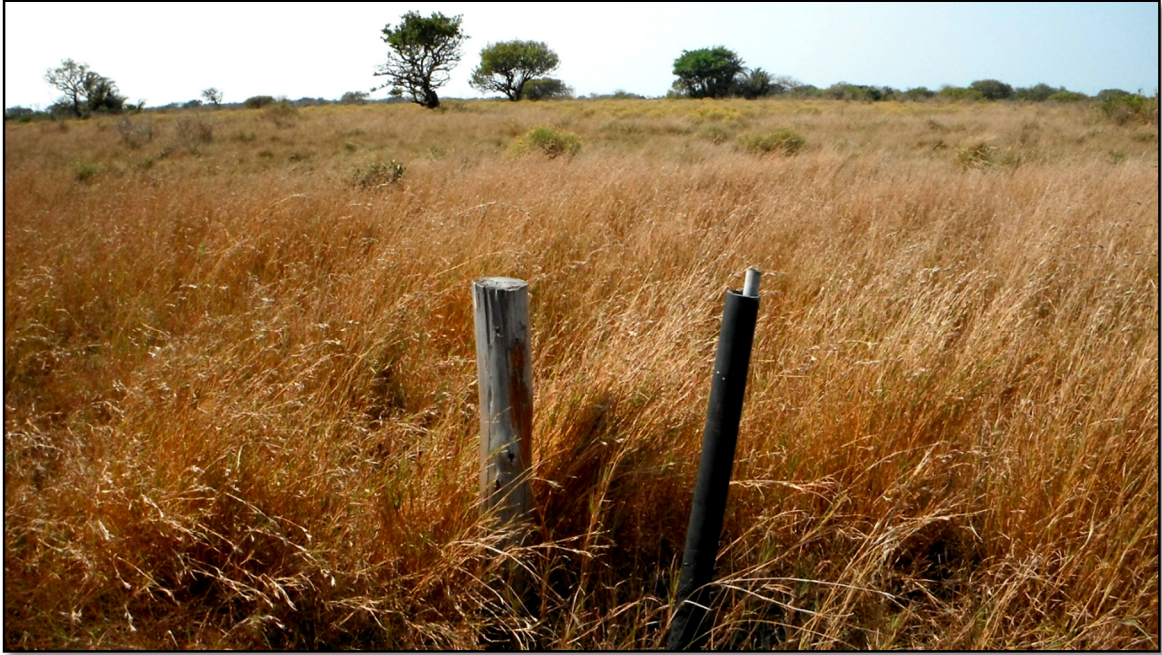
Figure 61: Monitoring point NT2a

NT2a is located approximately 100 metres east of NT1a (Figure 61) and also monitors the indigenous vegetation. NT2a also indicates comparable trends to the nearby NT1a and NU1a monitoring points (Figure 63). The trend in this monitoring point indicates a more gradual fluctuation whereas the other two indicated sharp responses in the water level. The initial water level of 2.42 mbch recorded in NT2a, was also shallower than those measured in NT1a and NU1a of 4.24mbch and 5.55mbch respectively, which are closer to the plantation. No data was collected between 2001 and mid 2004, for unknown reasons.

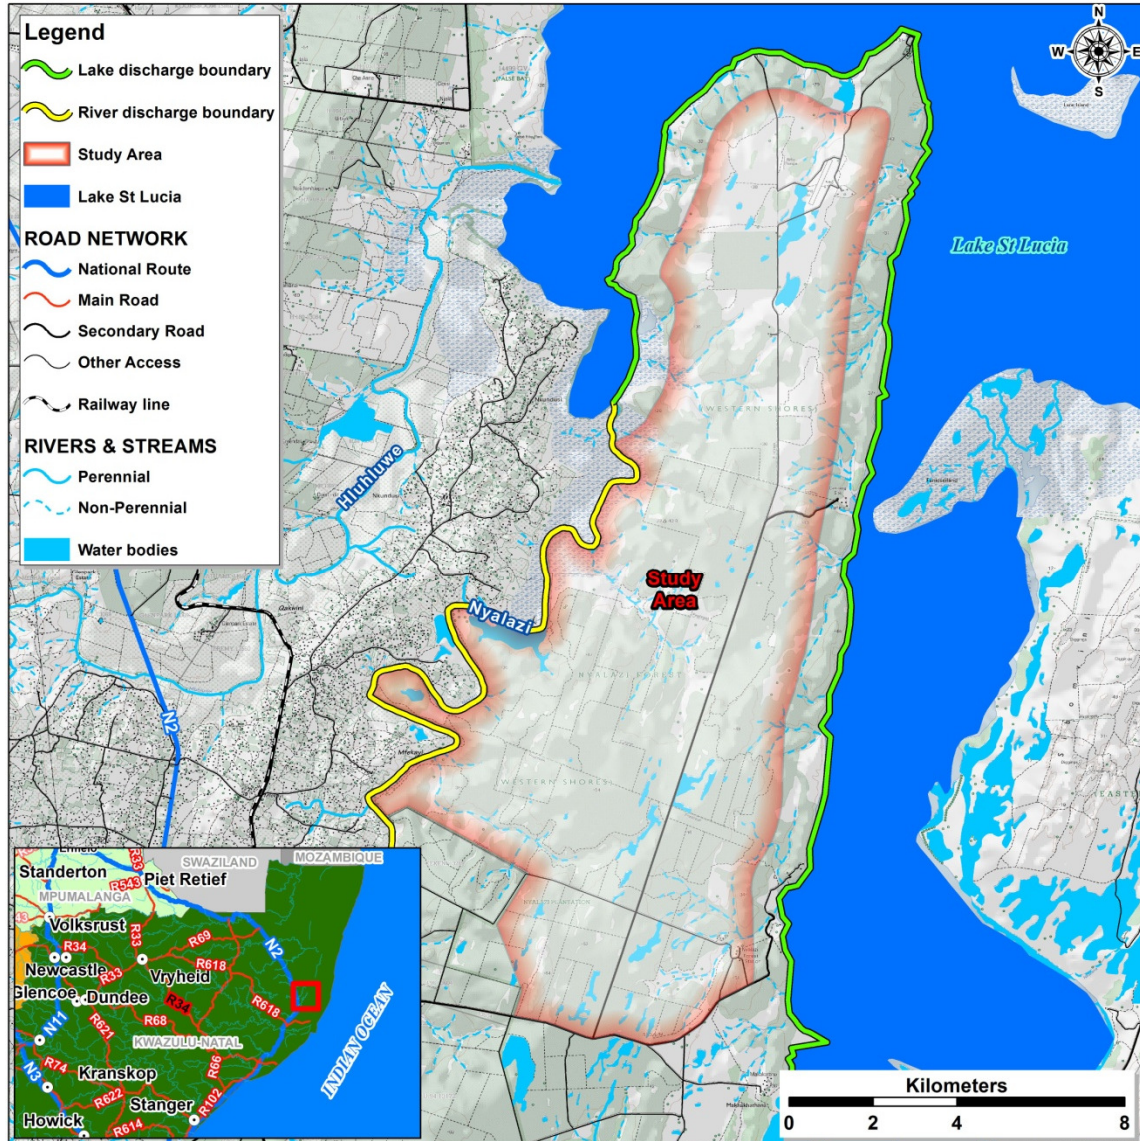
Figure 68: River and Lake Discharge boundary used for calculation

Therefore the total volume of water within storage which is lost based on the presence of the plantation, is $1\,150\,000m^3$ minus the $44\,676m^3$ discharged to the lake/river. This amounts to $1\,127\,020m^3$ on a yearly basis.

If it is assumed that all rainfall is also utilised by the plants, through canopy interception, evapotranspiration, utilising water within the soil moisture zone and assuming runoff is negligible for the site, then the amount of rainfall is also considered as water which is consumed by the plantation. This was calculated by determining the amount of rainfall which falls only on the commercially planted area. The average annual rainfall for the site area is 866mm/annum (0.866m/annum) and the area of commercial plantation within the site area is 69 405 000m². This results in an amount of 60 million m³ per year. Therefore the total volume of water lost by the plantation on an annual basis is roughly 60.1 million m³ per year, which equates to 8820 m³/year/ha which can also be expressed as 24 m³/day/ha.

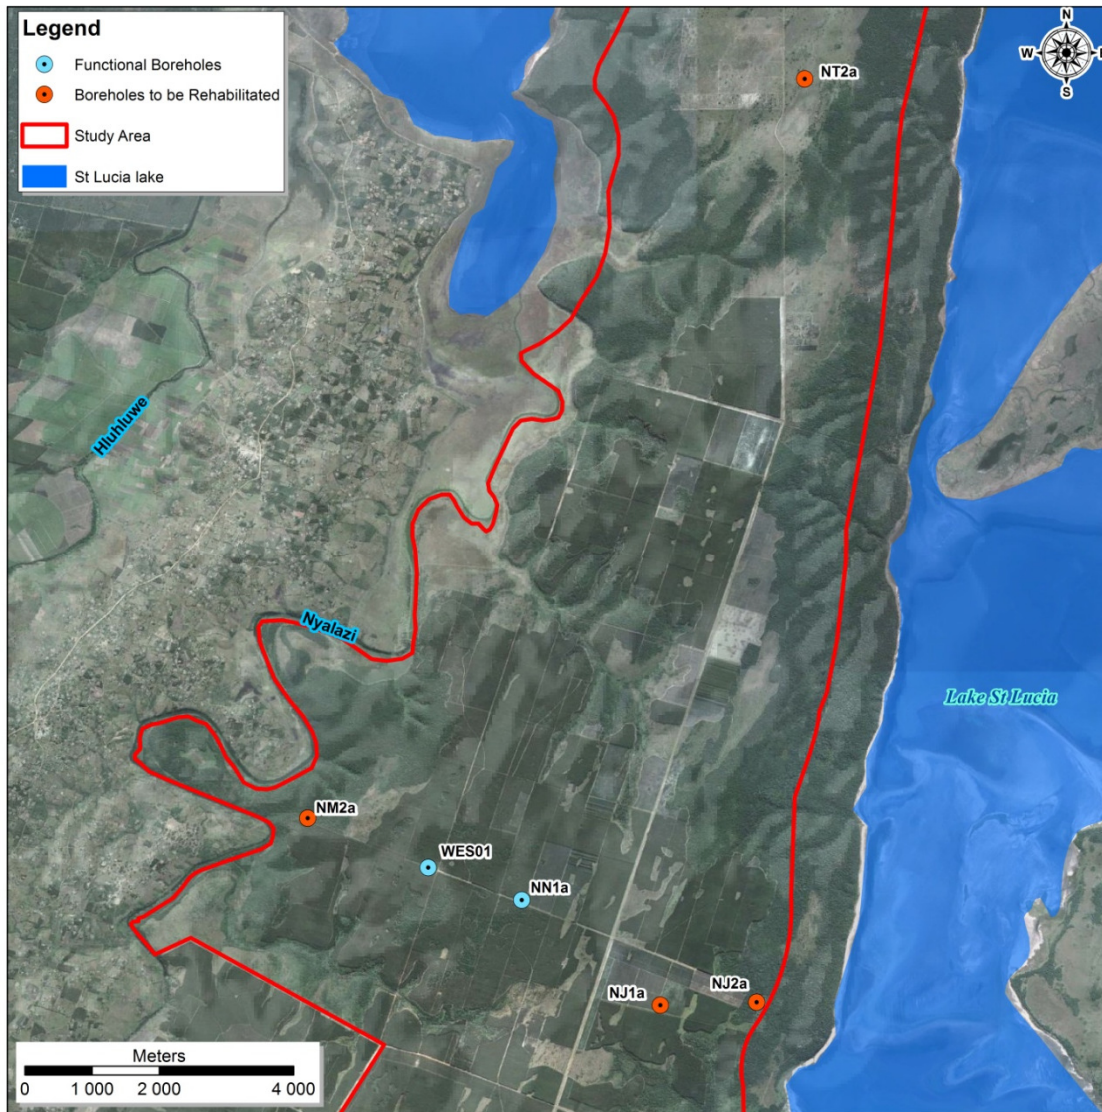
Figure 71: Borehole Rehabilitation Map

As a result of the current monitoring network status, recommendations are made in order to upgrade the necessary boreholes to allow for continuous monitoring across the study area. The boreholes recommended for rehabilitation are discussed in Table 6 and illustrated in Figure 71. This is the minimum amount of rehabilitation required to collect data from the different areas within the study area.

Borehole	Monitoring Description	Action Required
NT2a	Located within the northern portion of the study area, within the indigenous area west of the old Pine and Eucalyptus plantation which was cleared from 2001-2003	Blocked at 1.07 metres, therefore the blockage needs to be removed. If the monitoring point is dry after it is unblocked, it is recommended to redrill a new borehole.
NM2a	Located within the indigenous vegetation. Borehole was re-drilled in the past and is currently blocked and dry.	Remove blockage. If a water level measurement is then possible, upgrade the headworks to ensure validity as a monitoring borehole.
NJ1a	Borehole is located within the Eucalyptus plantation. Drilled to 21 metres but is blocked at 7 metres.	Remove blockage and upgrade headworks.
NJ2a	Located east of the plantation within the indigenous vegetation. Borehole is blocked at 11 metres.	Remove blockage and upgrade headworks.

Based on the current status of the monitoring network present on the site, whereby several monitoring points have been damaged by fires and wildlife, or are dry, it is recommended that the most critical monitoring points are rehabilitated. These monitoring points are NT2a, NM2a and NJ2a which monitor the adjacent indigenous vegetation as well as NJ1a which monitors the Eucalyptus plantation. Additionally, two monitoring boreholes are still functional within the plantation, namely NN1a and WES01.
