THE ENVIRONMENTAL IMPACTS OF THE GROUNDWATER ON THE ST. LUCIA WETLAND

A dissertation submitted to meet the requirements for the degree of
Magister Scientiae

In the Faculty of Natural and Agricultural Sciences
Institute for Groundwater Studies

April 2013

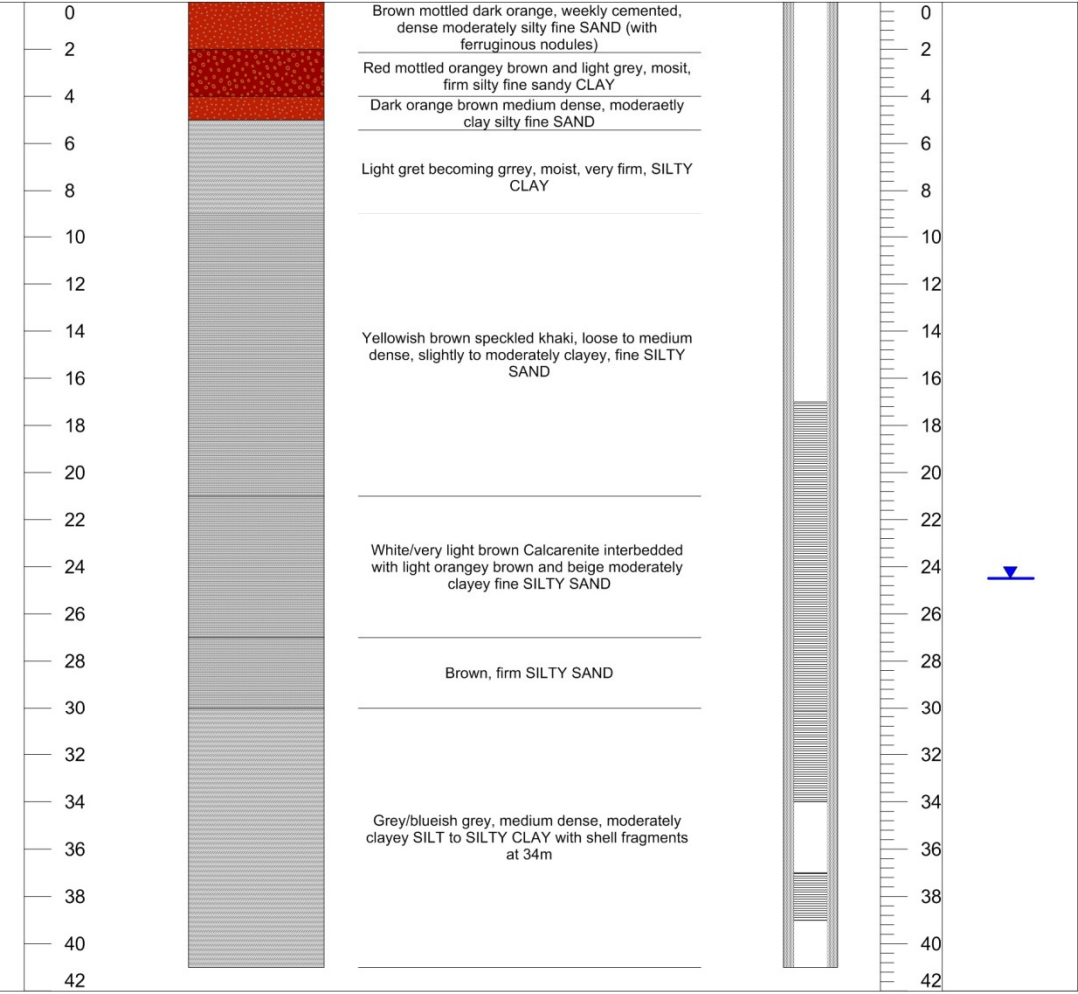
PROJECT: Nyalazi		BOREHOLE ID: WES01
	LOCATION: St. Lucia		LATITUDE: -28.16744
	DRILLING CONTRACTOR: Kwa_Natal Drilling		LONGITUDE: 32.36908
	DRILLING METHOD: Mud Rotary		ELEVATION: 52
	DATE COMPLETED: 12/30/2011		DEPTH: 41
Depth (m)	Graphic log	Description	Well Construction

An additional borehole, WES01 was drilled in November 2011 (Figure 47), in close proximity to NM1a. This borehole is located approximately 260 metres south east of NM1a. The water level recorded in WES01 in November 2011 was 24.25 metres below ground level. This level is deeper than the last water level recorded in NM1a of 20 metres, which indicates the water level continues to decline. The borehole was not accessible during the August 2012 site visit and therefore no updated water level was recorded.
