**A COMPARATIVE STUDY OF LANDSLIDES AND GEOHAZARD MITIGATION IN
NORTHERN AND CENTRAL MALAWI**

**Thesis Submitted for the Degree
Doctor of Philosophy,
Faculty of Agricultural and Natural Sciences,
Department of Geography,
University of the Free State**

November, 2007

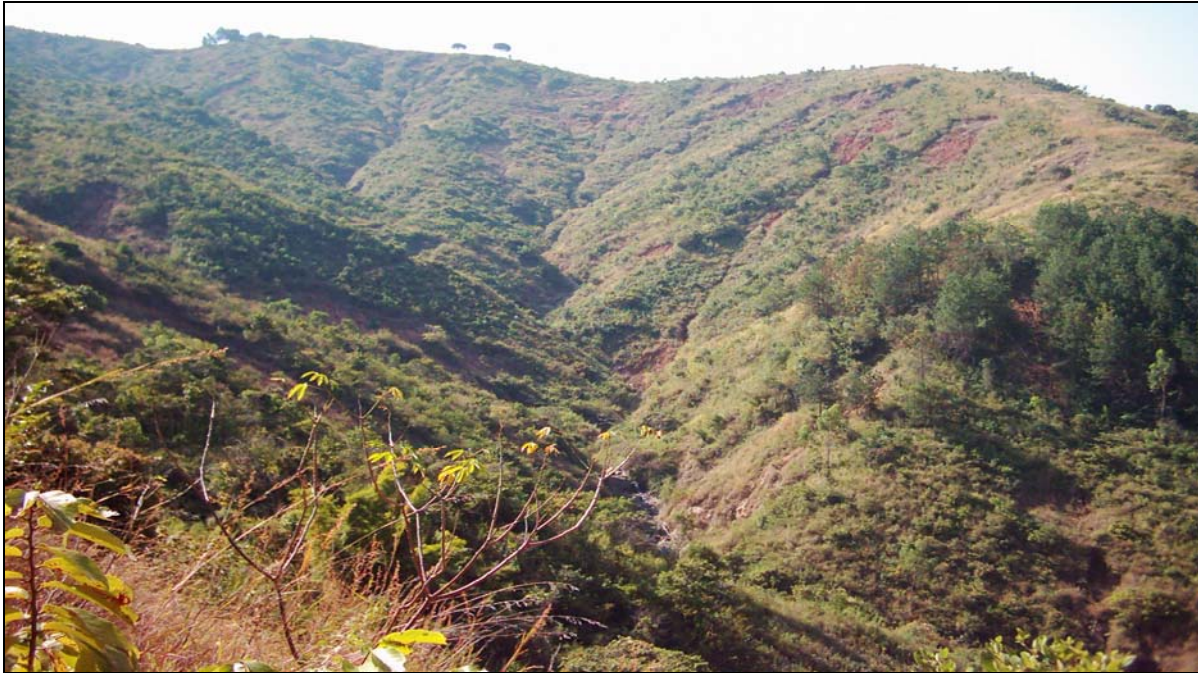
Figure 2.6: Part of the Ntchenachena Area with interlocking spurs and funnel-like valleys: Note the landslide scars (26.08.06).

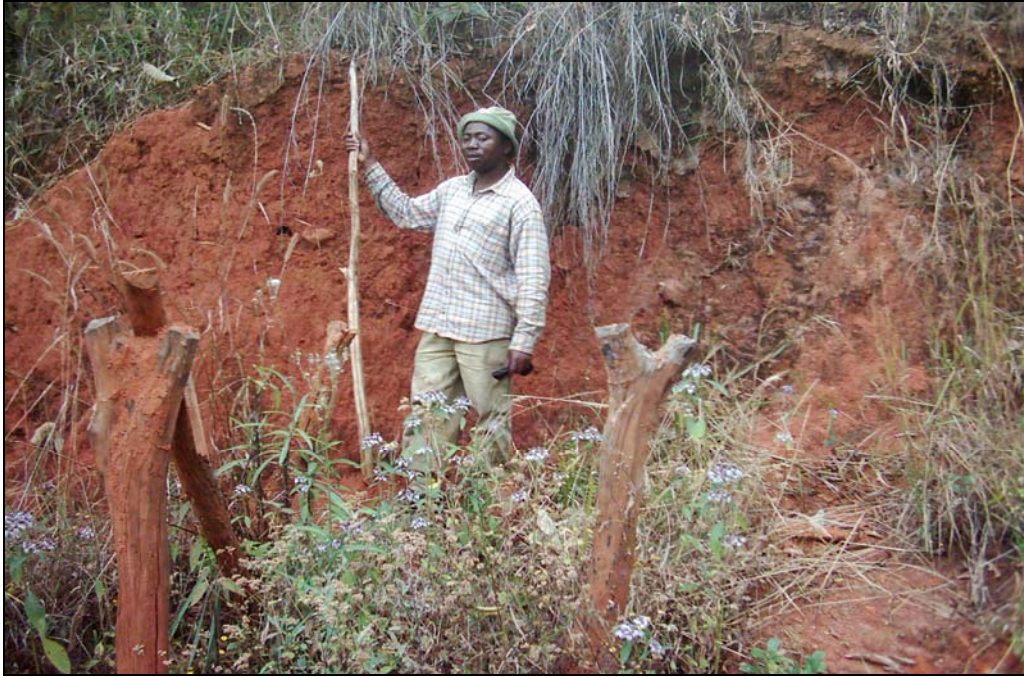
Figure 2.7: Deep ferrisols of the Ntchenachena Area in Rumph District which are prone to liquefaction (26.08.06).

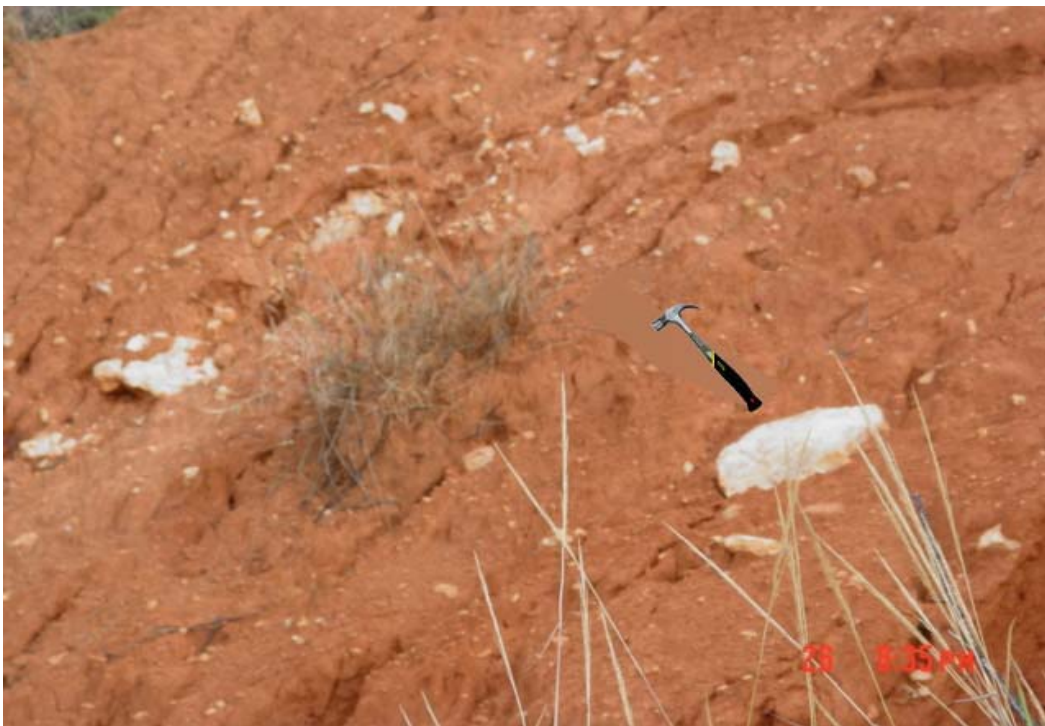
Figure 2.8: Ferrisols of the Ntchenachena Area with quartz floats which affect the shear strength of the soils. Note the formation of rills (26.08.06).

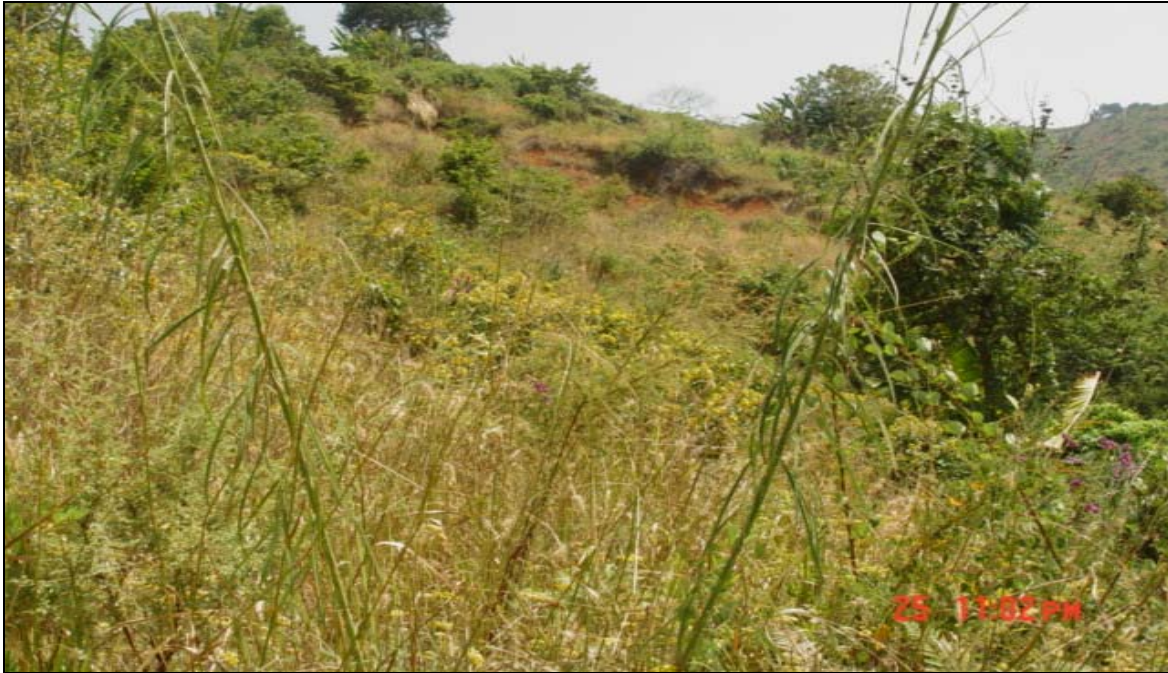
Figure 2.9: Afro-Montane vegetation of Ntchenachena. Grasses and shrubs are dominant which do not provide maximum mechanical binding to the deep ferrisols (25.08.06).

The vegetation of this area is classified as Afro-montane, with scattered grass and shrubs (**Figure 2.9**). Common shrubs in this area include *Protea*, *Faura saligna*, and *Syzigium* (**Section 7.3**). Most of the slopes are under cultivation (**Figure 7.5 p.131**), and this has resulted in large scale cutting down of trees, although isolated patches of pine trees are still growing along the ridges. The rate of deforestation has accelerated in recent years mainly due to seasonal burning of the trees, bushes and shrubs for shifting (slash and burn) cultivation and hunting. These shrubs and bushes represent a degenerated type of vegetation. Along the streams, dry season cultivation is being practiced, and that has resulted in the destruction of shrubs and dambo grass.

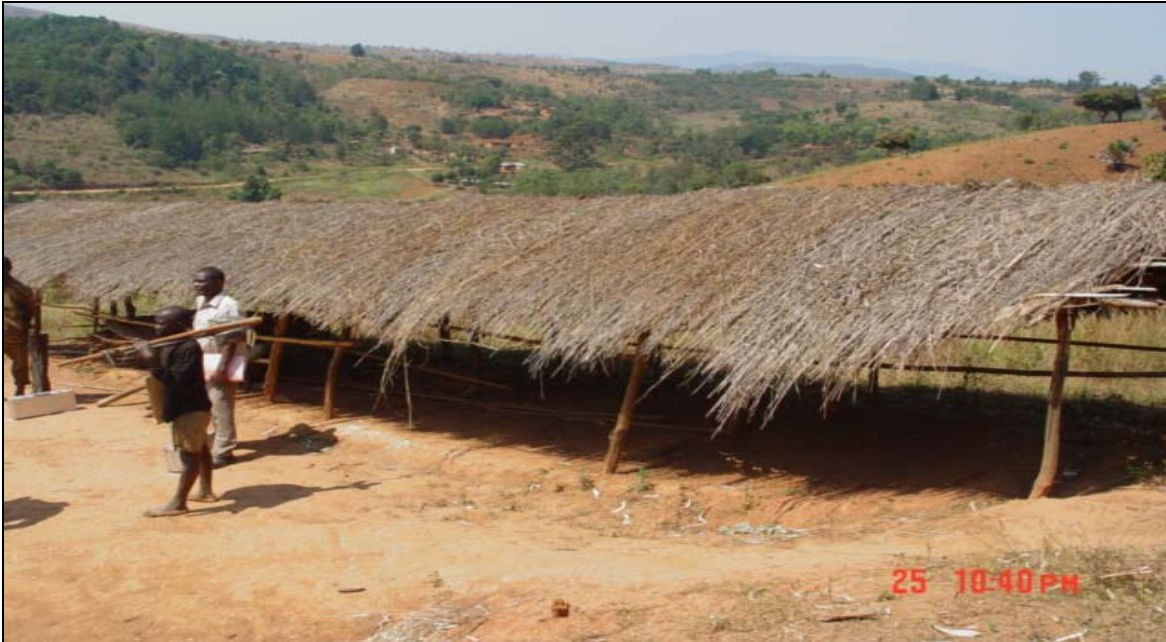
Figure 2.10: Tobacco curing shed in the Ntchenachena Area, contributing to deforestation. Note that the location of the Shed is on a remodeled slope affecting the balance of forces operating in slope (25.08.06).

Agriculture is the most important activity being carried out in the area. The majority of the people living in this area are subsistence farmers. The main crops grown in the area include maize, pineapples, cassava, millet, sorghum, bananas, and vegetables. Coffee and tobacco (Figure 2.10) are grown as cash crops, but on a small scale. The Phoka people herd animals, mainly goats (Figure 7.12 p.142), and they are also hunters.

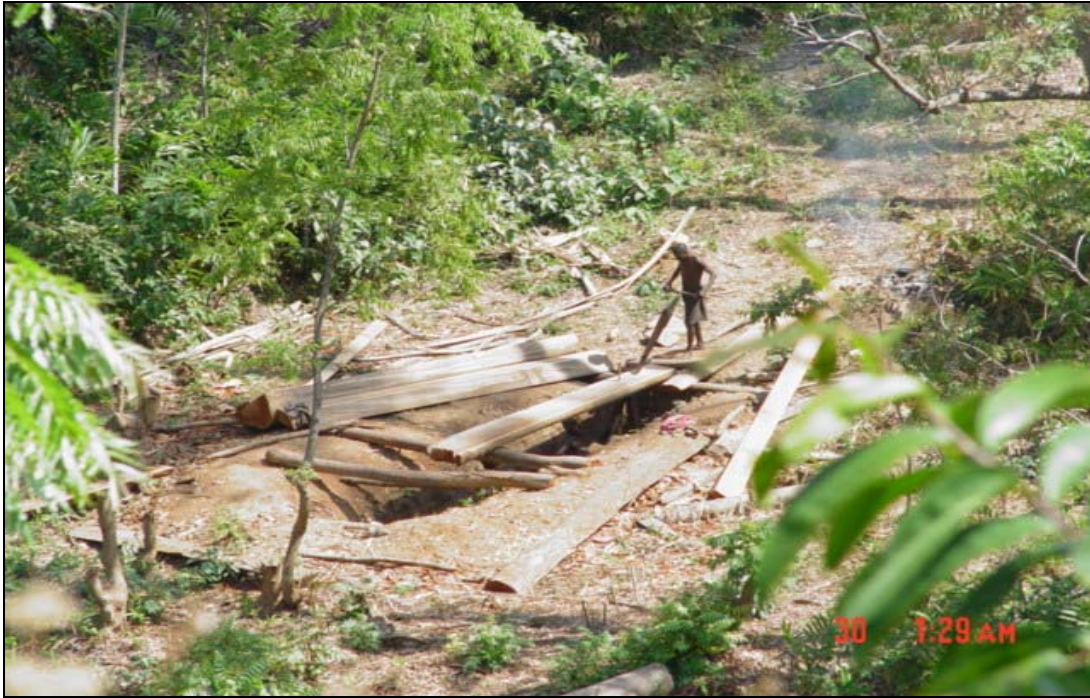
Figure 2.11: Pit sawing in the Ntchenachena Area, contributing to deforestation and slope instability (30.08.06).

Lumbering (mainly pit sawing) is an important activity in this area (Figure 2.11). This has been boosted by the construction and carpentry industries which provide income generating opportunities for the local population. Valuable timber tree species include *Gmelina Blue gum*, and *Pinus pitula*.

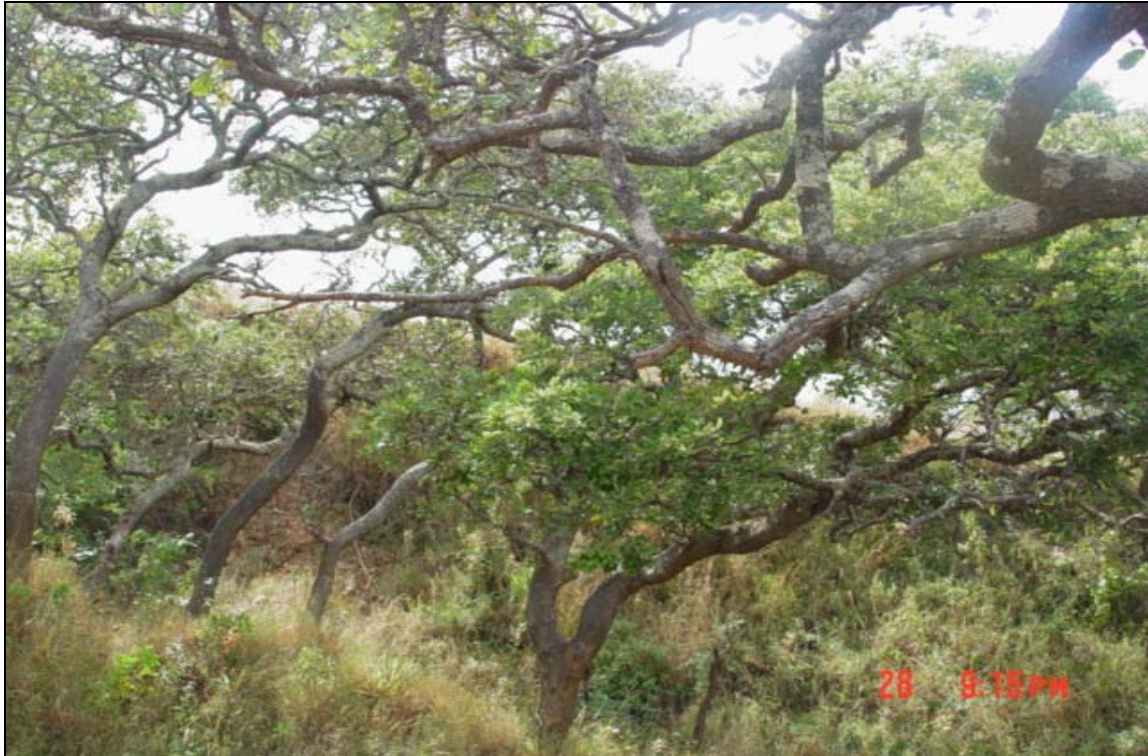
Figure 2.13: Miombo woodlands typical of the Chiweta, Mvai and Livilivi Areas, which were observed to contribute to slope stability through mechanical binding of particles (28.08.06).

The area is dominated by light forest trees, with bare areas along the slope cutting. This vegetation is broadly categorised as Miombo (**Figure, 2.13**), and the dominant tree species include *Brachystegia*, *Combretum*, *Diplorhynchus condylocarpon*, *Acacia*, and *Pseudolachnostilis* (**Section 7.3 p130**). Much of the forest is still undisturbed although the lower part is experiencing encroachment. Tree cutting is mainly due to a boom in tobacco production and increasing demand for fuel wood in Mzuzu City which is to the south of the study area. Because of the light forest canopy cover, savanna grasses flourish and are well-established. Areas along the lake are not forested due to the presence of sandy soils.

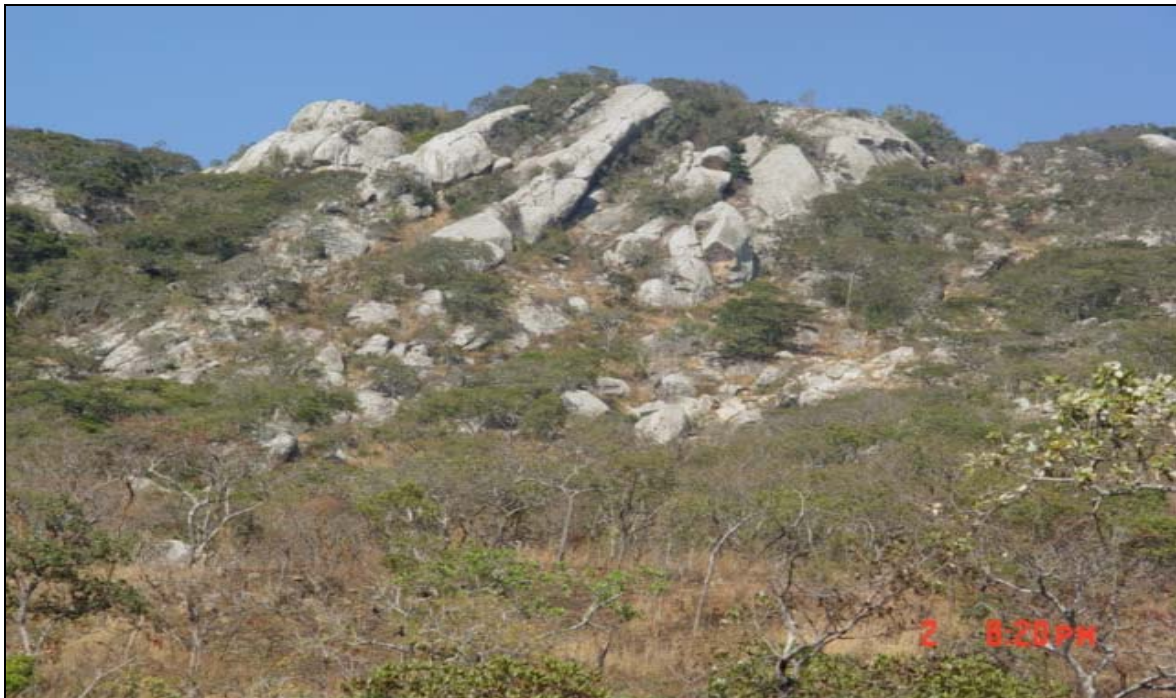
Figure 2.15: Rock outcrop (gneisses) within the Mvai/Livilivi Catchments. Rockfalls have been reported in this Area. Note the Miombo woodlands in fore ground which arrest some falling boulders (2.09.06).

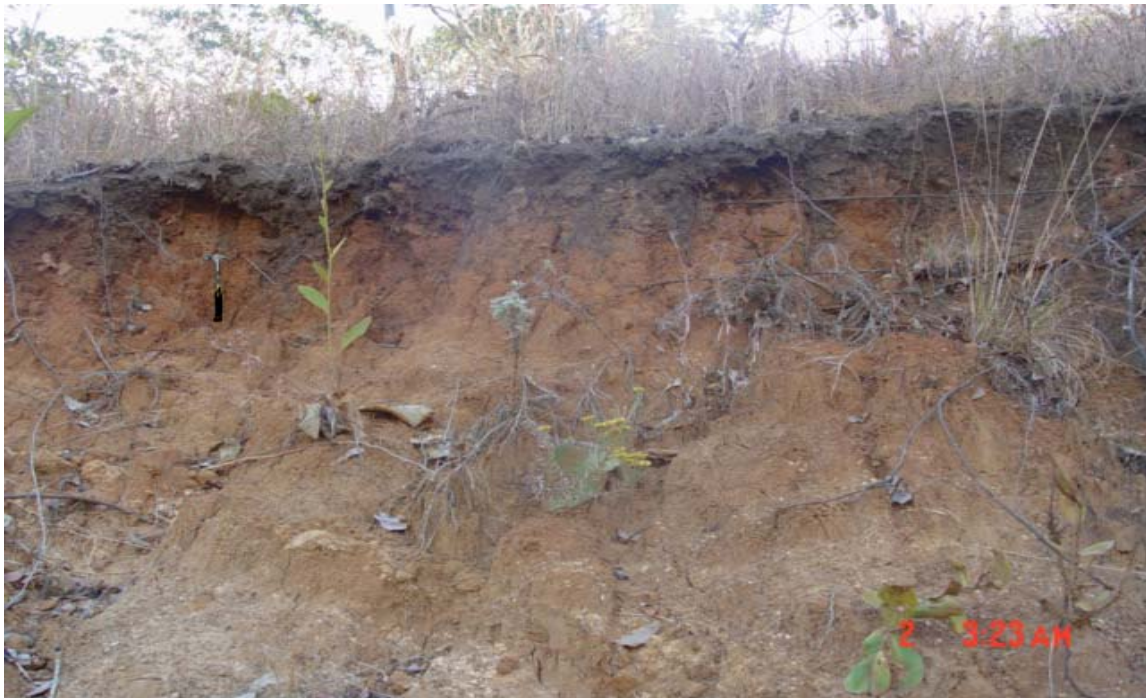
Figure 6.6: Curved surface rupturing, common in the Livilivi and Ntchenachena Areas. Photo taken at Livilivi, Ntcheu District (2.09.06).

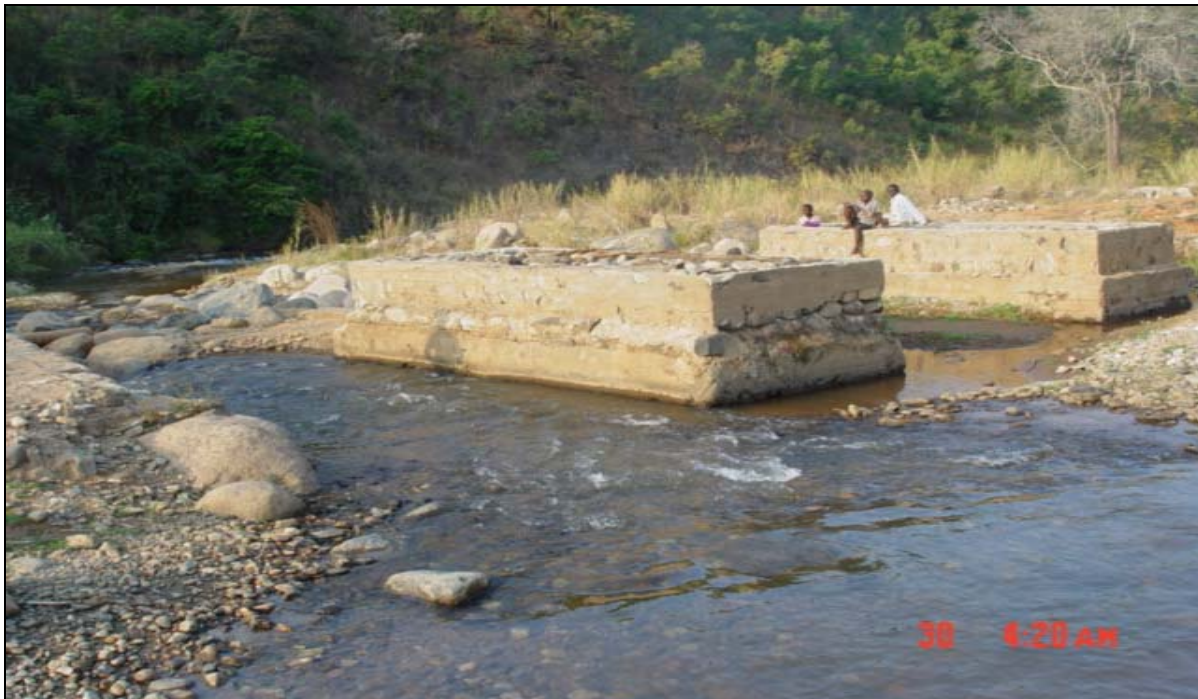
Figure 6.8: The remains of the Phoka Bridge at the confluence of the Mzinga and the North Rumphi Rivers after the 2003 landslides in the Ntchenachena Area (30.08.06).

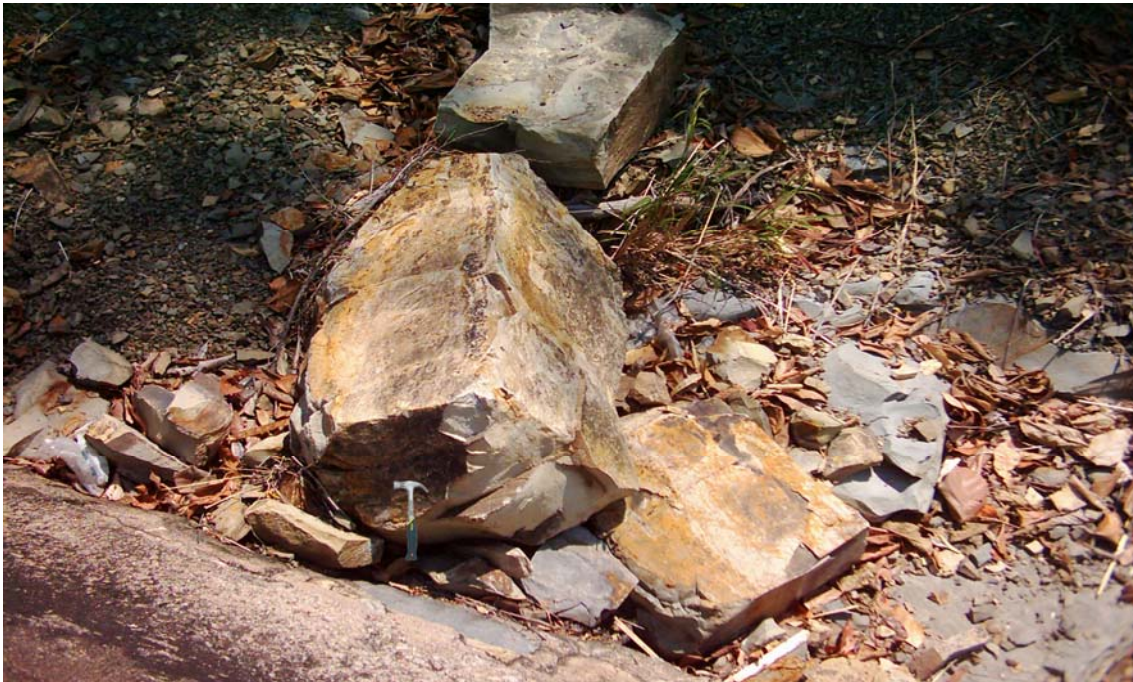
Figure 6.9: Rock falls along the M1 Road to Karonga, typical of the Chiweta beds. These have been a major cause of accidents (29.08.06).

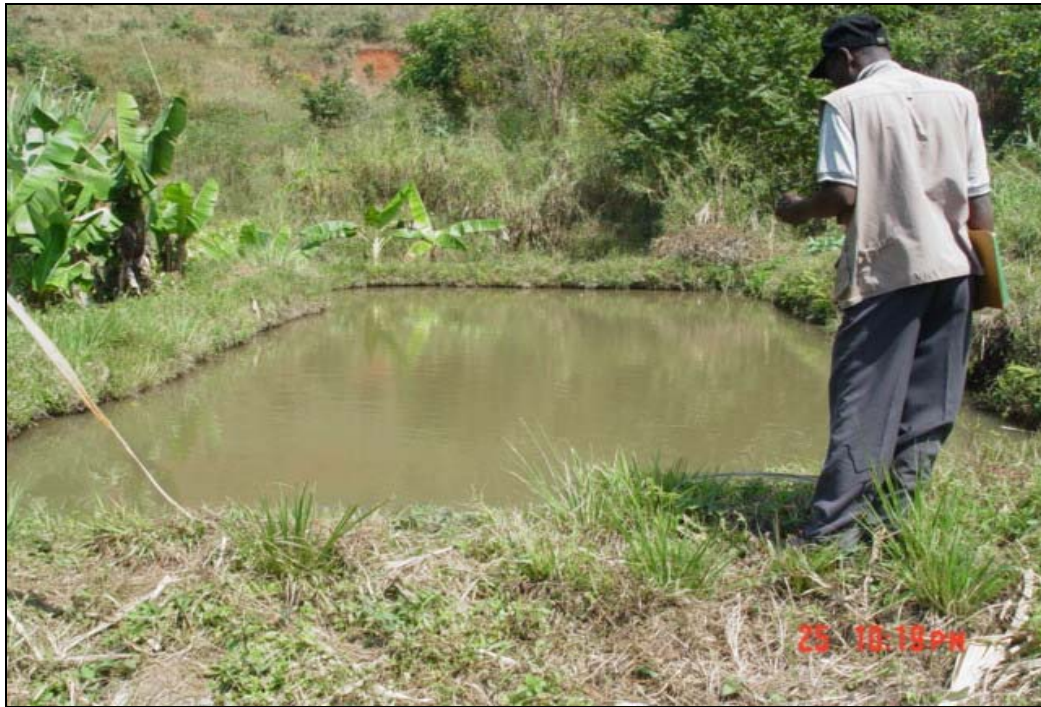
Figure 6.10: One of the three fish ponds that were destroyed during the 2003 Landslides in the Ntchenachena Area (25.08.06).

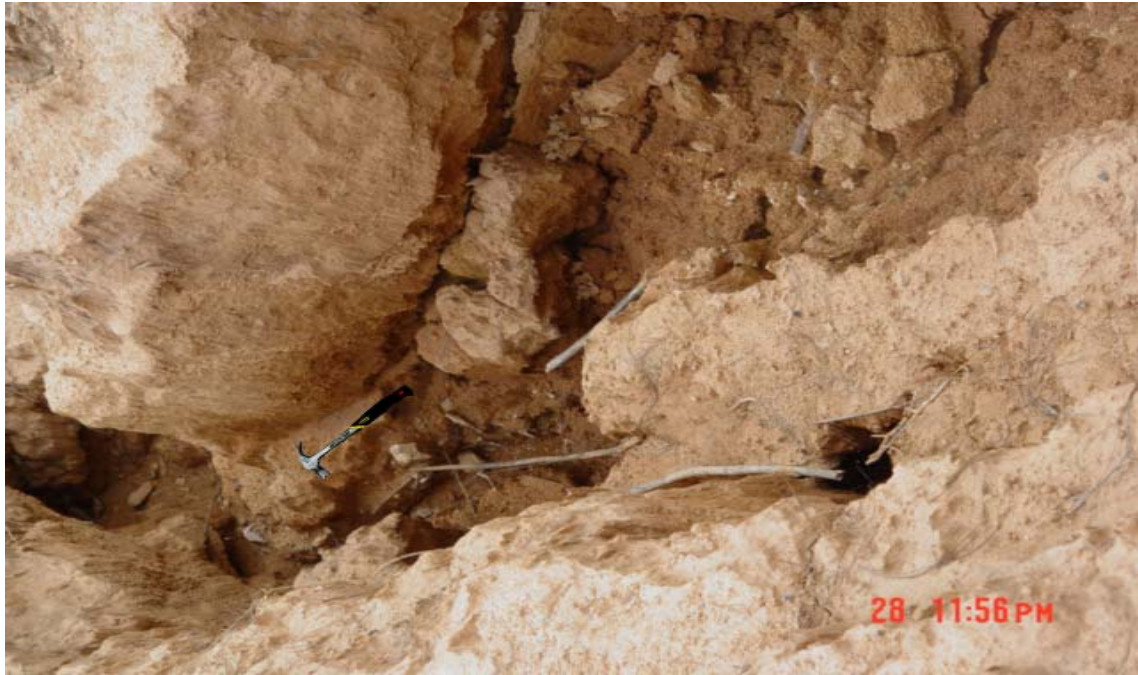
Figure 6.11: Active erosion in most of the landslide channels, degrading the environment further. This is typical of the Ntchenachena Area (28.08.06).

Most of the landslide channels undergoing dissection due to erosion were not recolonised by vegetation. Evidence of instability was observed which included cracking of soils (**Figure 7.1**), gullyng (**Figure 6.11**), fissuring (**Figure 7.11**), and the removal of basal support. Some channels had achieved 50% re-colonization by vegetation although erosion was still active in some parts of the channel. Those landslides which had achieved 90% or more of re-colonisation fall in this category. It should be noted that most of the landslides fall in the active and partially active categories because the channels are fairly new and need time to rehabilitate.

Landslides, particularly in the Livilivi/Mvai and the Ntchenachena Areas caused environmental damage. In most of the areas, landslides caused habitat degradation. The removal of soils and biomass by erosion and the formation of gullies interrupt natural processes which, in the long run are trying to achieve a climax community (Crozier, 1986). However, Moss and Rosenfeld (1978), suggest that instead of landslide activity being viewed as an agent of degradation, in some areas, it may present an important element in the maintenance of species diversity and re-vitalisation of the habitat. Much as this could be true, the catchments under study continue to experience further degradation, ranging from wanton cutting down of trees, to harmful bush fires and slope cultivation, resulting in accelerated soil erosion (**Figure 6.11**)

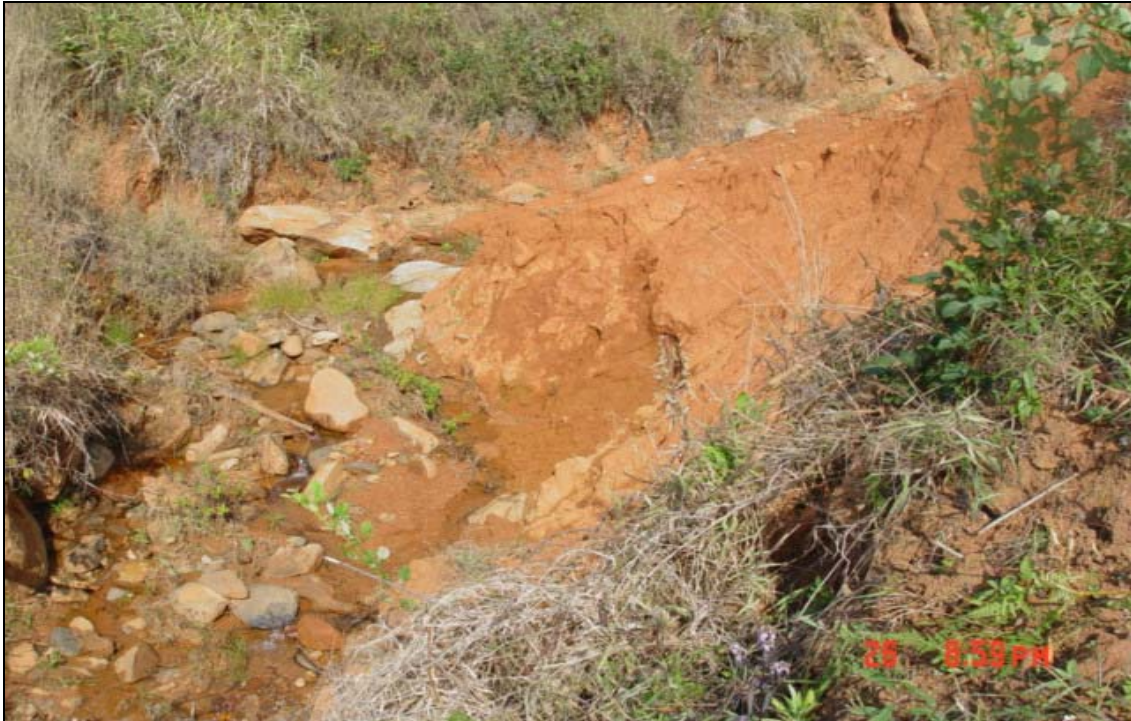
Figure 6.12: Position where landslide debris dammed the Lutowo River which resulted in the flooding of Mzinga River. Debris remains can be seen at the site (26.08.06).

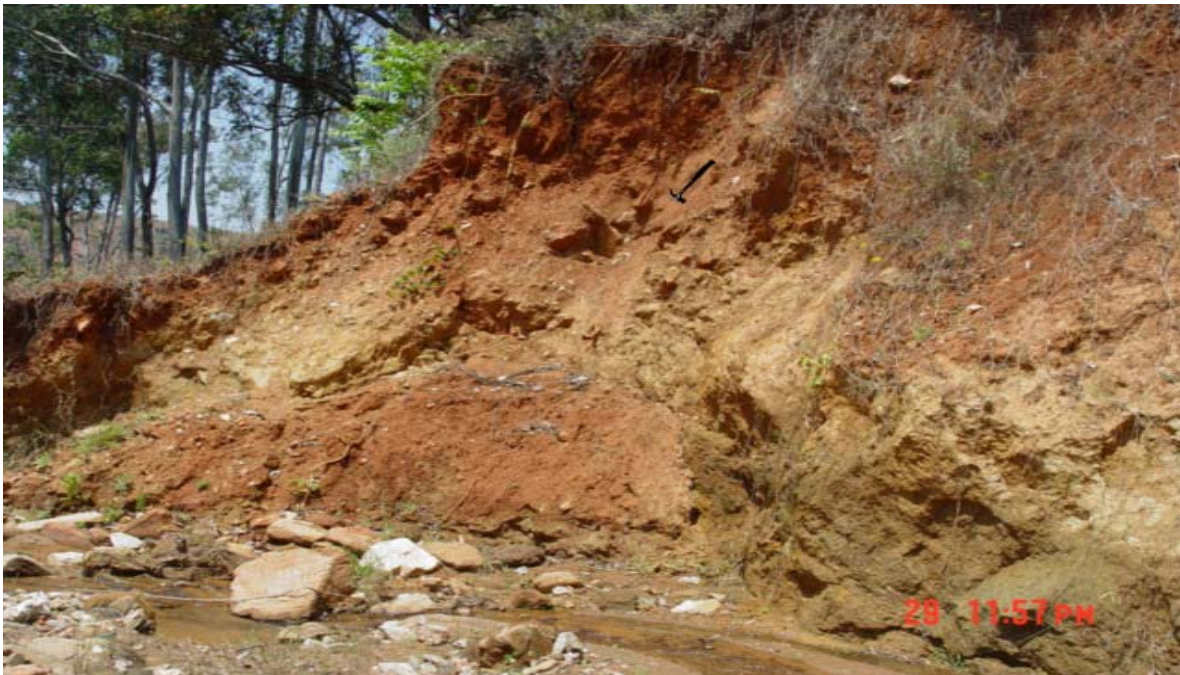
Figure 6.13: Bank collapse caused by landslides, common at all Study Areas and contributing to siltation of rivers. This is an example from the Livilivi Catchment (28.08.06).

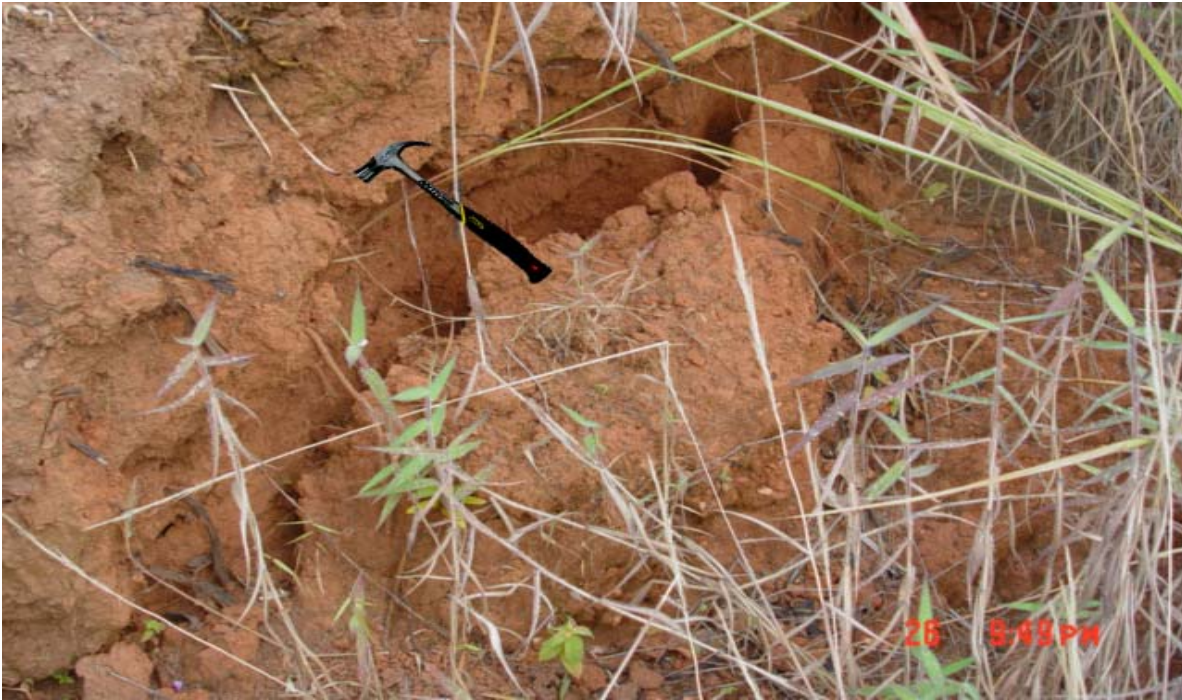
Figure 7.1: Soil cracking and deformation; an indication of instability, common in the Ntchenachena and the Livilivi Areas (Photo taken at Ntchenachena 26.08.06).

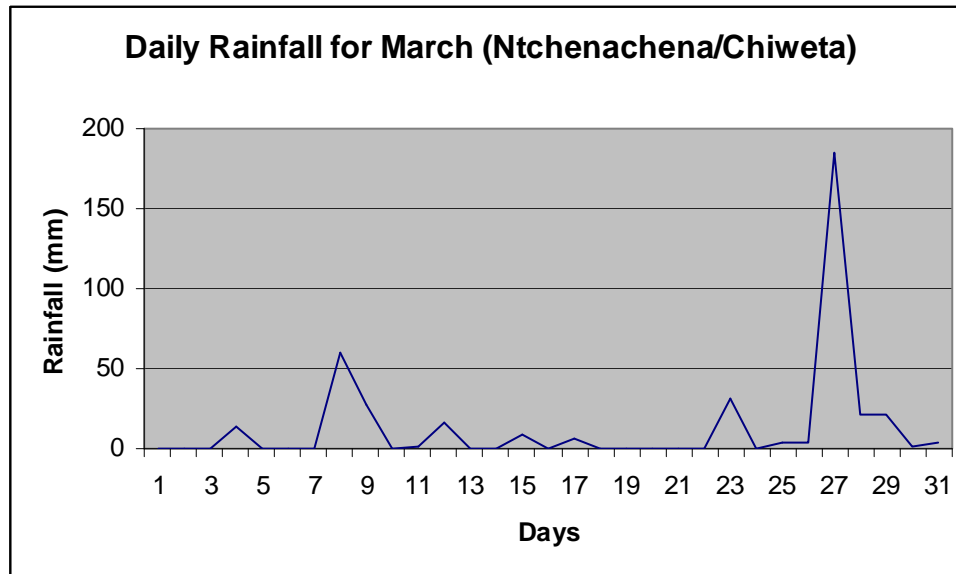
Figure 7.3A: Daily Rainfall for March for the Ntchenachena and Chiweta Study Areas. Note the critical rainfall that triggered the events.

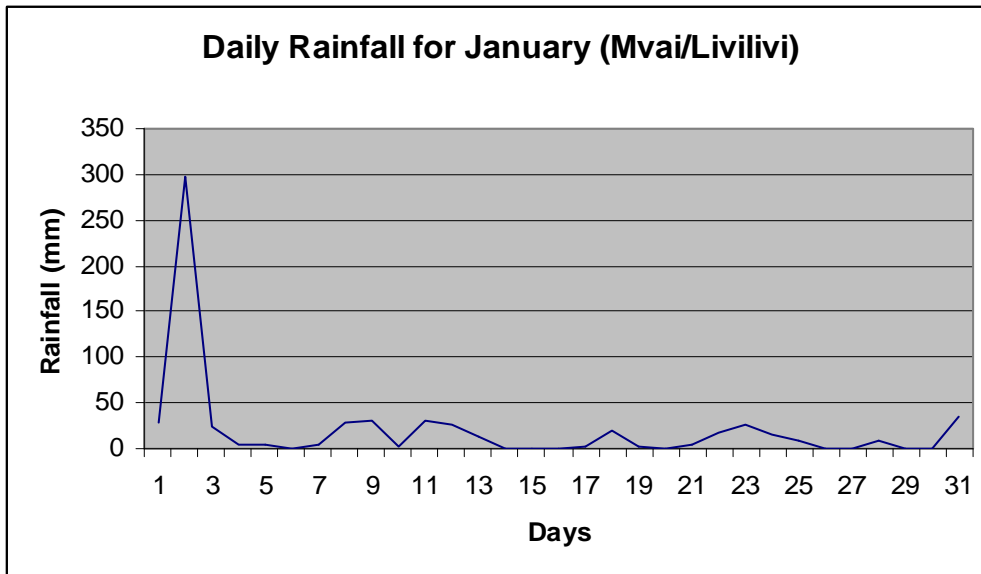
Figure 7.3B: Daily Rainfall for January for the Mvai and Livilivi Study Areas. Note the critical rainfall which caused the landslides.

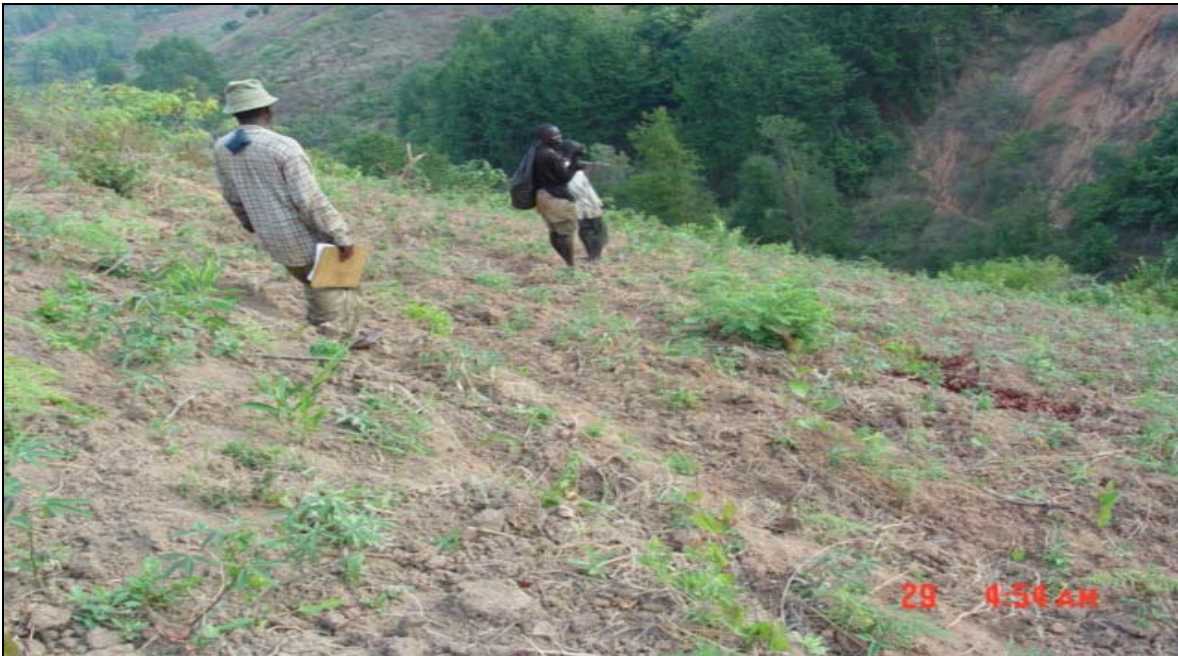
Figure 7.5: Cassava cultivation in the Ntchenachena Area leaves the ground bare, thereby making it prone to landslide (29.08.06).

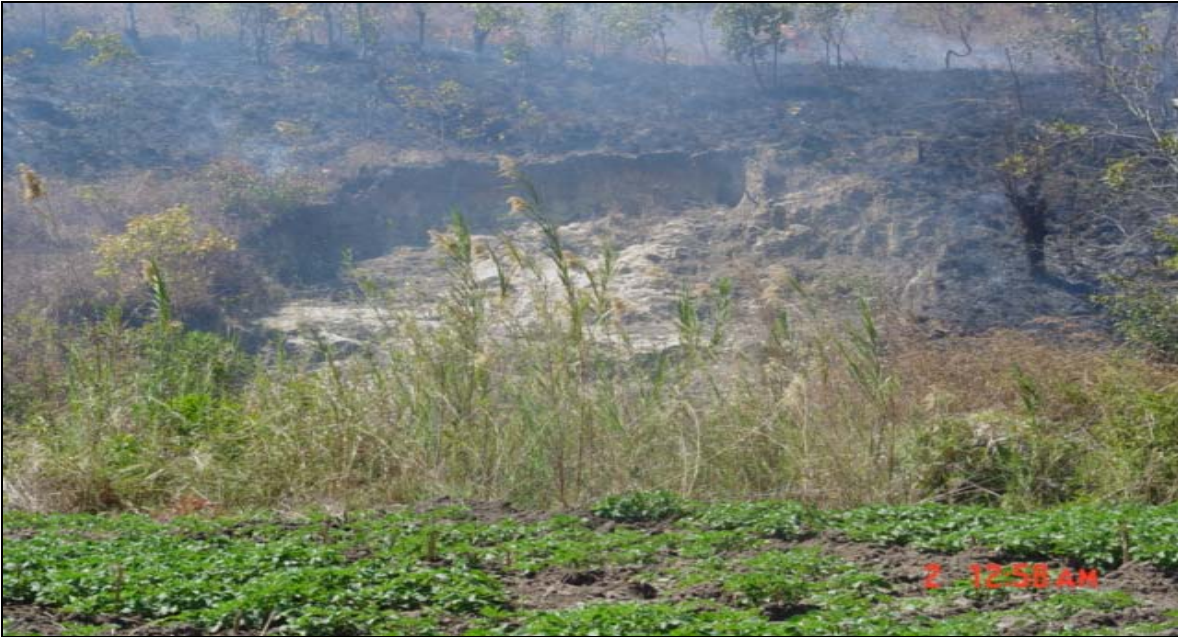
Figure 7.6: Destruction of the Mvai/Dzonzi Forest Reserves contributing to the loss of shear strength of the soil. In the foreground, landslide scar is clearly visible (2.09.06).

Patches of Afro-Montane vegetation are found although they have been disturbed by slash and burn cultivation. This practice is common in this area as was reported by Msilimba (2002). The Ntchenachena Area is dominated mostly by grasses and scattered shrubs along river valleys while the slopes are under cultivation, and settlement activity. The Chiweta Area is a proposed forest reserve dominated by Miombo trees. These trees are deep rooted with spreading canopies and of various ages and sizes (**Appendix 15**). The ground was completely covered with grass. The savanna grasses in this area are shallow rooted. The lower side of the remodelled slope shows minor disturbances by the road slope fills. The Mvai and Livilivi Areas are within forest reserves and dominated by Miombo woodlands. Tall grasses provide adequate ground cover although they are shallow rooted. Deforestation and seasonal burning were observed in the Chiweta and the Mvai/Livilivi Areas (**Figures 7.6 and 7.7**).

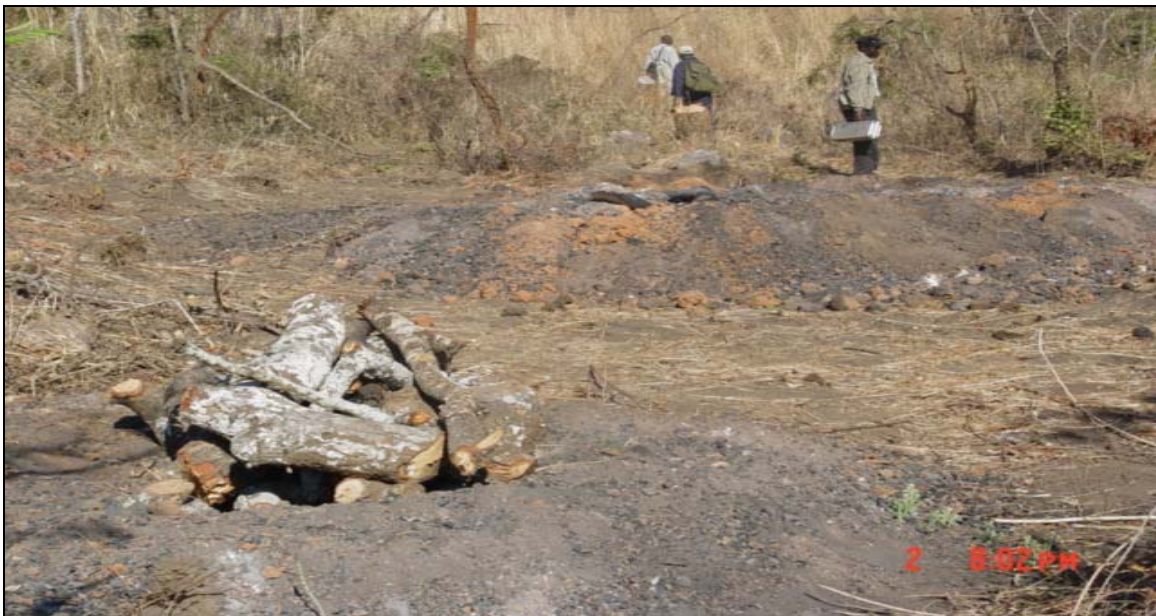
Figure 7.7: Charcoal making in the Livilivi/Mvai Catchments contributing to instability. In some areas, the Miombo woodlands have completely disappeared (2.09.06).

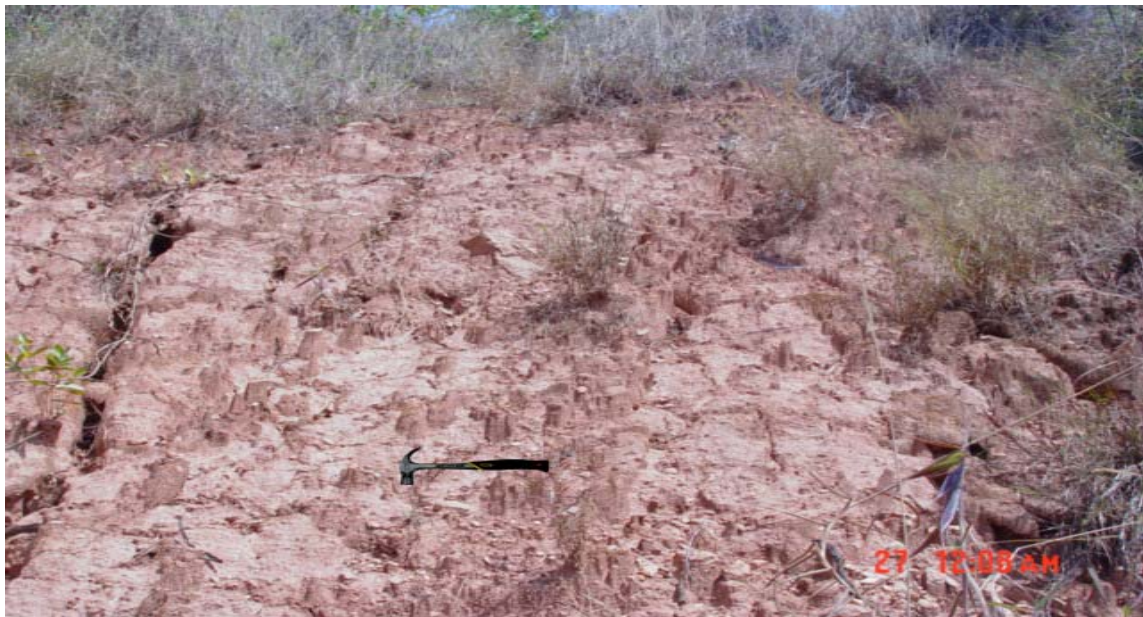
Figure 7.8: Soils which liquefied and dried are common in the all study areas. The photo represents liquefaction at the Lutowo unit of the Ntchenachena Area (27.08.06).

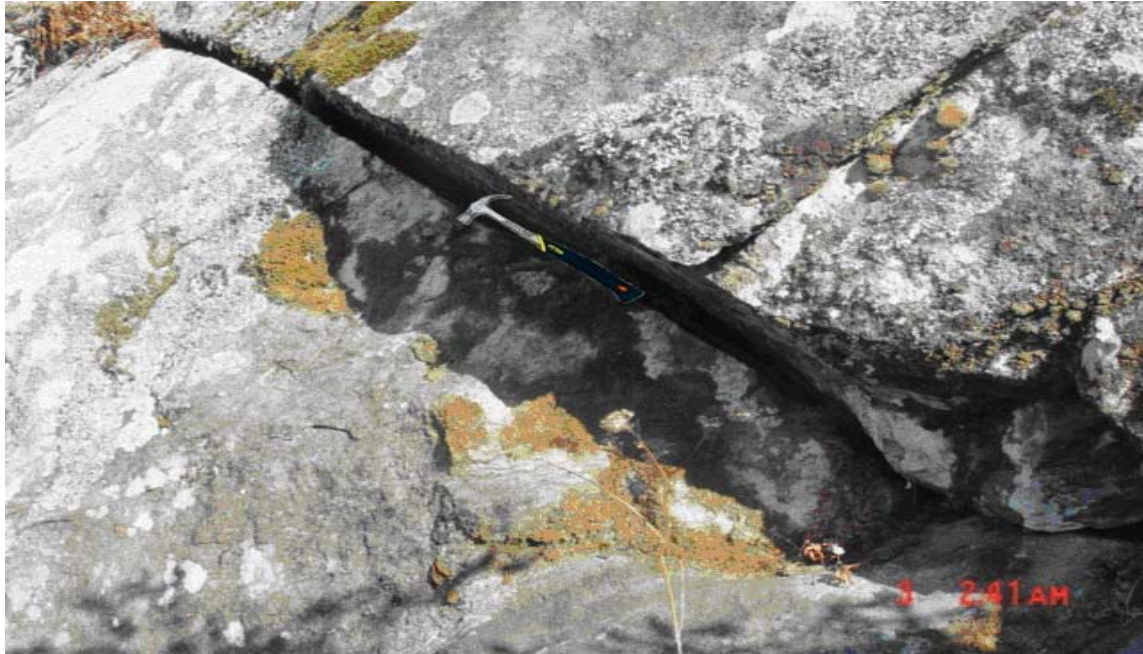
Figure 7.9: Structural rock weaknesses through which water penetrated, causing high cleft pressure and land sliding at the Mvai Study Area (3.09.06).

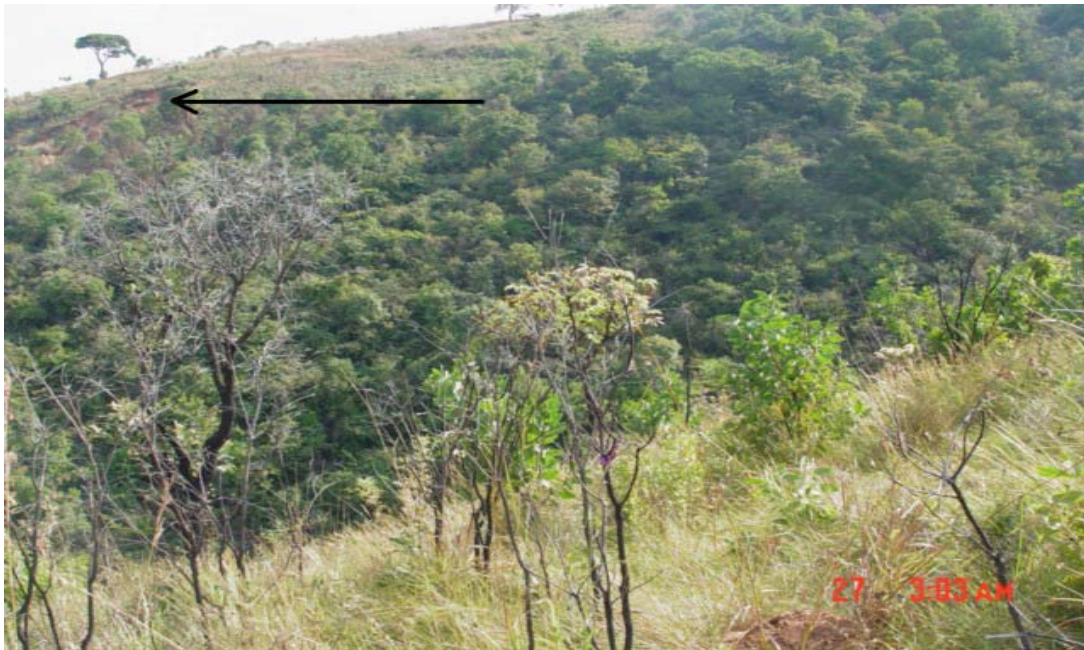
Figure 7.10: Part of the Kasese Forest where vegetation was observed to contribute to stability. All the observed landslides occurred outside the Forest (27.08.06).

cover of grasses and shrubs, recorded the highest number of landslides (**Table 6.1 and Section 6.1**). Although there is direct evidence to suggest that roots provide reinforcement through tensile resistance and frictional or adhesion properties (Anderson and Richards, 1985), root reinforcement depends primarily on the depth of the potential slip surfaces within the slope. At the Ntchenachena site, where the soils are very deep (> 10m), most of the landslides occurred beyond the root zone. This suggests that shallow rooted vegetation did not provide maximum tensile resistance to the soil mass. In areas where vegetation was cleared for cassava cultivation, the instability has been increased because cassava has low root density, and roots are shallow (Msilimba, 2002; and Msilimba and Holmes, 2005). Studies have shown that converting a forest to grassland or crops cultivation increases moisture in the soil, enough to cause landslide problems (De Graft, 1979). Similarly, cassava tubers crack the soil during formation, thereby increasing infiltration and slope loading. This was also noted to be a problem in landslide prone area of Banga in the same District (Msilimba and Holmes, 2005). The importance of forest cover in prohibiting mass movement was observed at the Kasese Unit within the Ntchenachena Area where no landslides were recorded (**Figure 7.10**).

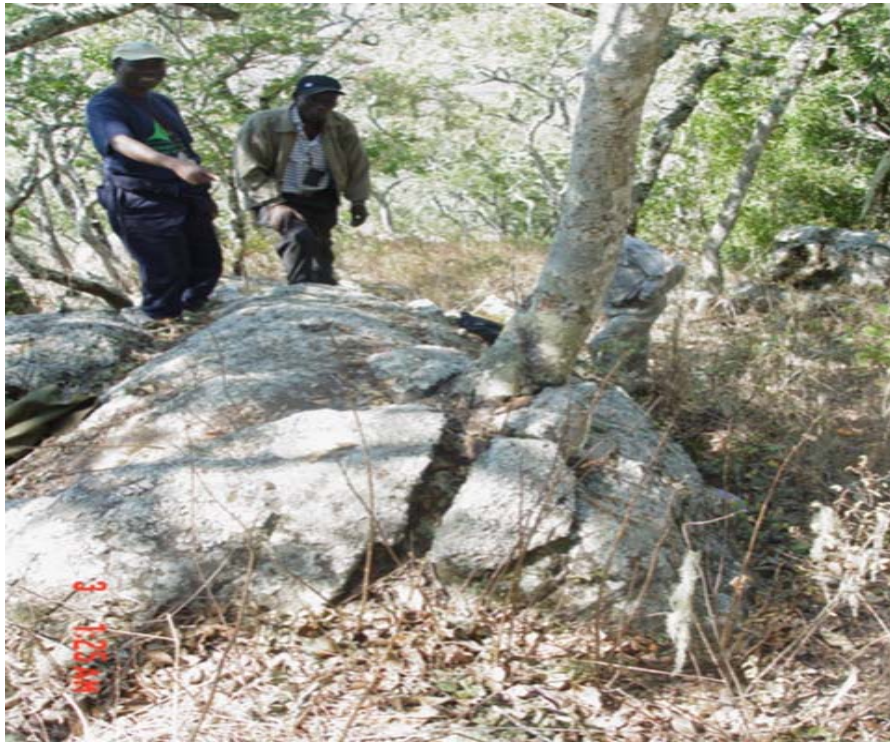
Figure 7.11: Vegetation wedging boulders apart at Mvai, contributing to mechanical weathering. Rockfalls were observed to have been caused by root wedging (3.09.06).

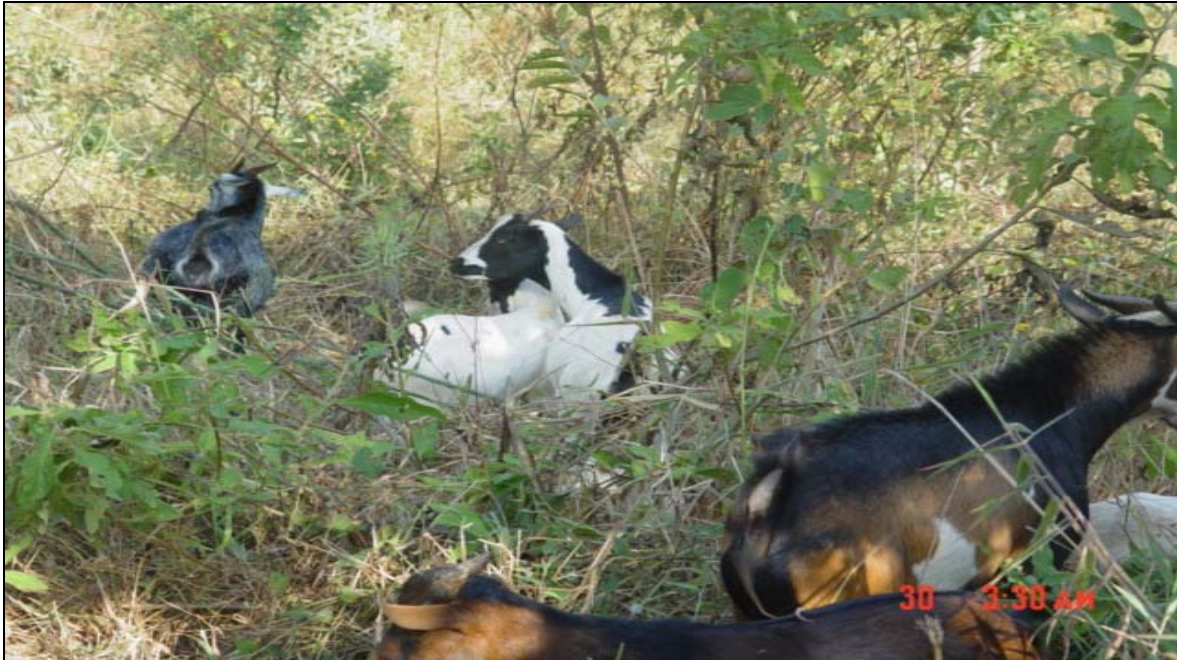
Figure 7.12: Goats destroying remaining shrubs and grass in the Ntchenachena Area, contributing to the loss of tensile strength of soils (30.08.06).
