**A COMPARATIVE STUDY OF LANDSLIDES AND GEOHAZARD MITIGATION IN
NORTHERN AND CENTRAL MALAWI**

**Thesis Submitted for the Degree
Doctor of Philosophy,
Faculty of Agricultural and Natural Sciences,
Department of Geography,
University of the Free State**

November, 2007

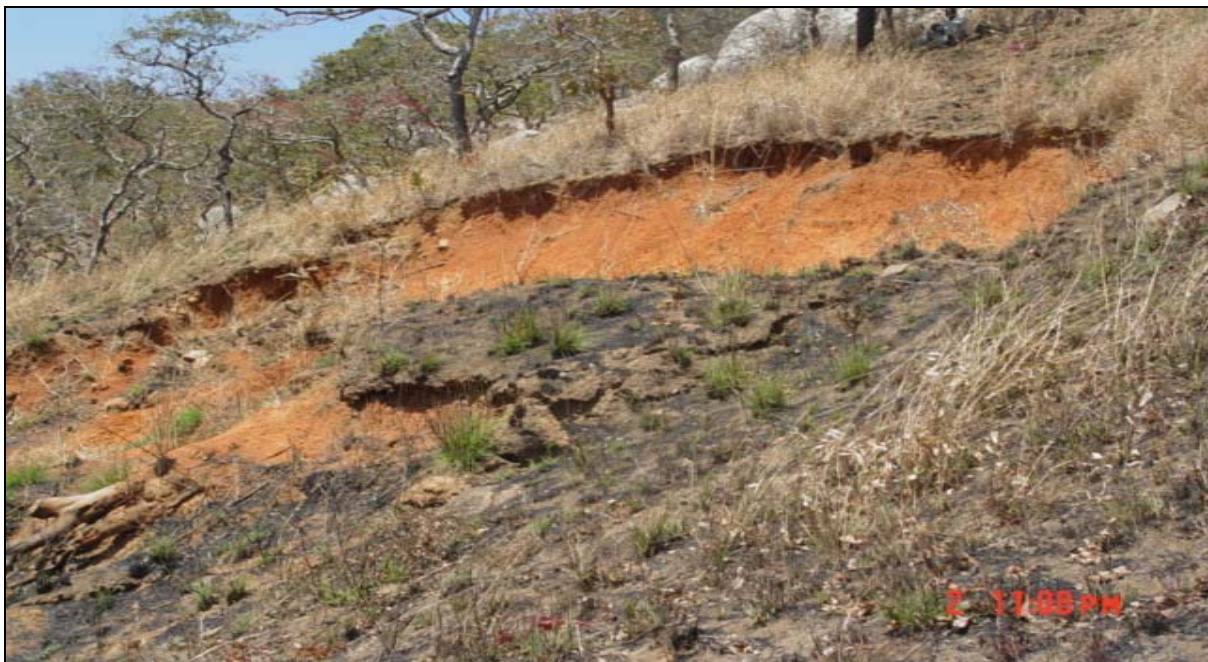
Figure 7.13: Landslide occurrences in the Mvai Area where deforestation has taken place (3.09.06).

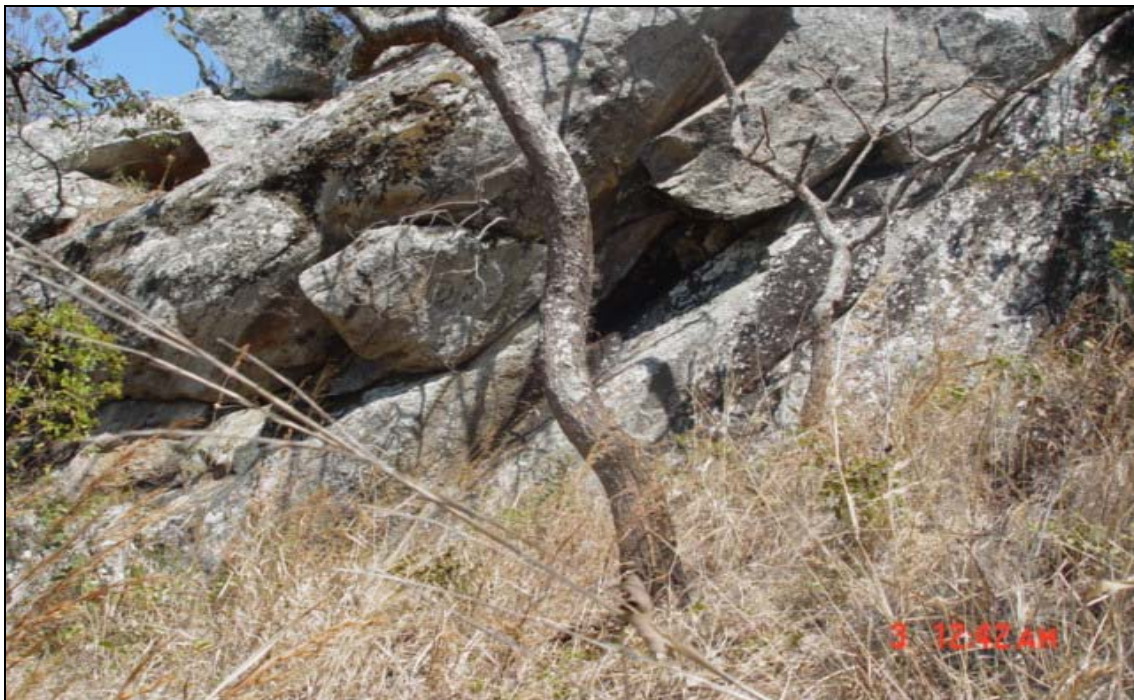
Figure 7.14: Hanging boulders within the Mvai/Livilivi Catchments. With increasing instability, they can roll down the slope (3.09.06).

The rocks of the catchments comprise mostly gneisses which include banded biotite gneiss and hornblende-garnet- gneiss. Bands of quartzo-feldspathic granulite and gneiss and perthite gneiss grading into perthosite represent major relief pattern in the area (Mwenelupembe, 2003). The rocks have a generally north-west trend which is also displayed by relief features in the area. In this area, rocks are heavily jointed and fractured and splitted (**Figures 7.9, 7.14 and 7.15 p.137, 145 and 146**), and this has led to the formation of boulders scattered through the hills making the catchments (**Figure 2.15**). In most areas, the boulders are resting in an unstable manner (**Figure 7.14 p.145**).

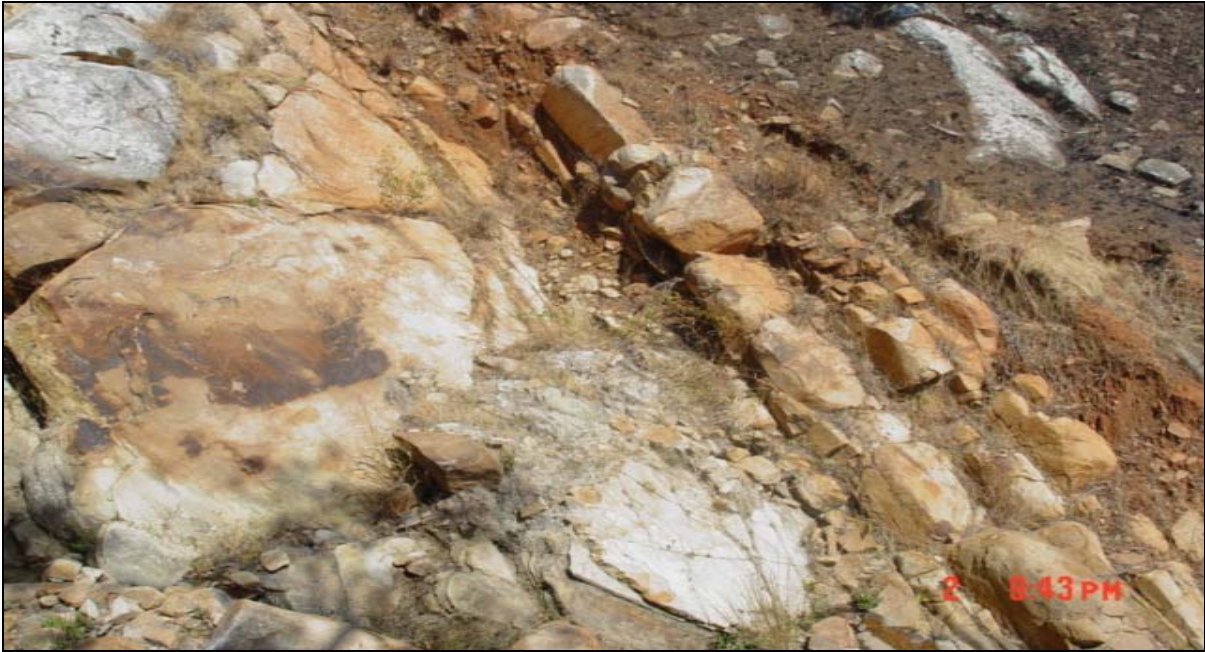
Figure 7.15: Point of failure between rock masses, as observed in the Mvai Area. Note the presence of shallow soils on the edge of the scar: an example of a translational slide, common in the Mvai and Chiweta Study Areas (2.09.06).

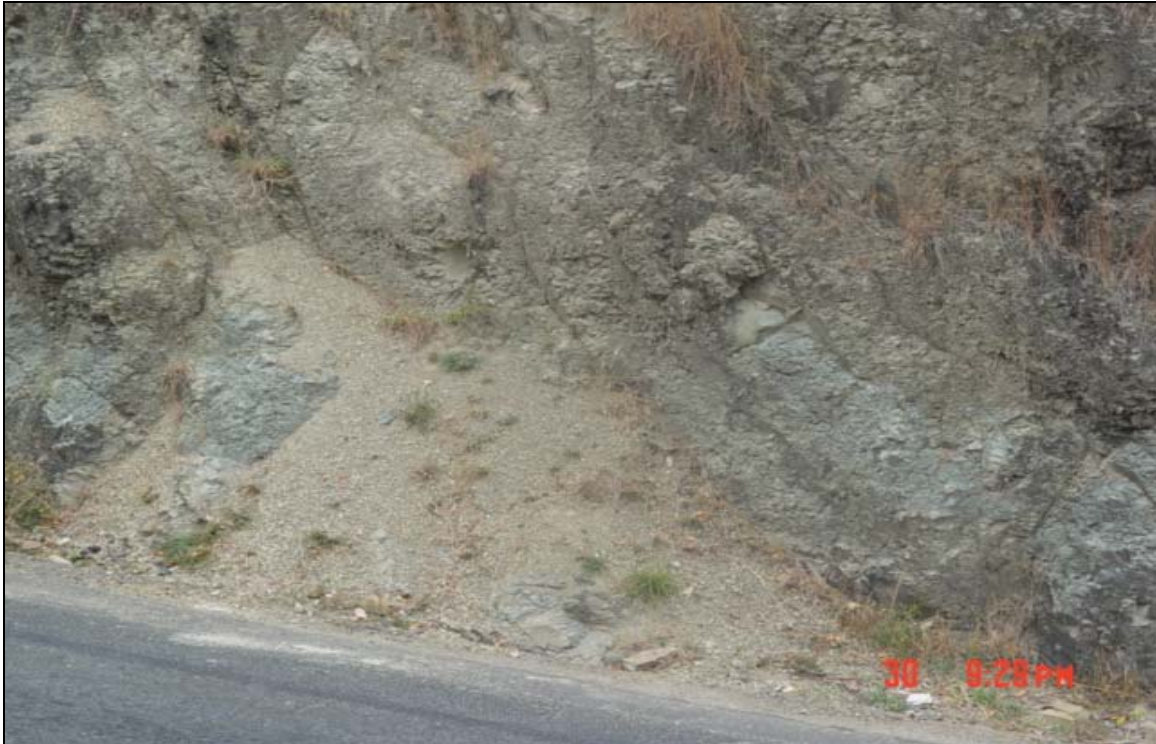
Figure 7.16: Highly weathered Chiweta beds dipping along the main road to Karonga. Note the creeping of weathered colluvium at the base of the cliff (30.08.06).

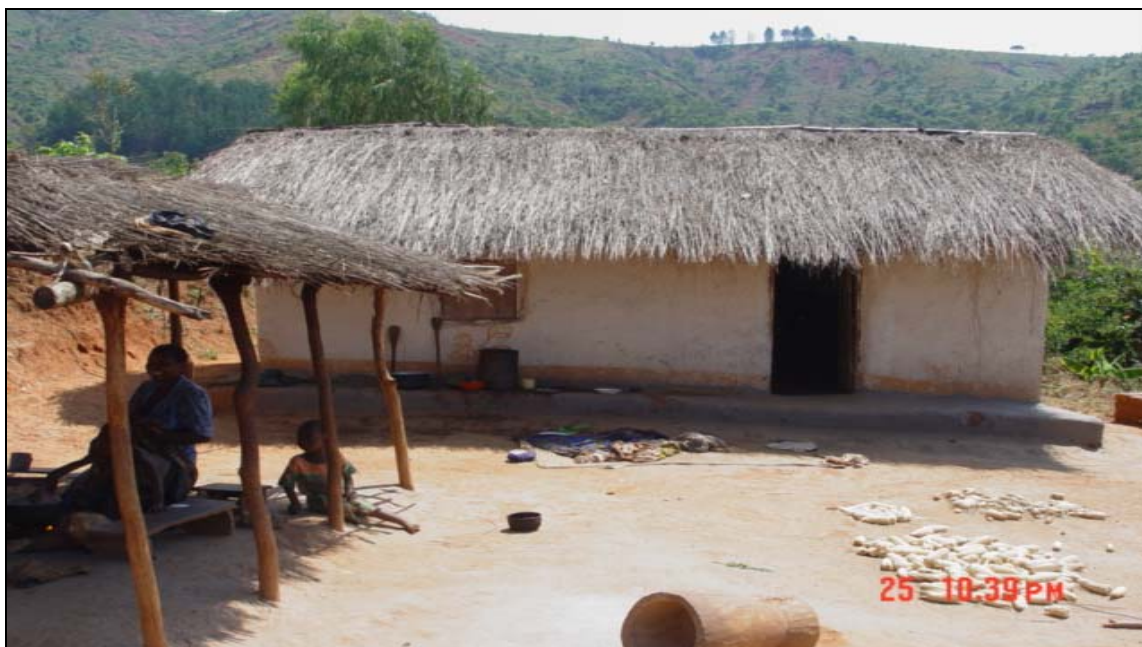
Figure 8.1: Traditional houses common in rural areas of Malawi. This house is built on an excavated slope in the Ntchenachena area (25.08.06).

The type of housing was determined with the aim of assessing the houses' vulnerability to landsliding and also as a measure of poverty. The results are presented in **Table 8.3**. In both districts, 94.75% of the respondents were living in temporary houses. There were no significant differences in the type of housing between the districts ($p=0.12$). There was no linear by linear association established ($p=0.012$). Over 90.4% of the respondents in Rumphi, and 97.5% in Ntcheu, resided in houses built of mud or unburnt bricks, with grass thatched roofs (**Figure 8.1**). This type of housing is in line with the poverty situation in Malawi in general (Slater and Tsoka, 2006), and in the study areas in particular (**Table 8.2B**). The houses were noted to be very vulnerable not only from landslides, but also from excessive precipitation.

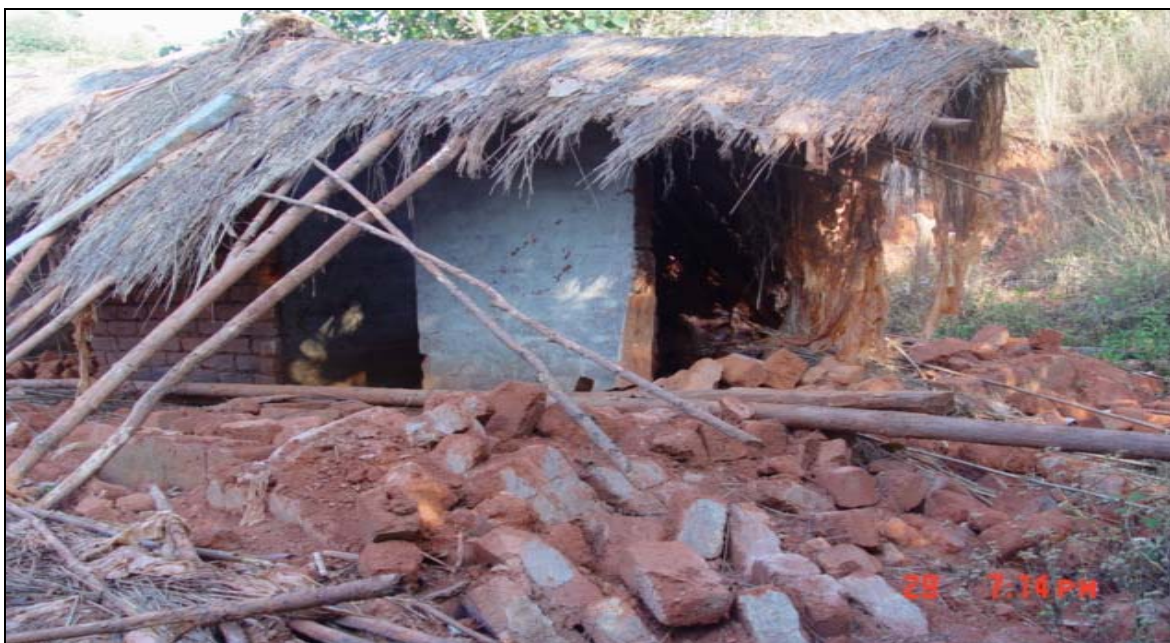
Figure 8.2: Remains of the abandoned settlement at Mwachumba Village at Ntchenachena after the 2003 landslides. Note the material of material used which increased the risk of failure (29.08.06).

construction during the rainy season; hence, the affected households lacked decent accommodation (**Figure, 8.2**).

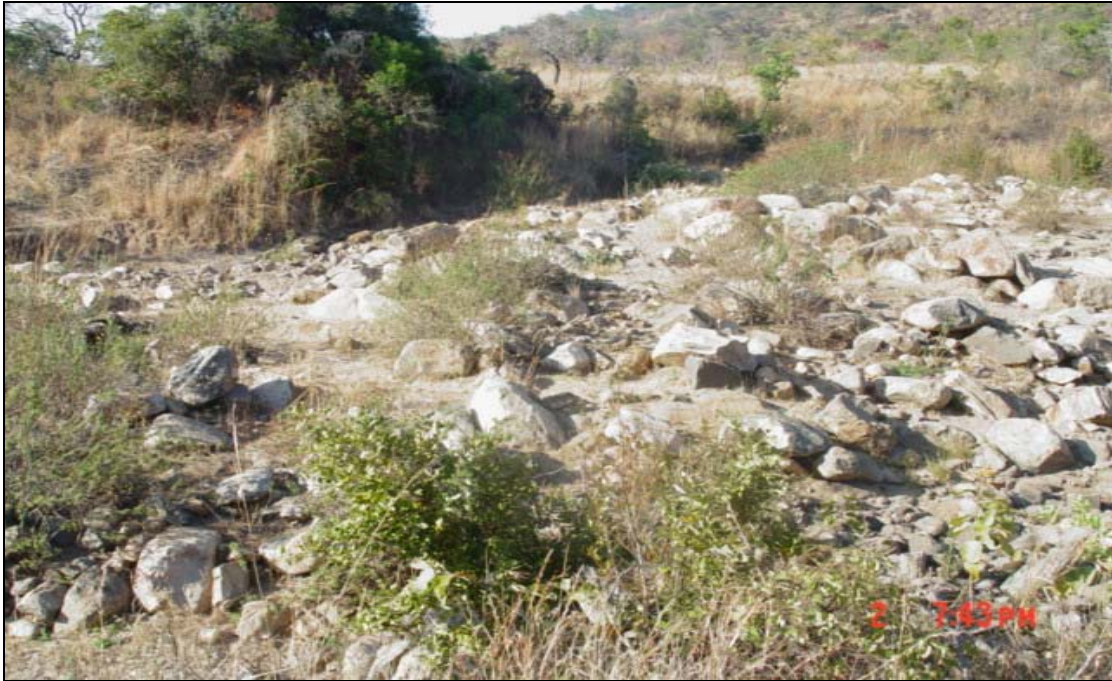
Figure 8.3: Degraded agricultural land along the Mpira River, Mvai Catchment, caused by the boulders deposited by the 2003 Landslides (2.08.06).

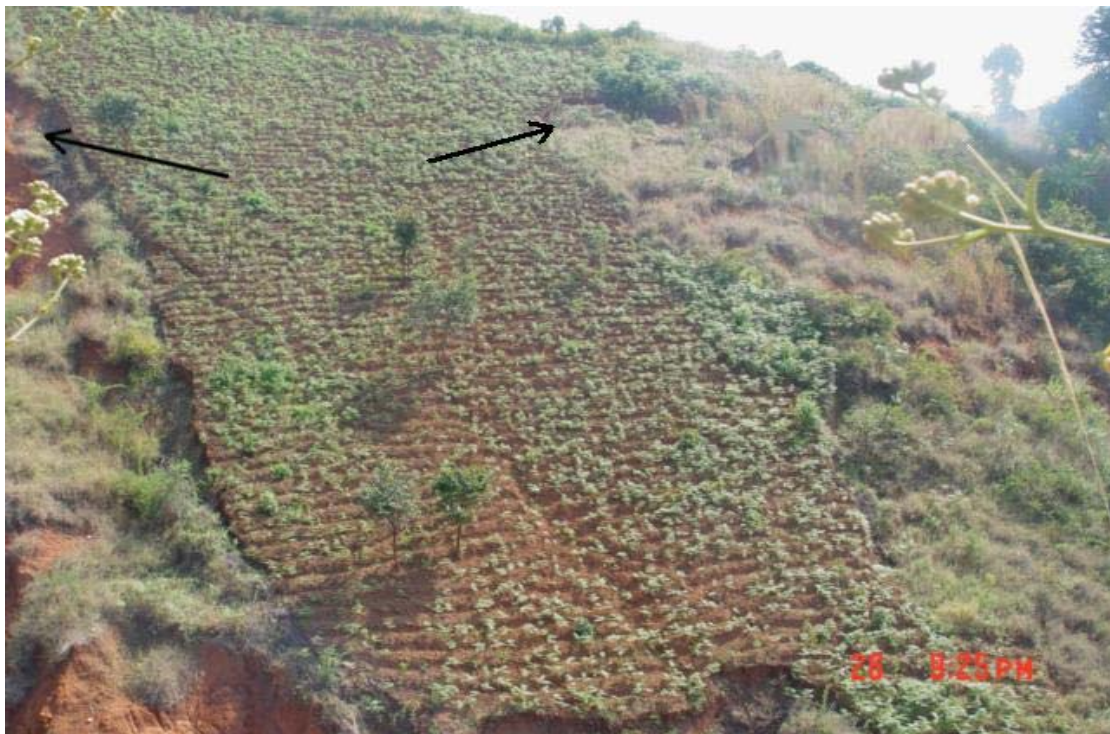
Figure 8.4: Destruction of agricultural land in the Ntchenachena Area. On both sides of the cassava field, scars can be seen. The edges are still collapsing, thereby reducing the area of land available for cultivation (26.08.06).

No significant differences were observed between the two districts in terms of destruction to farmland ($p=0.162$), with a linear by linear association of $p=0.028$. A total of 42% of the respondents lost more than one hectare of farmland (19.7% from Rumphu, and 22.3% from Ntcheu). Only 10.9% of the respondents lost less than a quarter of a hectare, 25.8%, half of a hectare, and 21.4% one hectare (**Table 8.18**). The damage was assumed to be high, considering that the average farm size is 0.5ha at national level (NSO, 1998; and Slater and Tsoka, 2006). The damage to crops and farmland was high because landslides occurred in rural agricultural areas, and that crops were being grown in marginal or fragile areas, as discussed in **Section 8.10.2**. Degraded marginal land along the Mpira River in the Ntcheu District is clearly observable in **Figure 8.3**. In the Ntchenachena Area, the degradation of farmland is still continuing as shown in **Figure 8.4**.

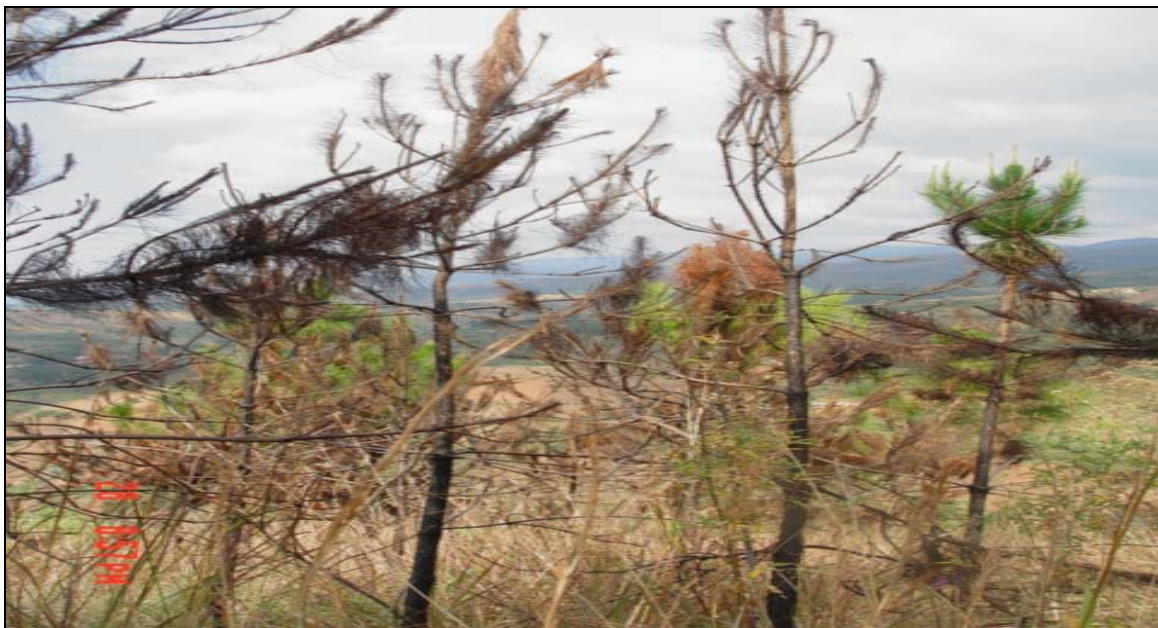
Figure 8.5: Deliberate destruction of pine trees planted by MASAF in the Ntchenachena Area by arson, thereby increasing the probability of slope failure (29.08.06).

The indifference to carryout mitigation measures was partly due to lack of resources, and partly due to the fact that some mitigation measures were in conflict with their production systems. For instance, in the Ntchenachena Area (Rumphi District), in areas where pine trees were planted by the Malawi Social Action Fund (MASAF), local people destroyed them deliberately (**Figure 8.5**). The people have come to realize that pine trees provide good habitat for monkeys which destroy their crops, especially maize and cassava. The efforts by MASAF were seen as affecting negatively their source of livelihood which is agriculture. Furthermore, cultivation on marginal lands is continuing because flat areas are limited and abandoning cultivation on such areas will create land shortage problem. Therefore, mitigation measures need to address the problem of land if the people are to abandon cultivation on steep slopes. In addition, a clear understanding of local people's production systems is crucial to the successful implementation of mitigation measures.

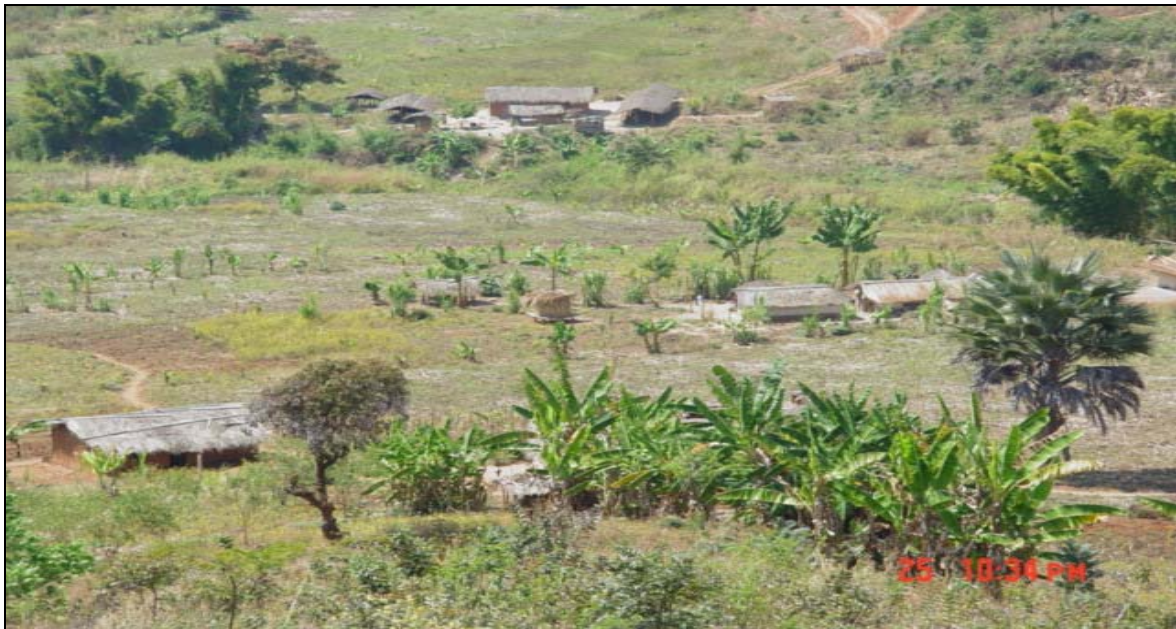
Figure 8.6: Houses located in a floodplain along the Mzinga River in the Ntchenachena Area. This is the Area which was flooded during the 2003 Landslide (25.08.06).

In both districts, the location of settlements increased the societies' vulnerability to landslides. Most of the settlements were located on areas susceptible to failure (**Figures 8.6 and 8.7**). The Ntchenachena Area is located in a very rugged topography, with interlocking spurs (**Section 2.2.1.3**). Flat areas are absent, except along the Mzinga River. Two recent waves of migration into the area (in 1974 and 1992/3) increased land pressure and demand for resources. The settlement activities have contributed to instability in four ways:

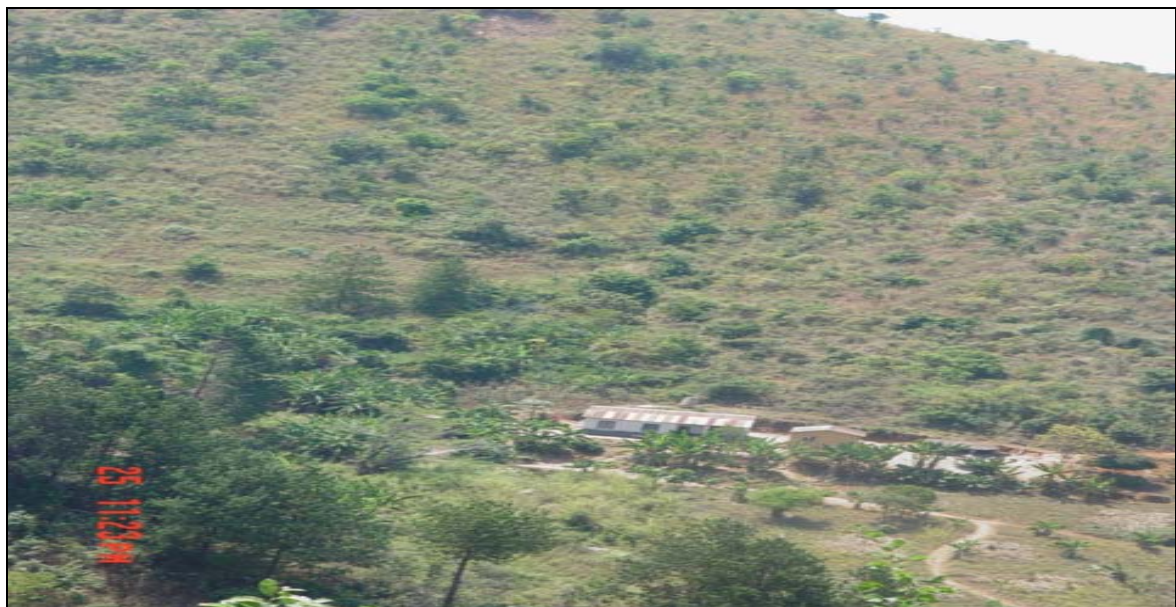
Figure 8.7: A settlement located at the foot of Mankhorongo Hill. Note the landslide scar above the settlement, an indication of slope instability (25.08.06).

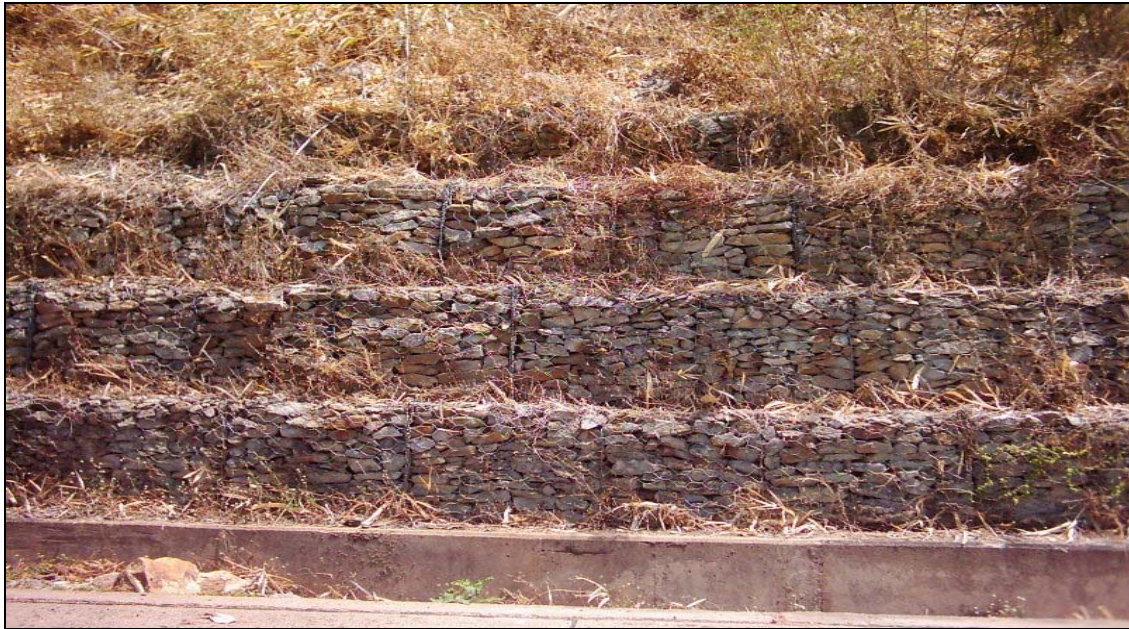
Figure 9.1: Stone embankments, using wire mesh, constructed to stabilise Nyankhowa slopes in Northern Malawi. Similar structures can be used to stabilise the Chiweta beds (11.08.01).

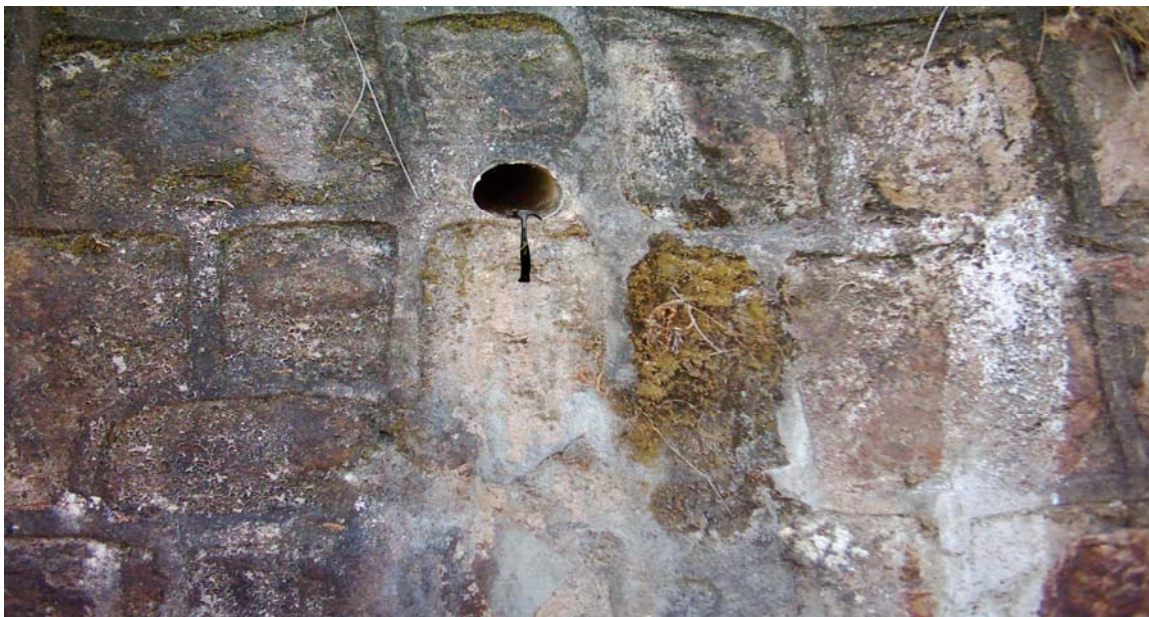
Figure 9.2: Concrete stone embankments constructed to stabilise landslide prone slopes at Overtoun in Northern Malawi. Note the plastic tubing to prevent the build up of water table (11.08.01).
