**Towards a Conceptual Hydrogeological Model of the  
Chimwungo Ore Body, Lumwana Mine. Northwestern  
Zambia**

Thesis submitted in the fulfillment of the requirements for the degree of

**Institute for Groundwater Studies**

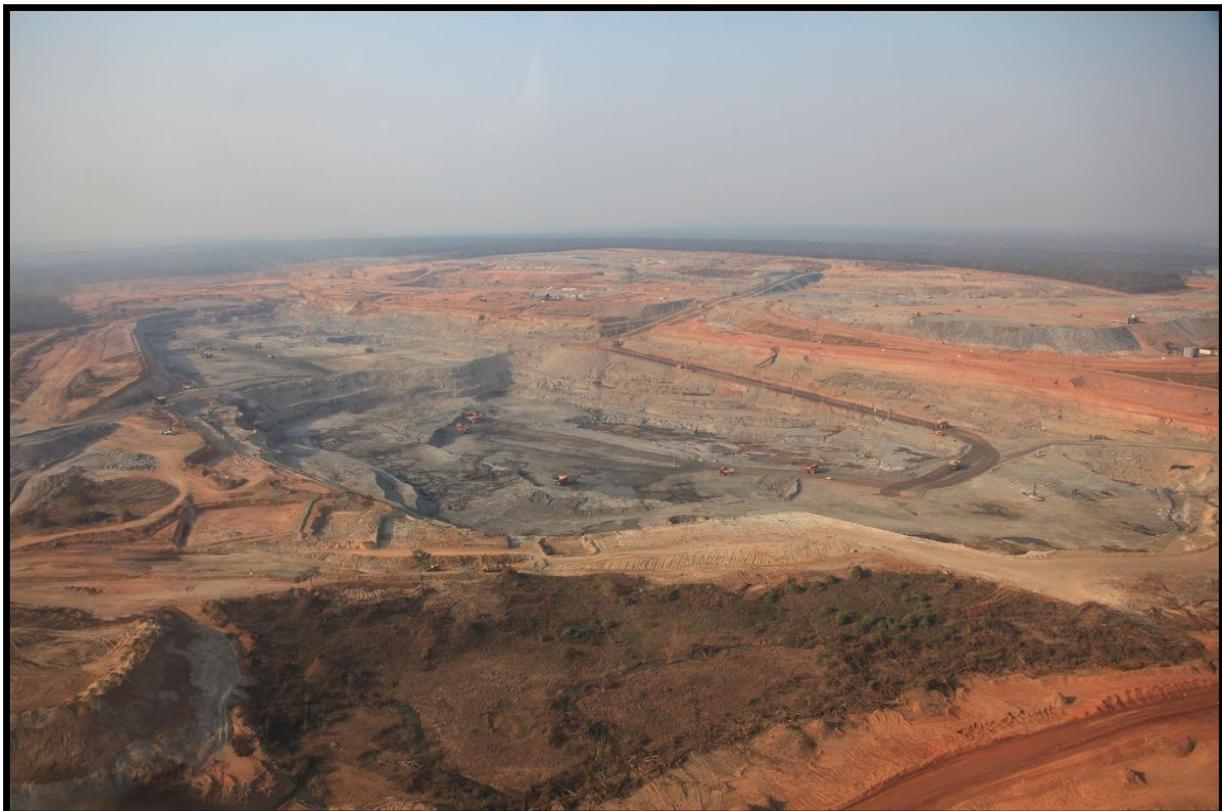
**Figure 2-2. An aerial view of the Malundwe Pit where open pit mining methods are employed**

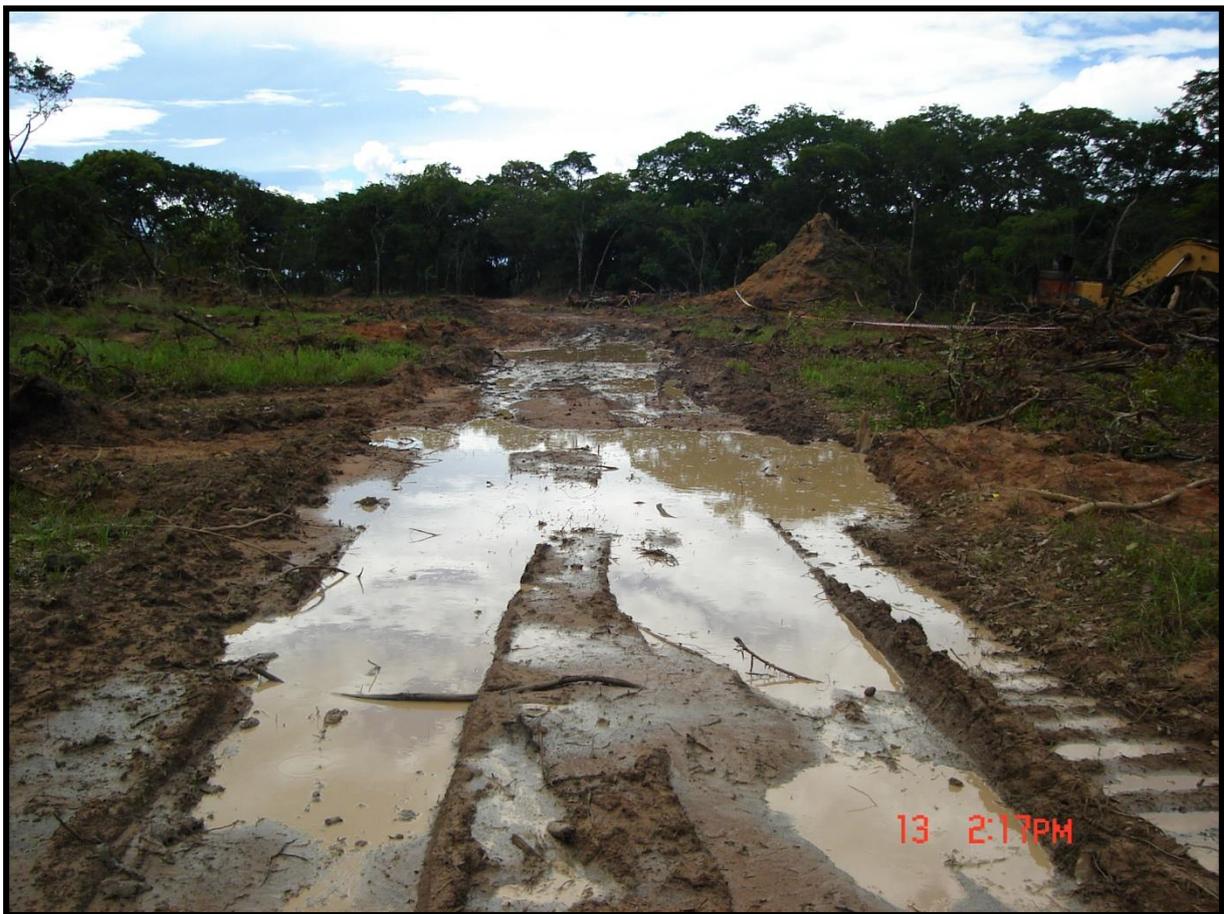
Figure 5-2. Access road to MH06

A major problem with site access came with the onset of the rainy season. Due to the high rainfall of the 2010/2011 season, the top soil within Chimiwungo became saturated with water. Low lying areas became inundated with runoff from higher topographical areas. Dirt roads that were used most frequently got damaged through the combined action of tyres and the ponding water. Figure 5-2 shows the access road to the drilling area for borehole MH06 in early December 2010.

An LMC contractor on site worked relentlessly to ensure that most of the access roads were rehabilitated. Where alternative access needed to be provided, dozers were brought in to blaze new trails. In instances, huge amounts of crushed rock had to be brought in and compacted onto the problem areas. The road works led to significant delays in equipment movement as rigs incessantly got stuck at several points along the access roads.

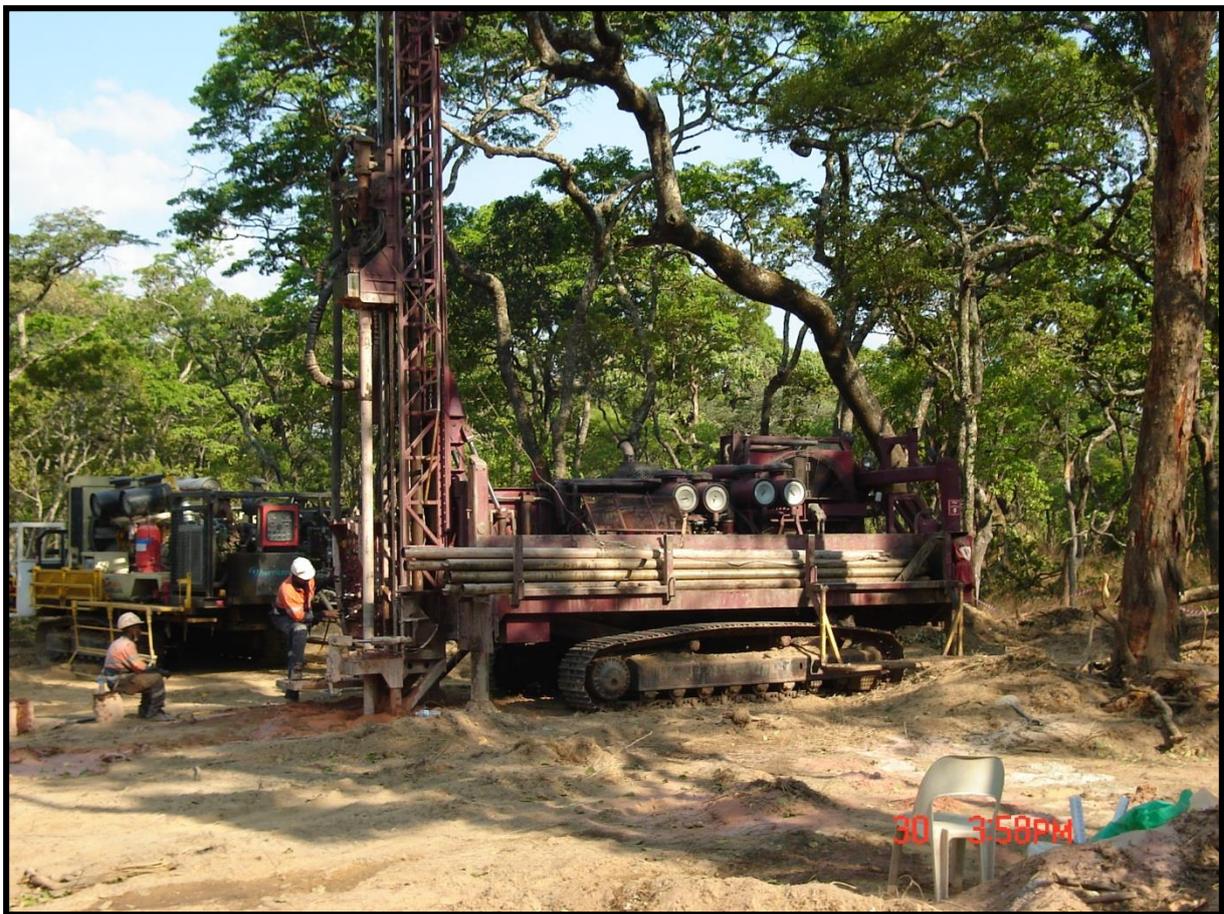
Figure 5-4. RC Drill Rig in action

Figure 5-4 shows an RC drill rig in action in Chimiwungo and Figure 5-5 shows the diagram of a dual wall reverse circulation rotary method.

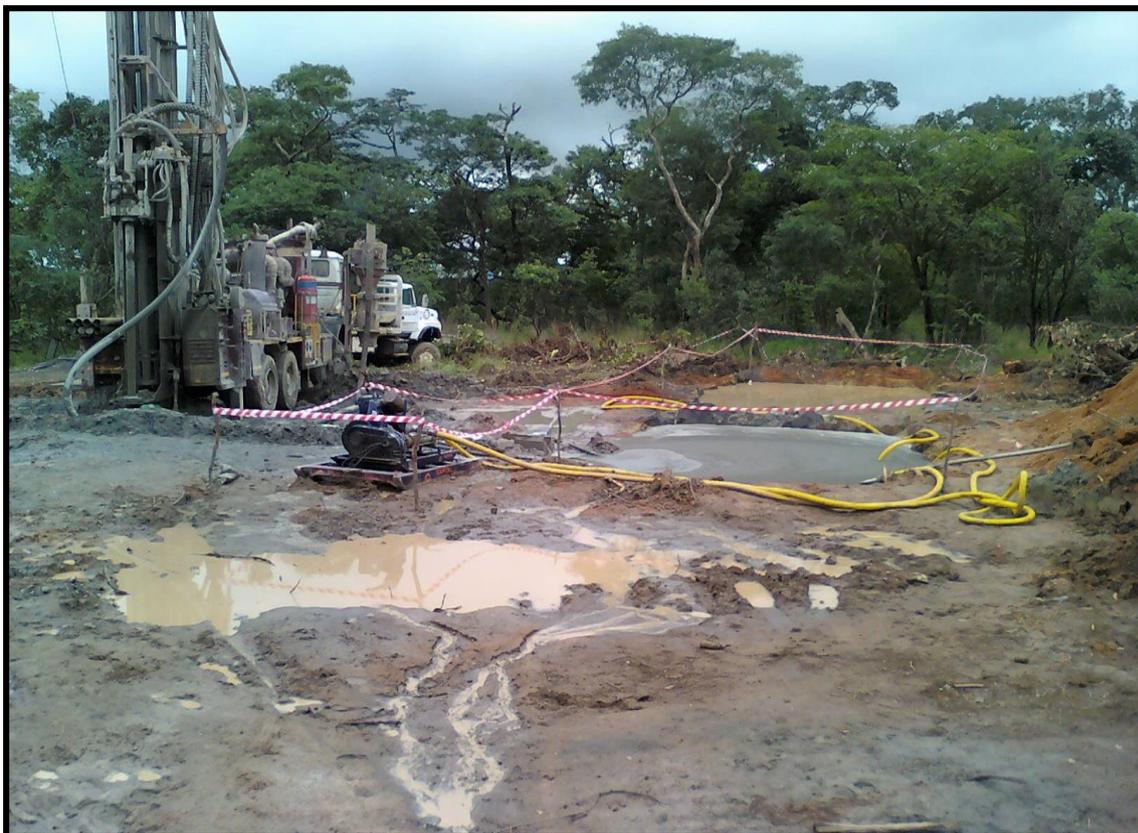
Figure 5-6. Mud Rotary Drilling (MH05)

In the direct- mud rotary method, the borehole is advanced by rapid rotation of a drill bit mounted upon the end of drill rods. The bit cuts and breaks the material at the bottom of the hole into small pieces (cuttings). The cuttings are removed by pumping drilling fluid (water, or water mixed with bentonite or other fluid enhancers) down through the drill rods and bit and up the annulus between the bore hole and the drill rods. The drilling fluid also serves to cool the drill bit and stabilize the borehole walls, to prevent the flow of fluids between the bore hole and surrounding earth materials, and to reduce cross contamination between aquifers (USEPA, 2003). Figure 5-6 shows a mud rotary drilling rig in action in Chimiwungo.

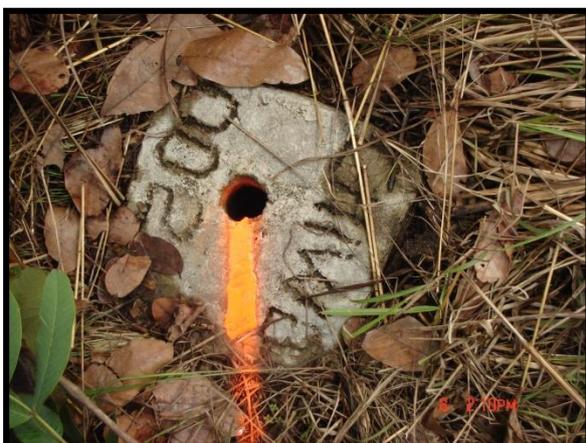
Figure 6-1. Borehole CHIWB002

An initial groundwater source Hydrocensus was carried out at the Chimiwungo deposit in September 2010. The process remained open and ongoing throughout the project period. In September 2010, nine old boreholes were located and used for water level and water quality monitoring (Table 3). The majority of boreholes located during the hydrocensus were those drilled by Golder Associates in the 2003 Bankable Feasibility Study. Figures 6-1 to 6-9 show photographs of the boreholes identified during the hydrocensus, while the positions of these boreholes are shown in Figure 6-10.

Borehole	GPS Coordinates (UTM 35L) WGS84		Elevation (mamsl)	Depth (m)
	X	Y		
CHWB 002	376,980	8,640,300	1,370	150
CHWB 005	377,429	8,640,701	1,364	143
CHWB 006	377,935	8,640,677	1,355	204
CHWB 007	376,897	8,641,032	1,378	132
CHWB 011	377,897	8,641,631	1,349	174
CHWB 012	377,553	8,642,615	1,346	126
EQ CH 229	377,269	8,642,914	1,338	72
EQ CH 238	377,258	8,643,098	1,346	45
EX M 001	377,550	8,642,447	1,337	7

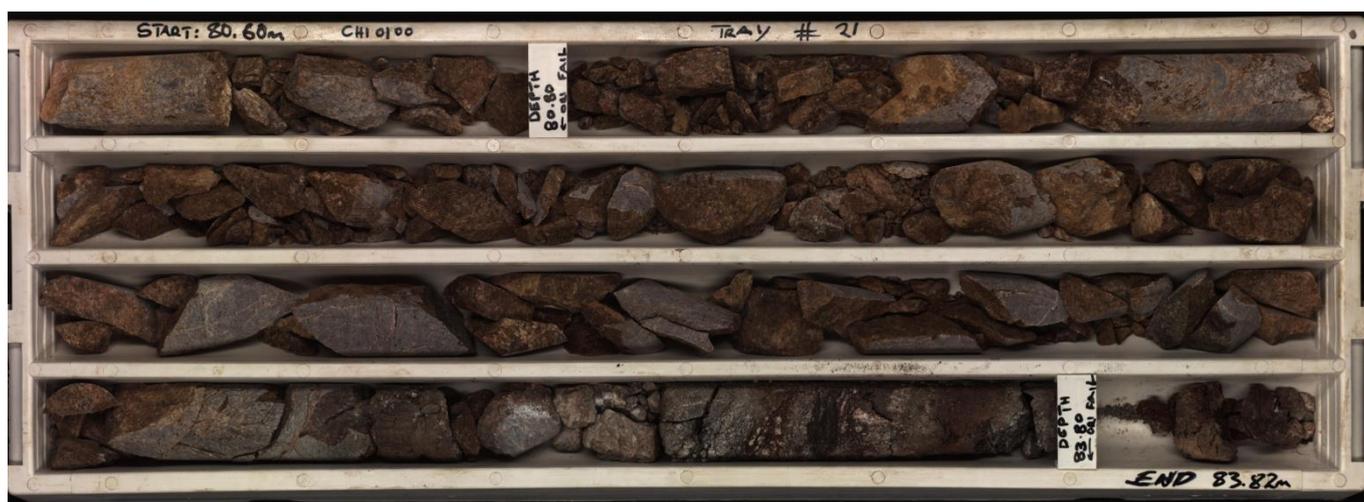
Figure 6-12. Fault zone lithology

Figure 6-12 shows the massive fracturing within the fault zone. The samples were taken from an exploration hole drilled 60 m to the south of the MH06 site.

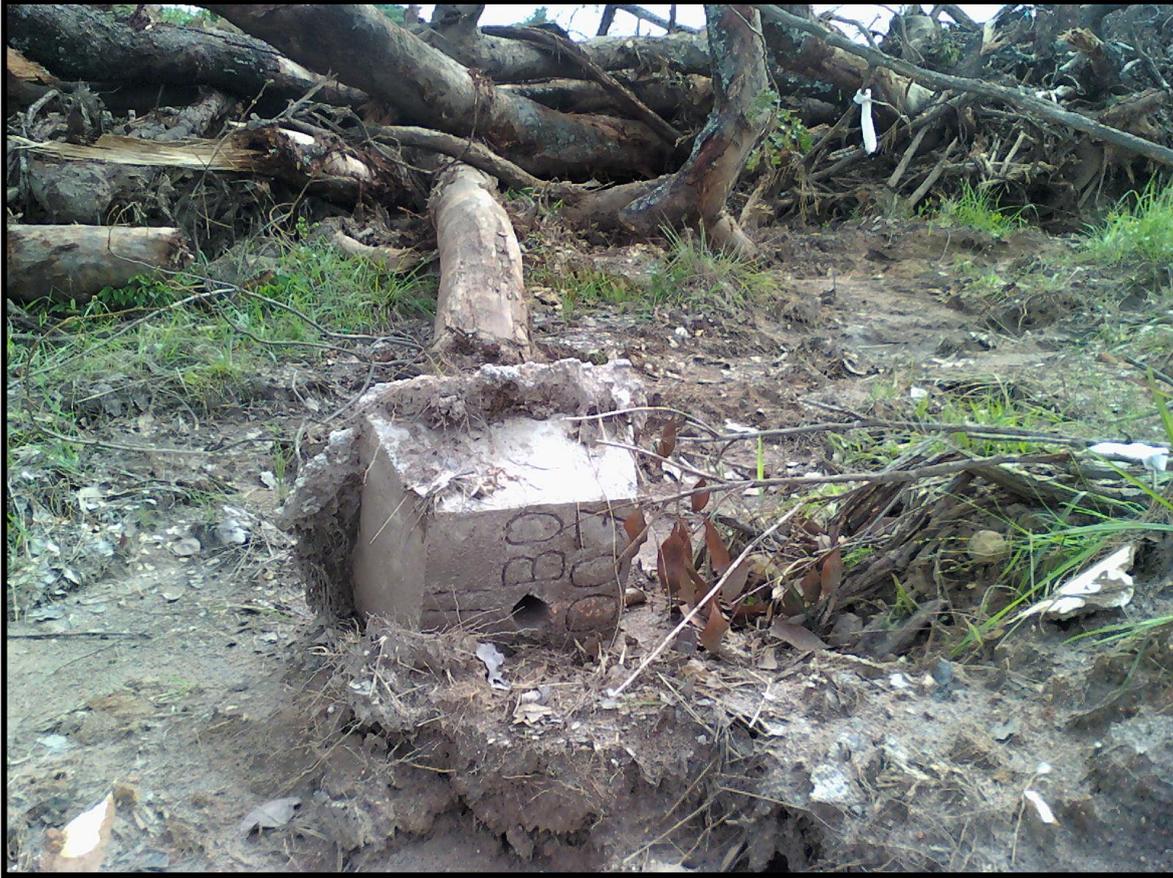
Figure 6-14. Destroyed borehole CHIWB007

One of the boreholes drilled by Golder in 2003, CHIWB 007, was destroyed in mid-December 2010 during a bush clearing process (Figure 6-14). The borehole had exhibited a continually declining water level even well into the rainy season. CHIWB007 was situated in the centre of the future mining area and had to be destroyed to enable mining to proceed.

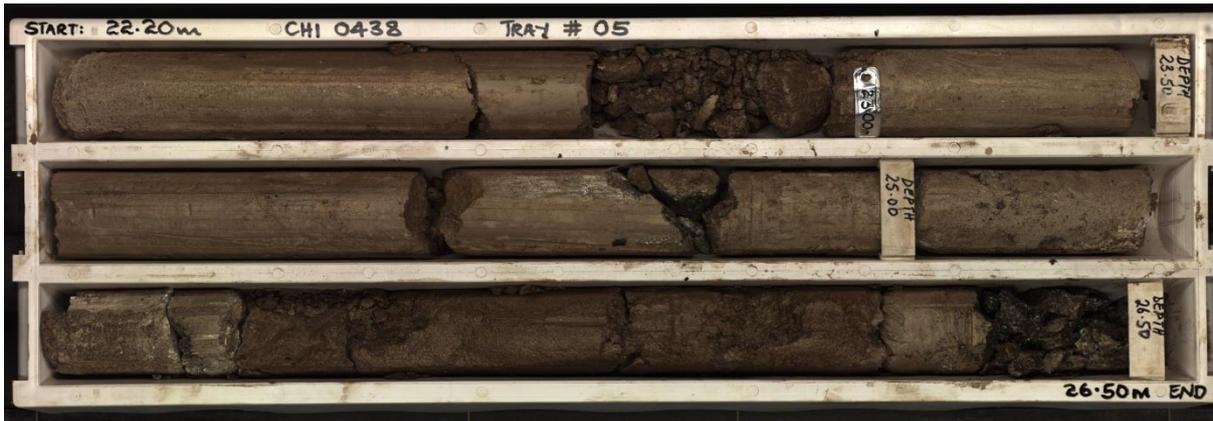
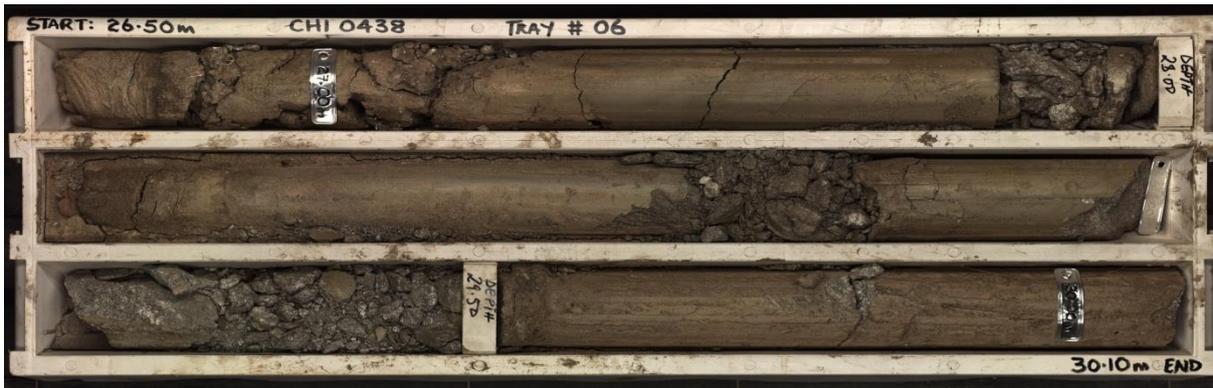
Figure 7-1. Core samples from the upper weathered aquifer

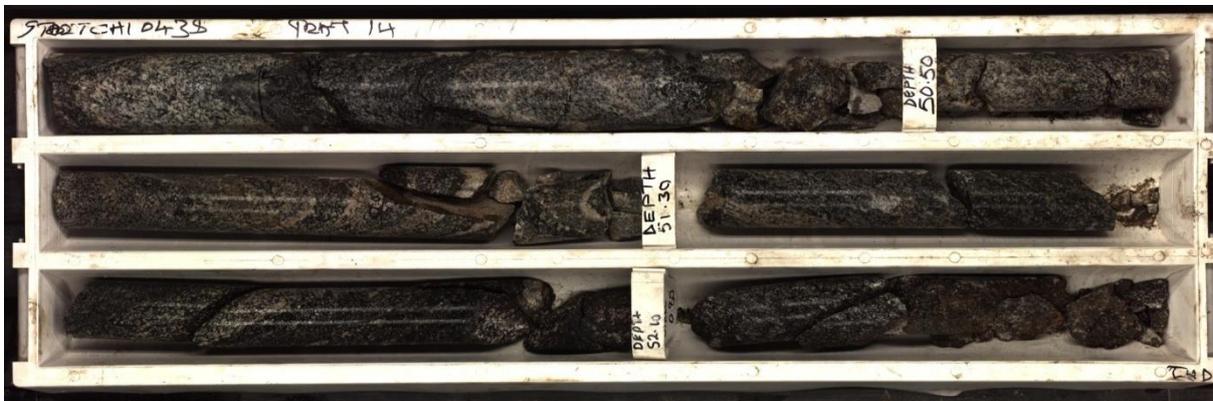
Figure 7-2. Core samples from the fractured aquifer

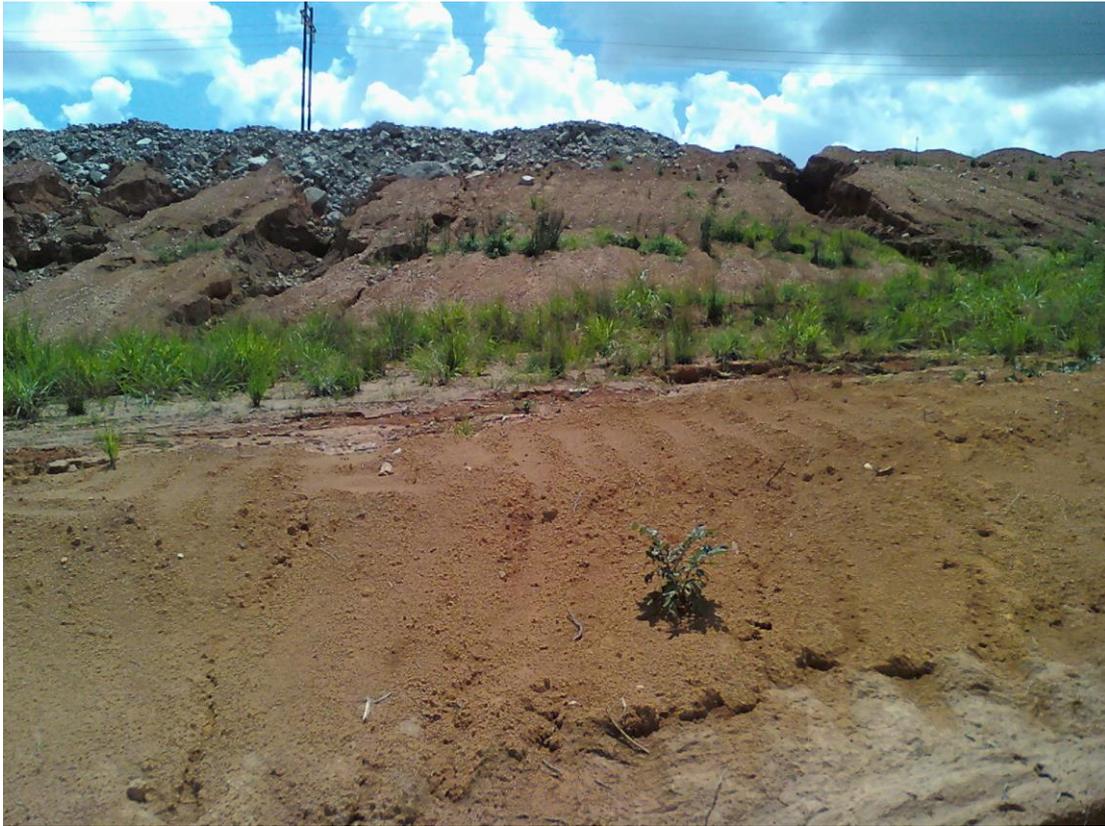
Photograph C1. Signs of high wall instability in Malundwe pit

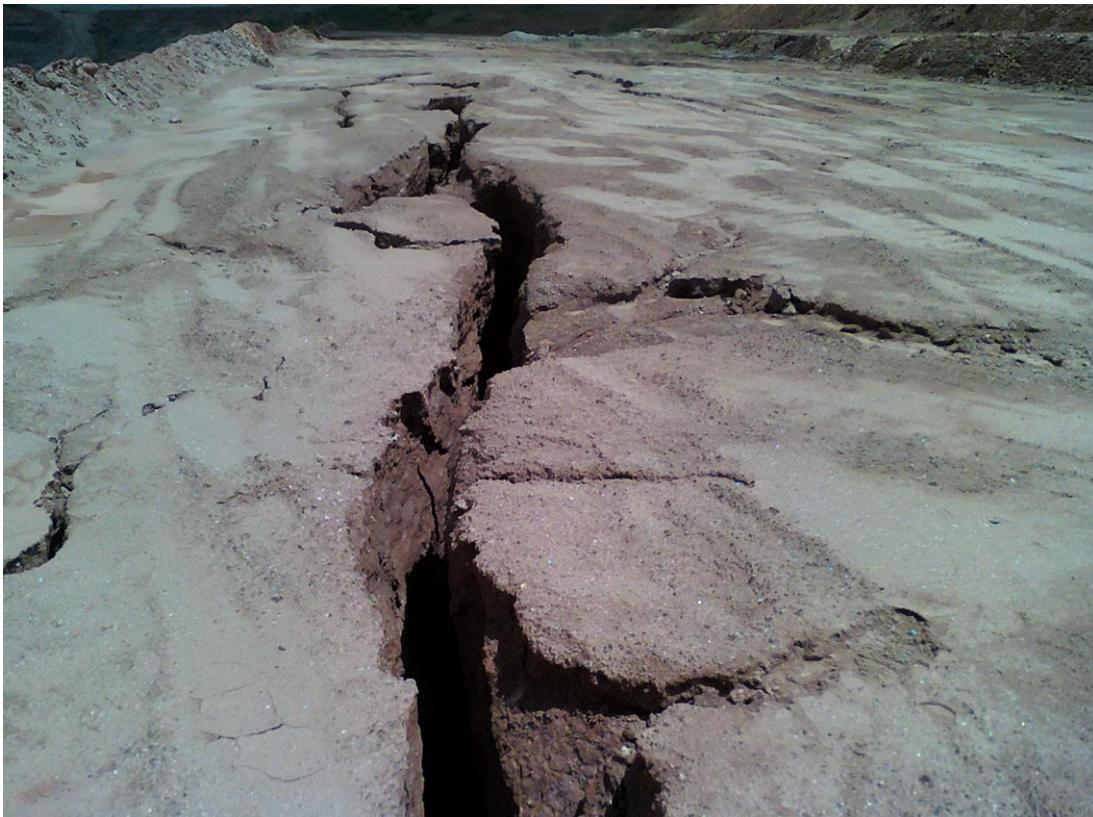
Photograph C2. Cracks behind the high wall at Malundwe pit

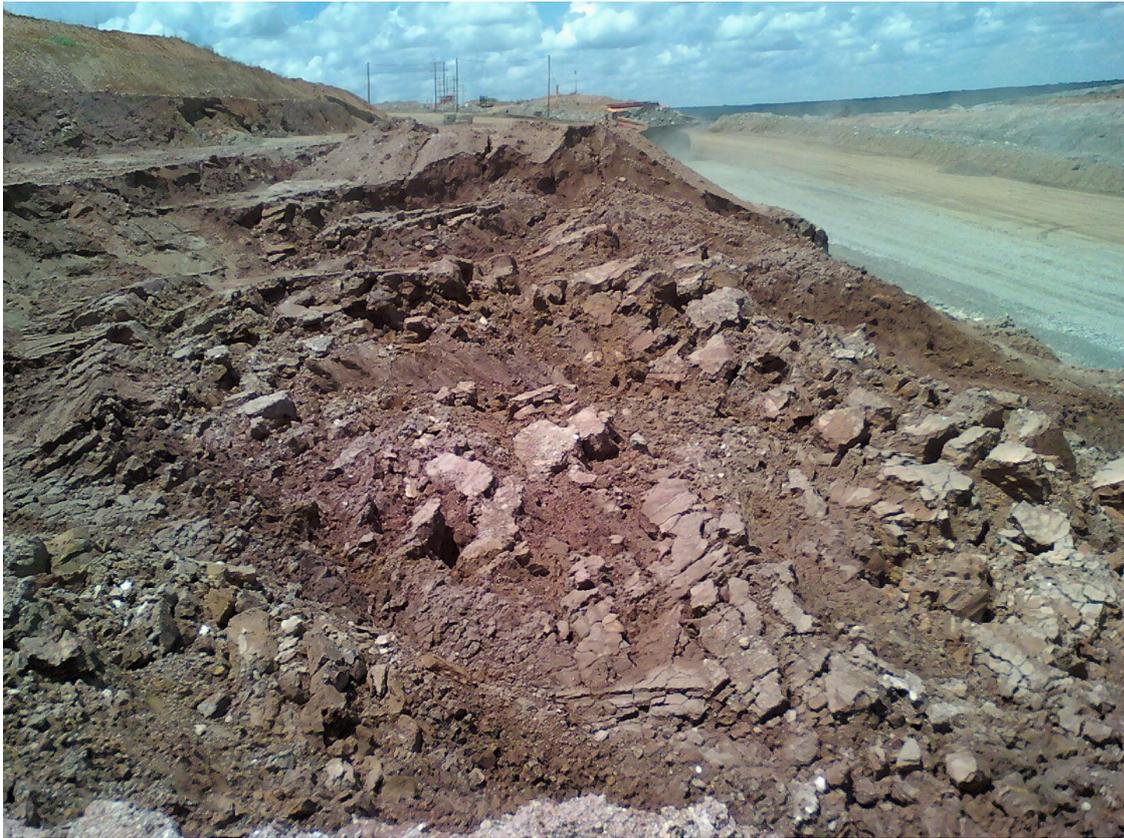
Photograph C3. Slope failure at Malundwe pit

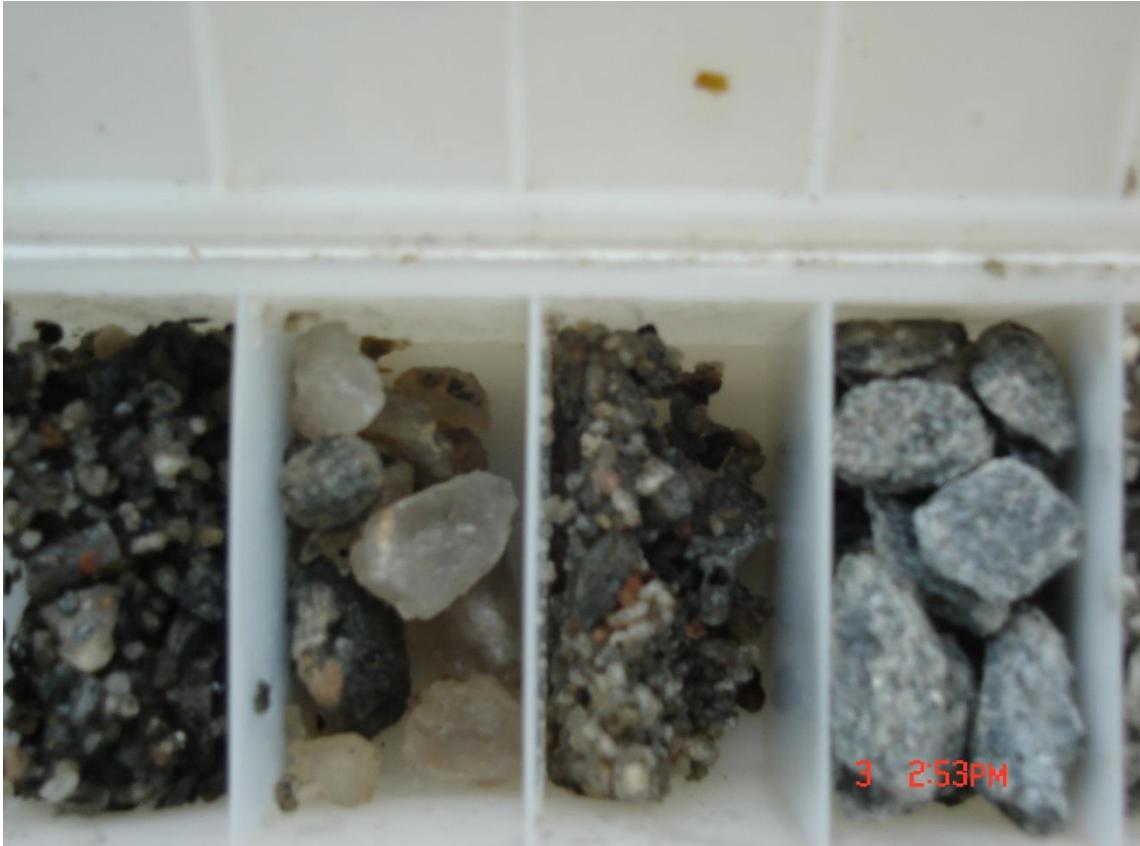
Photograph C4. Lithological chips collected during drilling at Chimiwungo
