DETERMINATION OF THE POSSIBLE  
REQUIREMENT FOR REMEDIATION OF  
MANGANESE IMPACTED GROUNDWATER AT AN  
INDUSTRIAL FACILITY IN NELSPRUIT

*Magister Scientiae in Geohydrology*

University of the Free State

January 2018

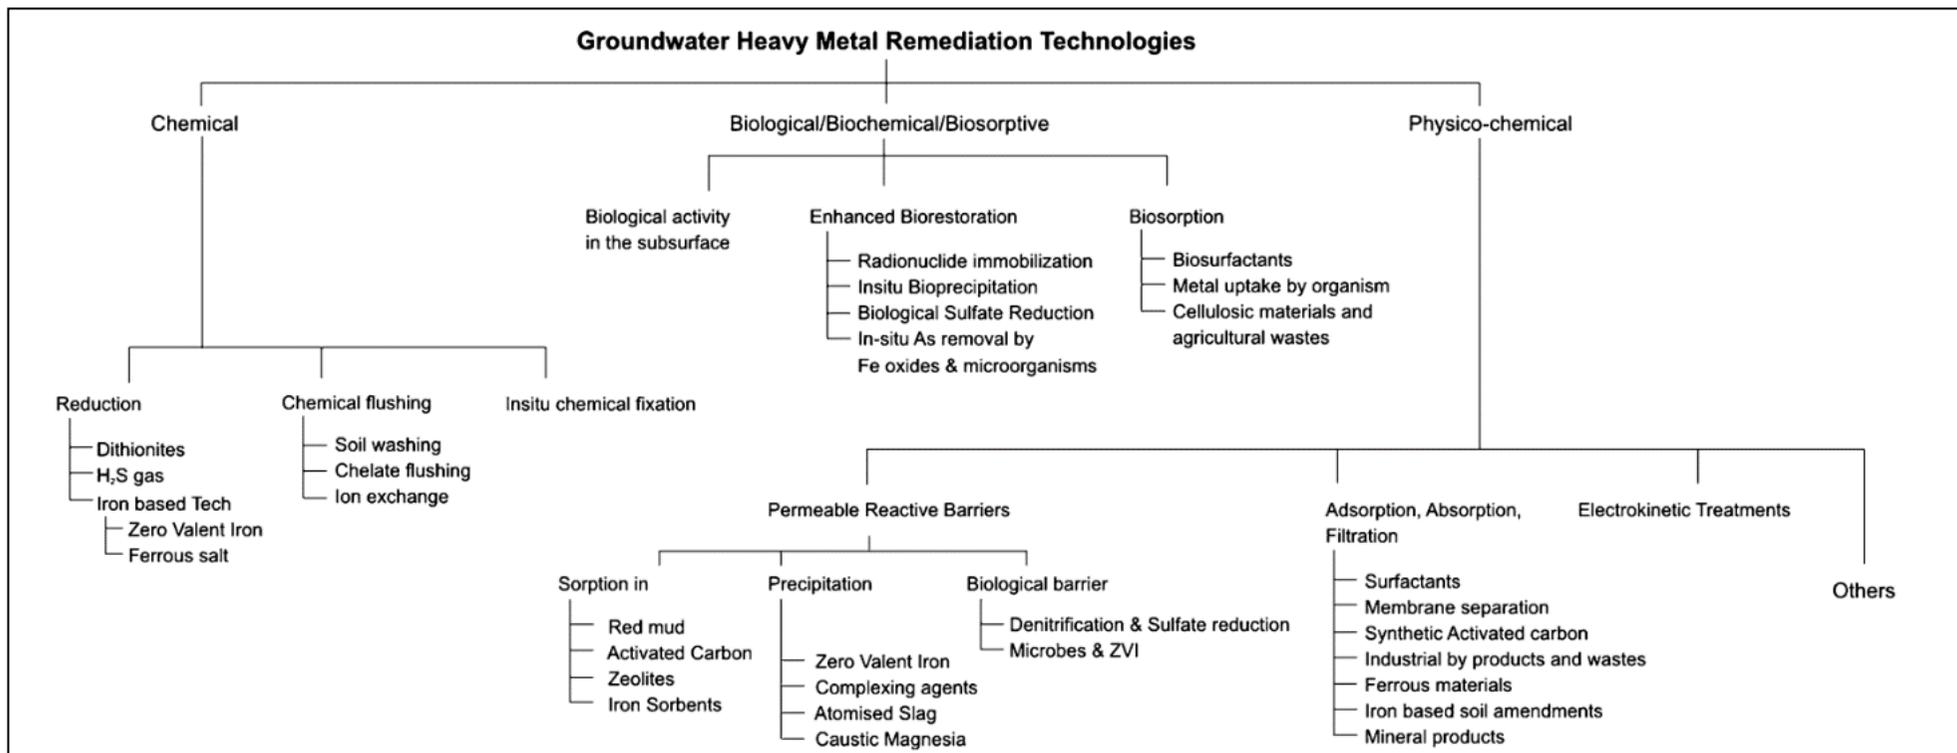
Figure 2-1: Groundwater heavy metal remediation technologies (Taken from Hashim et al., 2011)

Figure 2-1 is taken from Hashim et al. (2011) and provides a summary of the various types of remediation methods available for the treatment of groundwater impacted by the presence of elevated concentration of heavy metals. The various techniques can be divided into three main treatment technologies: Chemical; Biological/Biochemical/Biosorptive; and Physio-chemical.

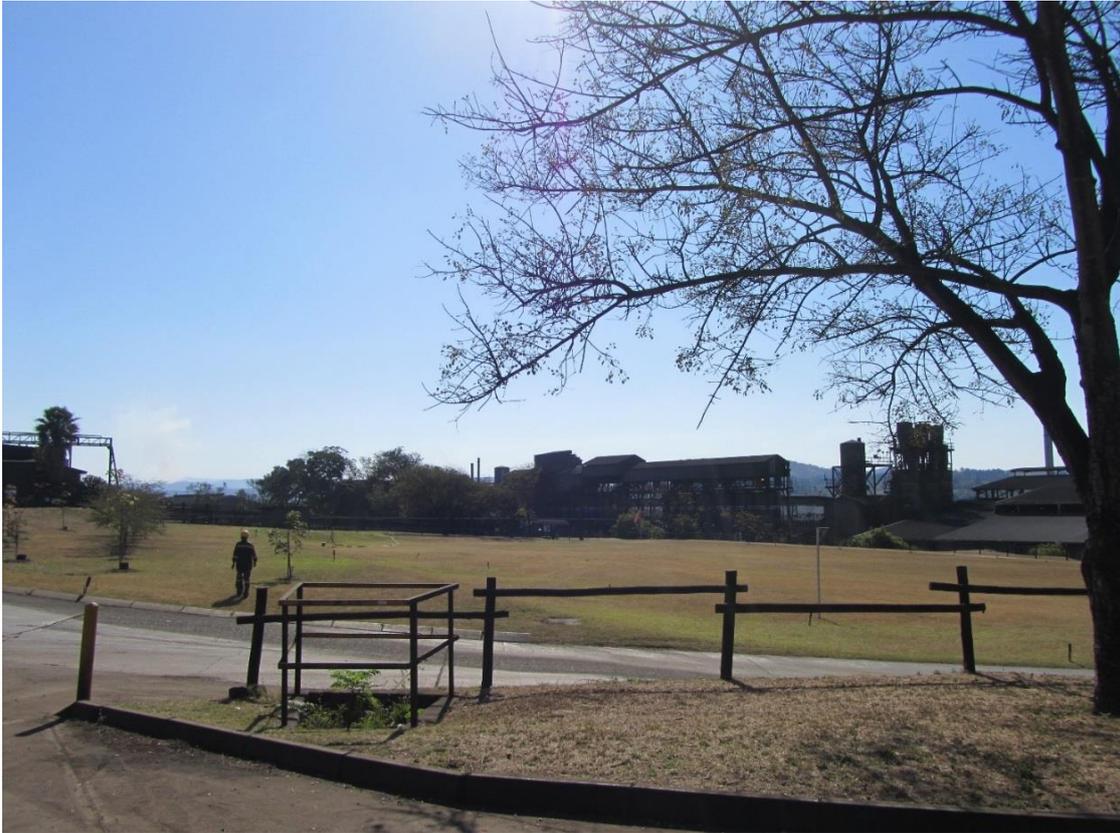
**Figure 3-3: Delta E.M.D. facility looking towards the north**

The site is located within an industrial zone to the north of Nelspruit, within the Mbombela (MP322) Local Municipality, a sub-structure of the Ehlanzeni District Council (DC32). A site location drawing is provided as Figure 3-2. Two images of the site and an image of the facility taken from the south of the site facing north are provided as Figure 3-3 and Figure 3-4, respectively. The Crocodile River is present between the site and the hills shown in the distance in Figure 3-3.

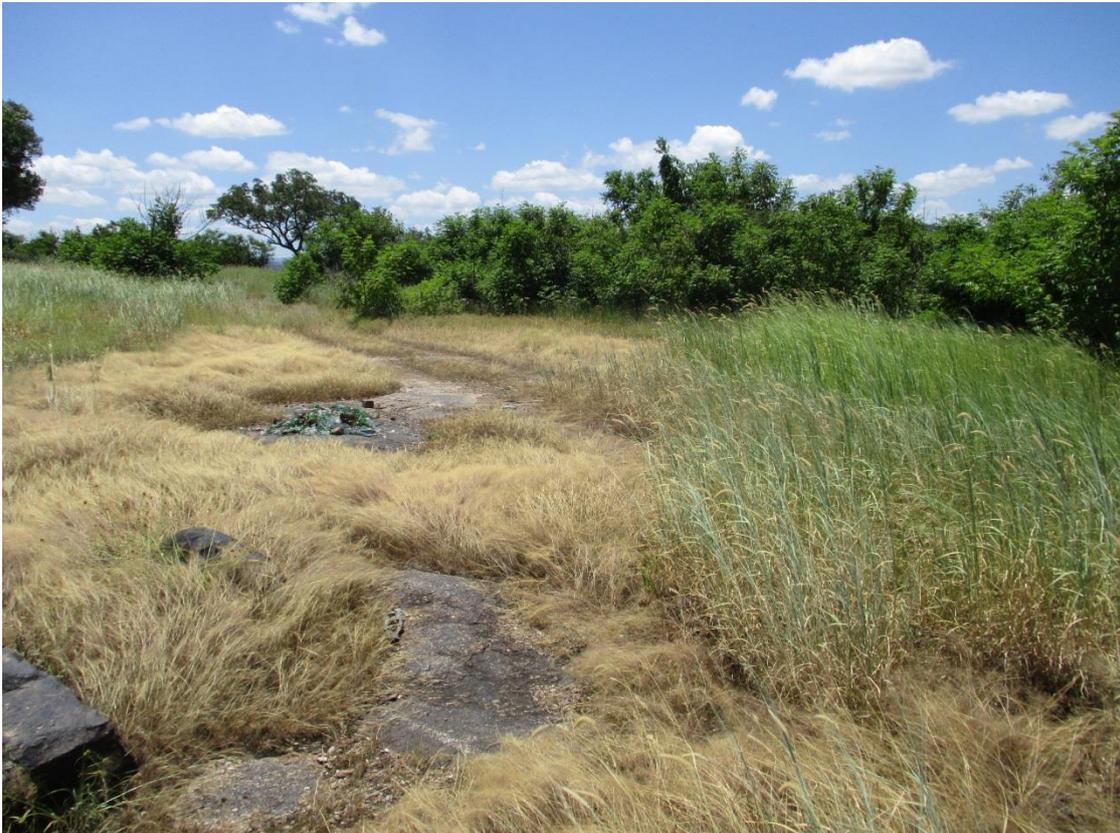
**Figure 3-6: Undeveloped Bush Land looking towards the north-west**

To the immediate north of the site a generally east-west running wide single-carriageway road (R2296) is present which links Nelspruit with residential communities to the north and east (see Figure 3-5). Beyond the road is undeveloped bush land (see Figure 3-6) which slopes moderately steeply down towards the Crocodile River located 200 m north of the site. The eastern boundary of the site is bordered by various light industry typically associated with transportation and vehicular maintenance. Immediately to the south of the site is a railway line, a canal and a fuel depot. At the time of the investigation, the railway line was operational and was used for the transportation of manganese ore to site. The canal is of unknown age, however it is connected to the Crocodile River at its western extremity, and it was constructed to facilitate the movement of water from the Crocodile River to a citrus farming area located to the east of Nelspruit. A picture of the canal looking towards the north-east is provided as Figure 3-7. The fuel depot is operated by BP Southern African (Pty) Ltd and is located approximately 500 m from the site boundary. The site neighbour along the western boundary is the Manganese Metal Company (Pty) Ltd (MMC). There is known to be connectivity between near surface infrastructure on the Delta and the MMC sites.

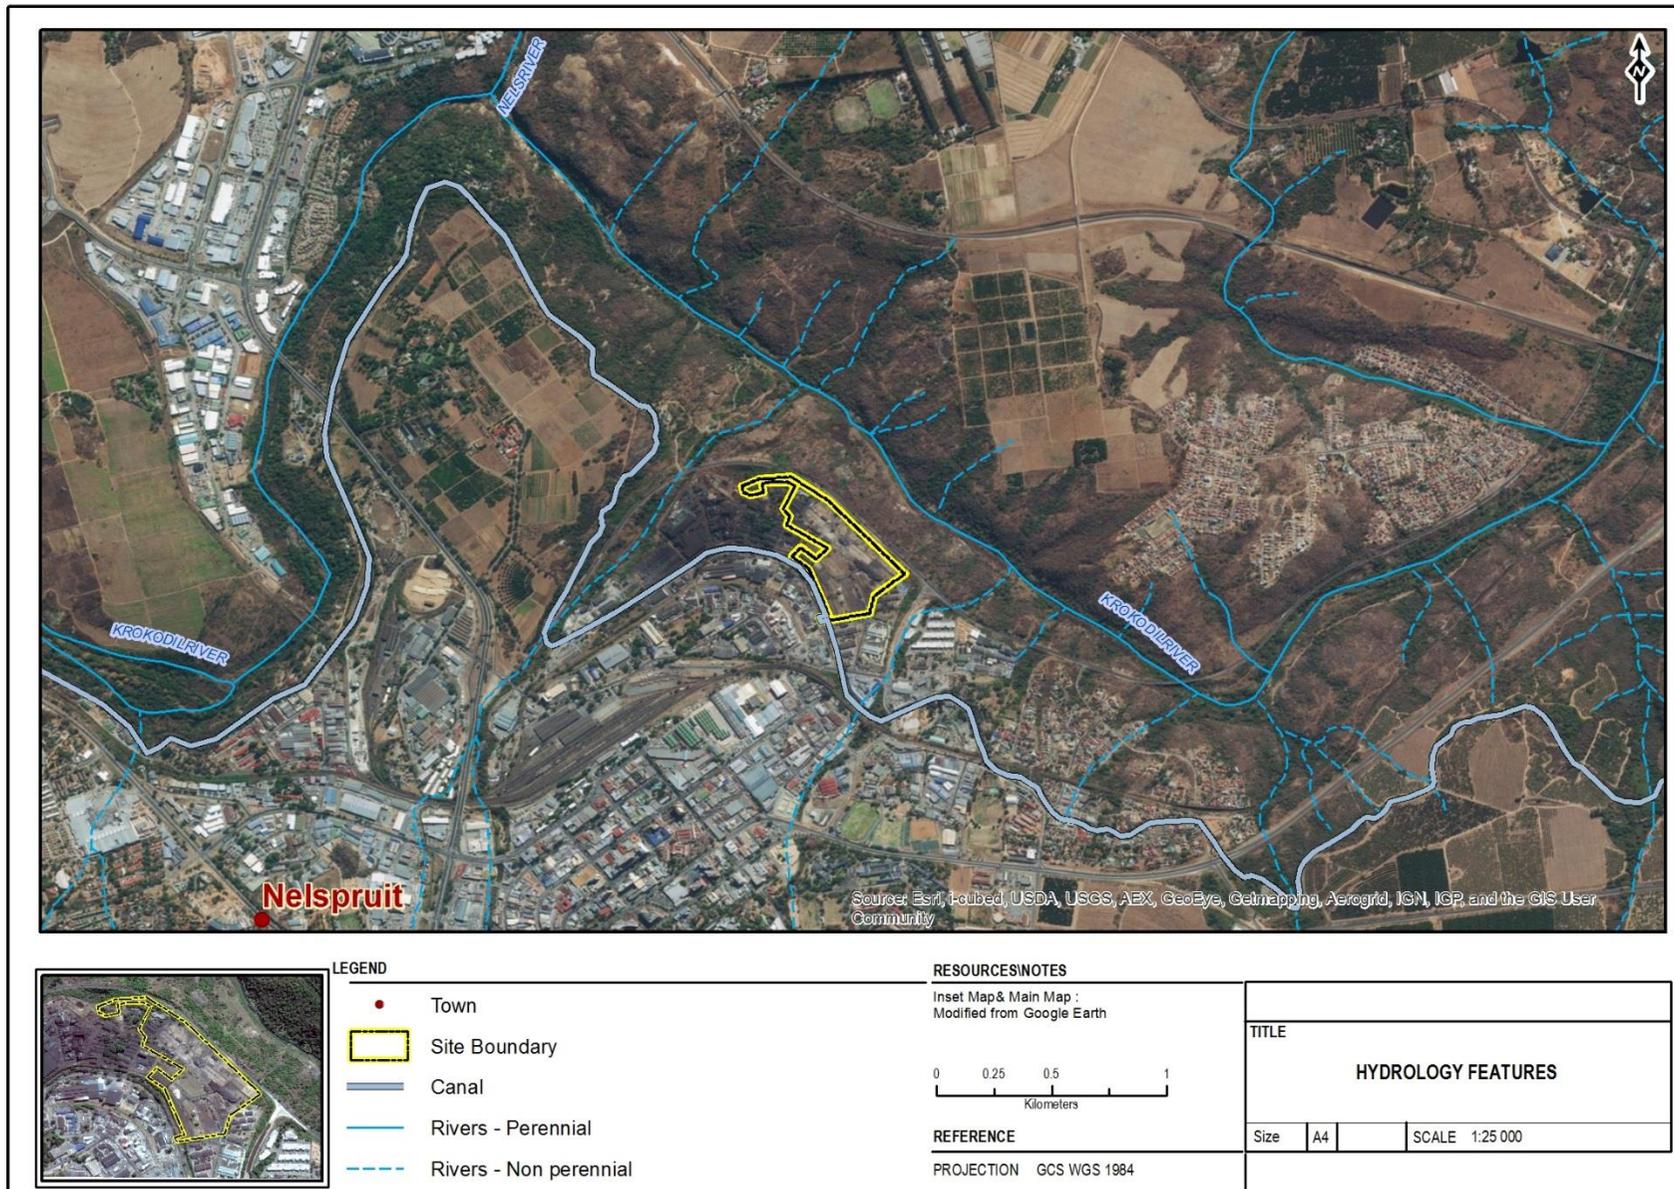
Figure 3-10: Hydrology Features

Hydrological features close to the site are shown in Figure 3-10. To the north of the site is the Crocodile River. In the area of the study, the river is wide and relatively shallow. A photograph of the Crocodile River in the near vicinity of the site is provided as Figure 3-11. The Crocodile River flows in an easterly direction eventually reaching the Indian Ocean via Mozambique. To the west and east of the site there are two non-perennial streams trending south-west to north-east (see Figure 3-12 and Figure 3-13). These streams are in full flow during time of heavy rainfall whereas at other times of the year they simply capture and divert surface run-off or near surface interflow to the Crocodile River.

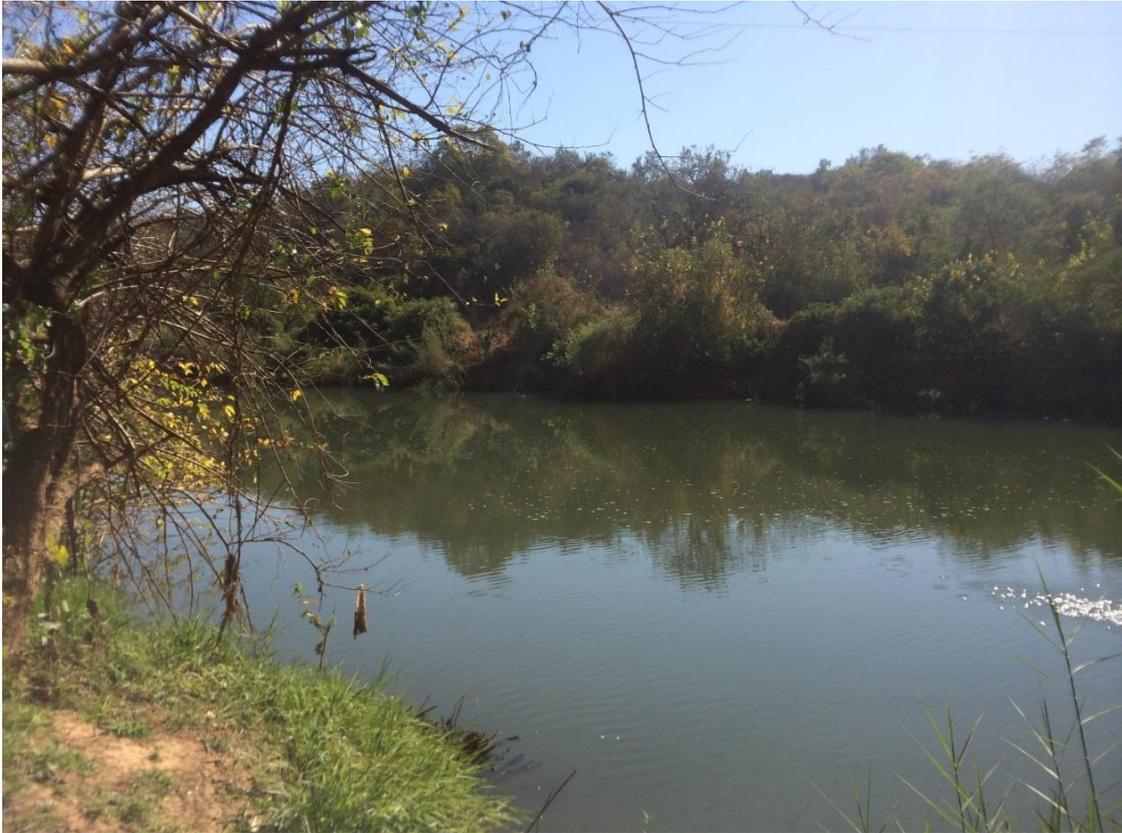
**Figure 3-11: Crocodile River located to the north of the site looking north**

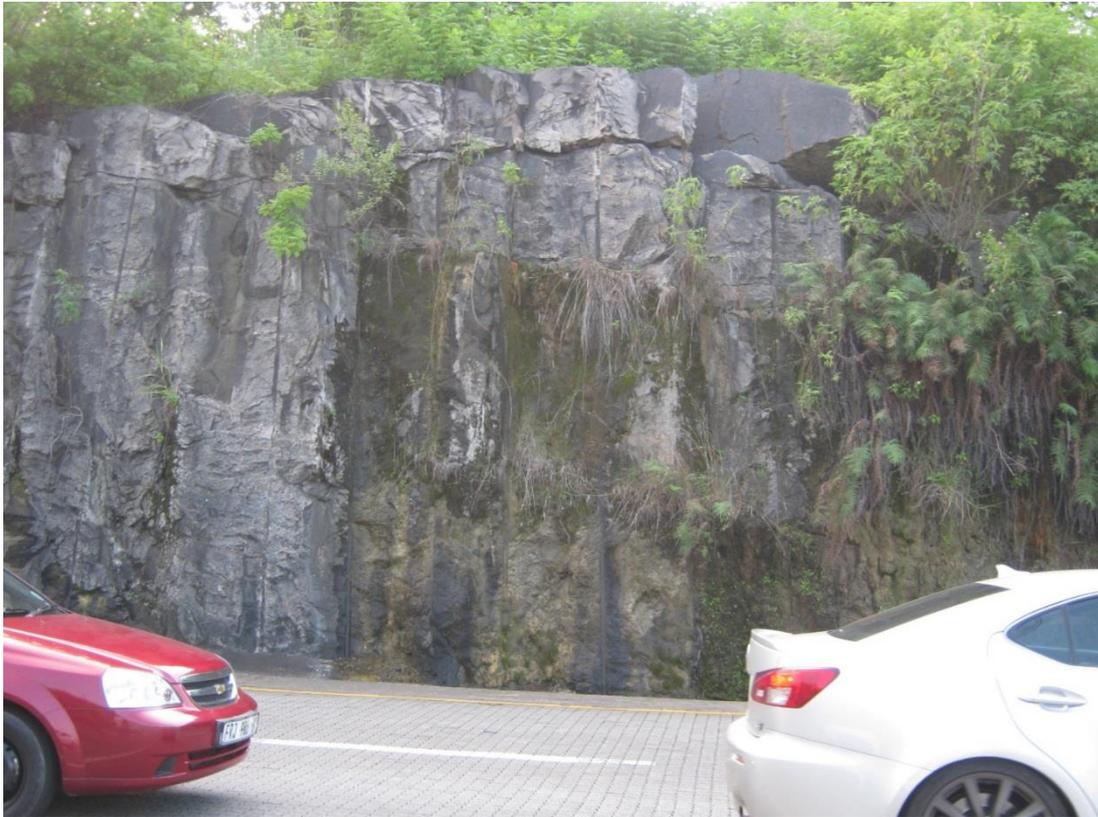
**Figure 3-14: Shallow Water Seepage through Rock face to the west of the site**

has been in place for many tens of years (possibly constructed in the 1940's but not confirmed) and groundwater levels have stabilised to that which they are today. If the canal was not present it is highly probable that groundwater levels would reduce and that fractures that allow for the passage of groundwater would simply facilitate the movement of interflow during times of increased precipitation. A groundwater flow map for the site developed using site specific measurements is provided in Chapter 4.

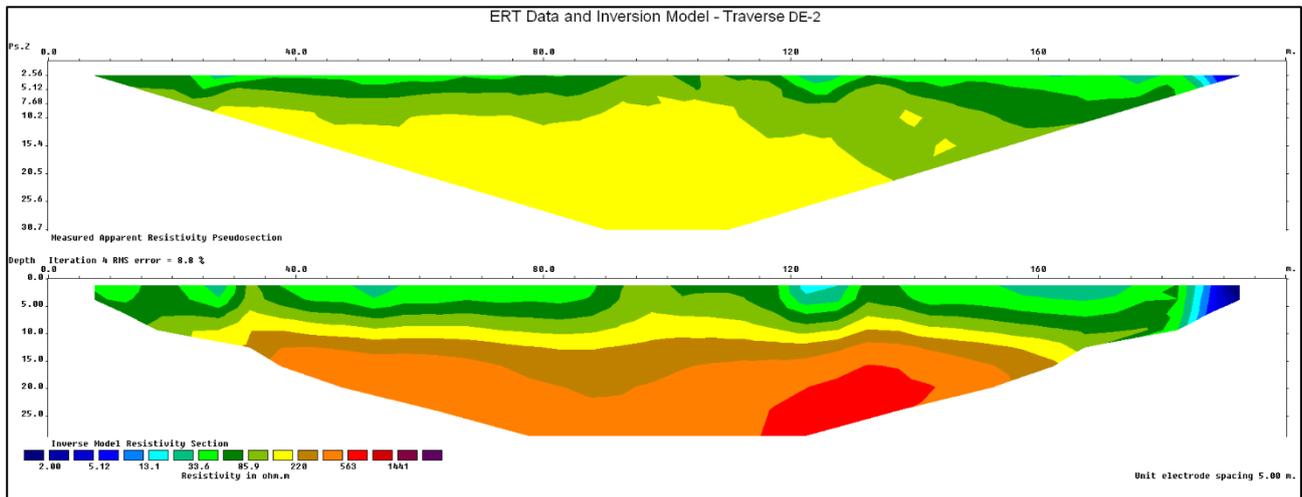
**Figure 4-3: DE02 - ERT Data and Inversion Model (Taken from Hughes, 2014b)**

ERT traverse DE02 was a relatively short survey line of only 200 m in length that was limited in distance due to the presence of buildings and other infrastructure preventing a longer continuous line being surveyed. The traverse was oriented north-south and was taken over a football pitch that had been created on an area backfilled in part with treated sludge “Greenfill”.

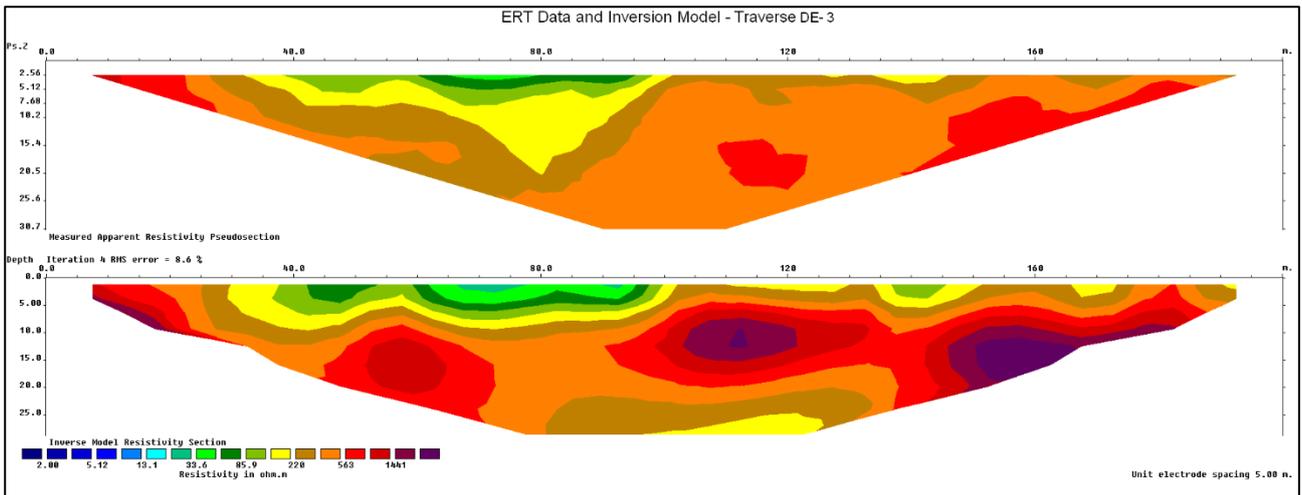
Figure 4-4: DE03 – ERT Data and Inversion Model (Taken from Hughes, 2014b)

ERT traverse DE03 was the only traverse undertaken off-site. It was located immediately north of the northern boundary wall and adjacent to the east-west running section of the R2296 road. Safety concerns for site personnel associated with fast-moving traffic immediately adjacent to the line of survey prevented the author undertaking a survey longer than a length of 200 m along a relatively wide-area of layby. A section of low to moderate apparent resistivity was identified from approximately 35 m to 100 m along the traverse (Figure 4-4). This section is considered to represent a zone of moderately weathered and fractured rock to a depth of approximately 8 mbgl (Hughes, 2014b). Observations by the author along the northern external wall of the site suggested that near surface seepage of waters and possible contaminant migration may occur in this area and such may therefore be identified in the ERT cross section.

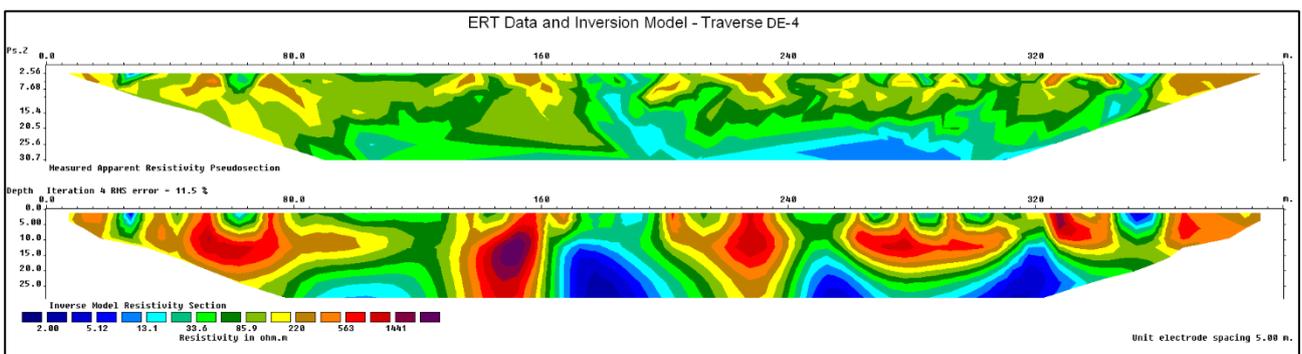
Figure 4-5: DE04 - ERT Data and Inversion Model (Taken from Hughes, 2014b)

Given the close proximity of this line to the wet-process sections of the facility it is considered that these sections likely indicate areas of in-ground contamination associated with leakage of process water during site operations. The weathering profile is considered to extend to a depth of 15 mbgl (Hughes, 2014b).

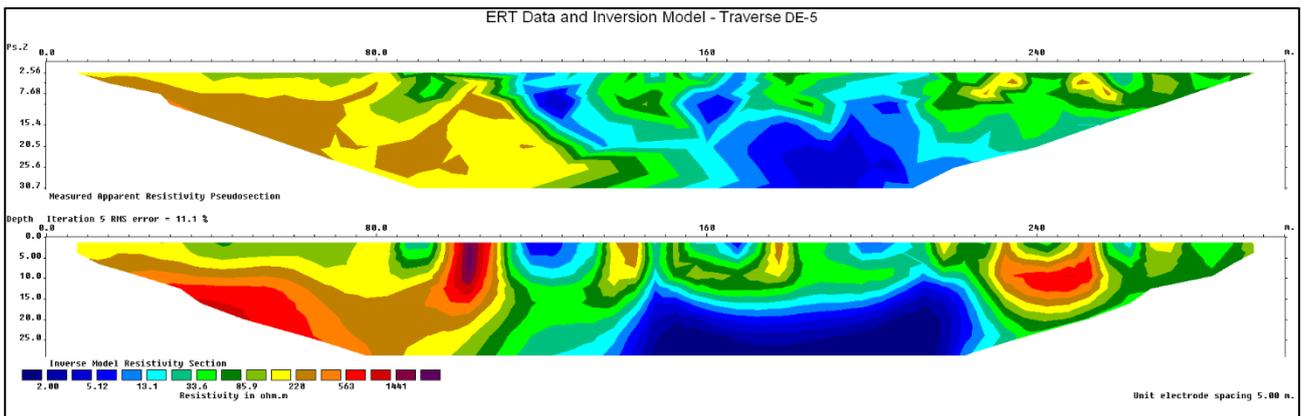
**Figure 4-6: DE05 – ERT Data and Inversion Model (Taken from Hughes, 2014b)**

The fifth survey line DE05 was 300 m in length and was advanced in a south-east to north-west direction along a partially raised internal road adjacent to a retaining wall and in front of Cell House 2 of the Eastern Plant. An area of very low resistivity was identified from 140 m to 220 m and indicated by the blue colour towards the base of Figure 4-6. At this point along the traverse the area under investigation was located immediately down-gradient of Cell House 2 of the Eastern Plant. The depth of weathering was estimated at 12 m to 15 mbgl in this area (Hughes, 2014b) with less weathered strata and more competent rock being present to the east and west of the survey line.

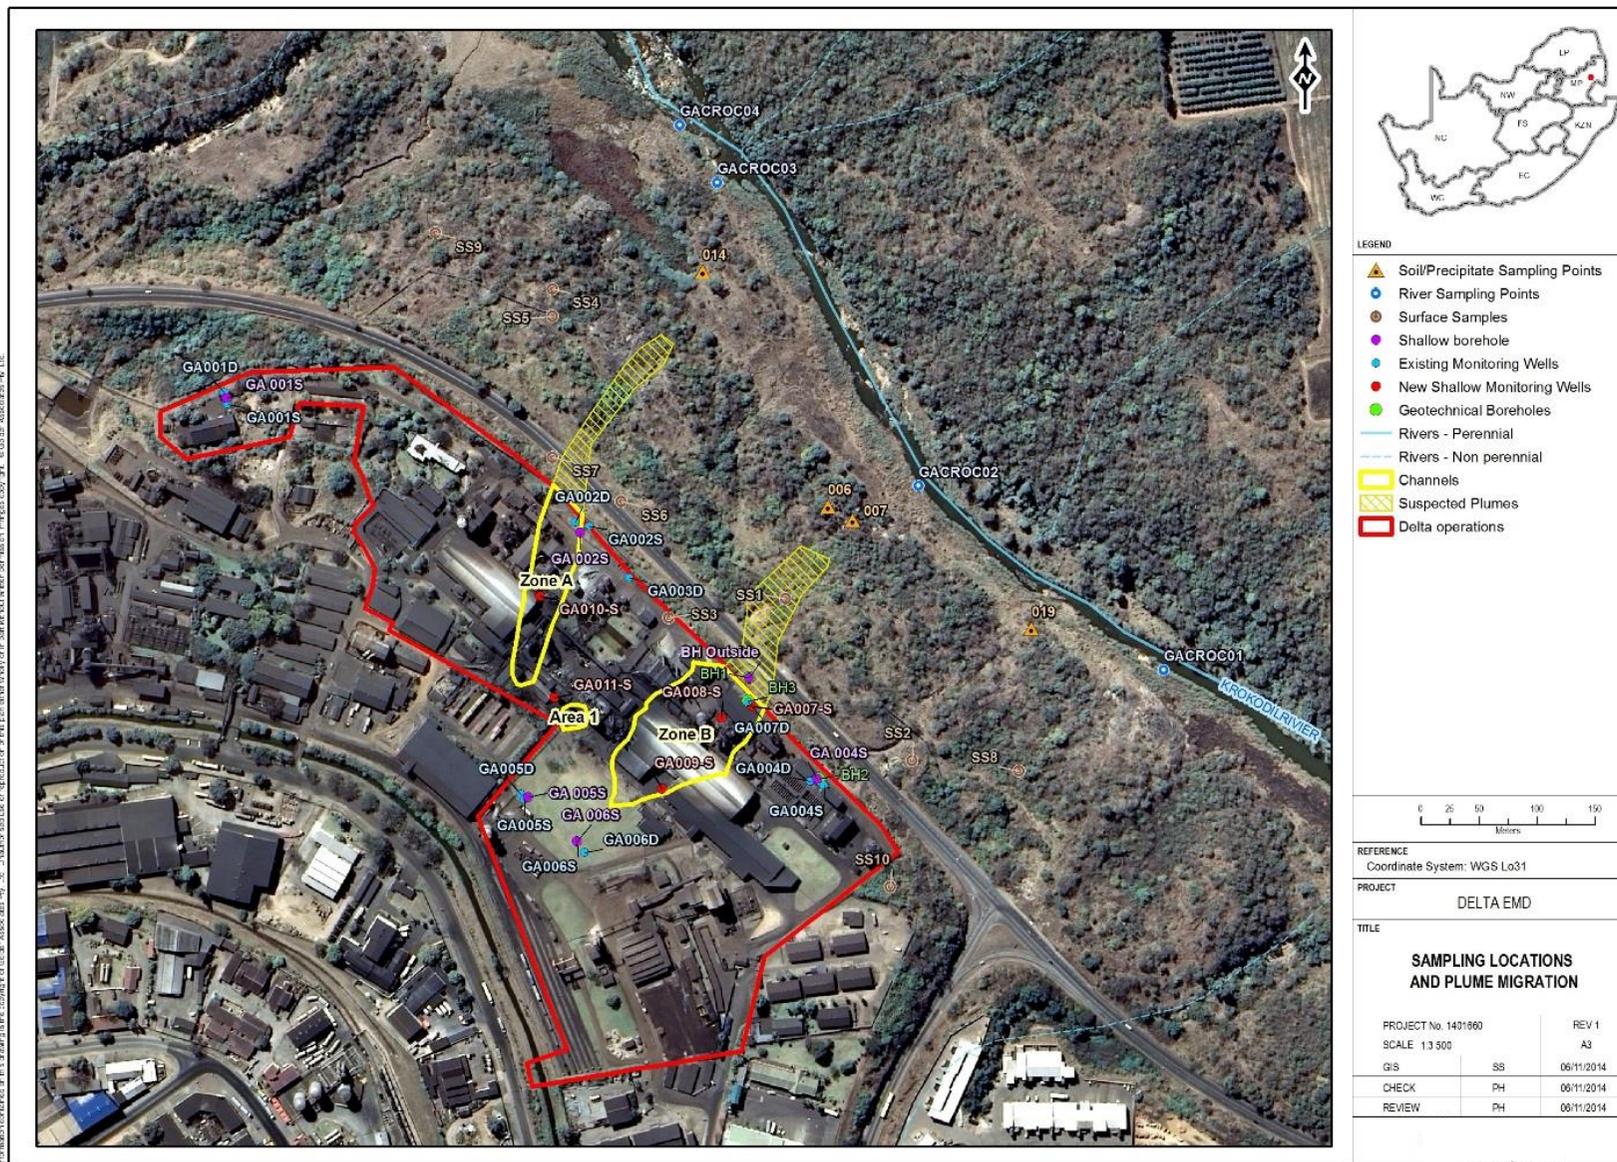
Figure 4-8: Plume Location and Proposed Sampling Points (Taken from Hughes, 2014c).

The location of monitoring wells, proposed soil sampling locations and surface water sampling locations are indicated on Figure 4-8.

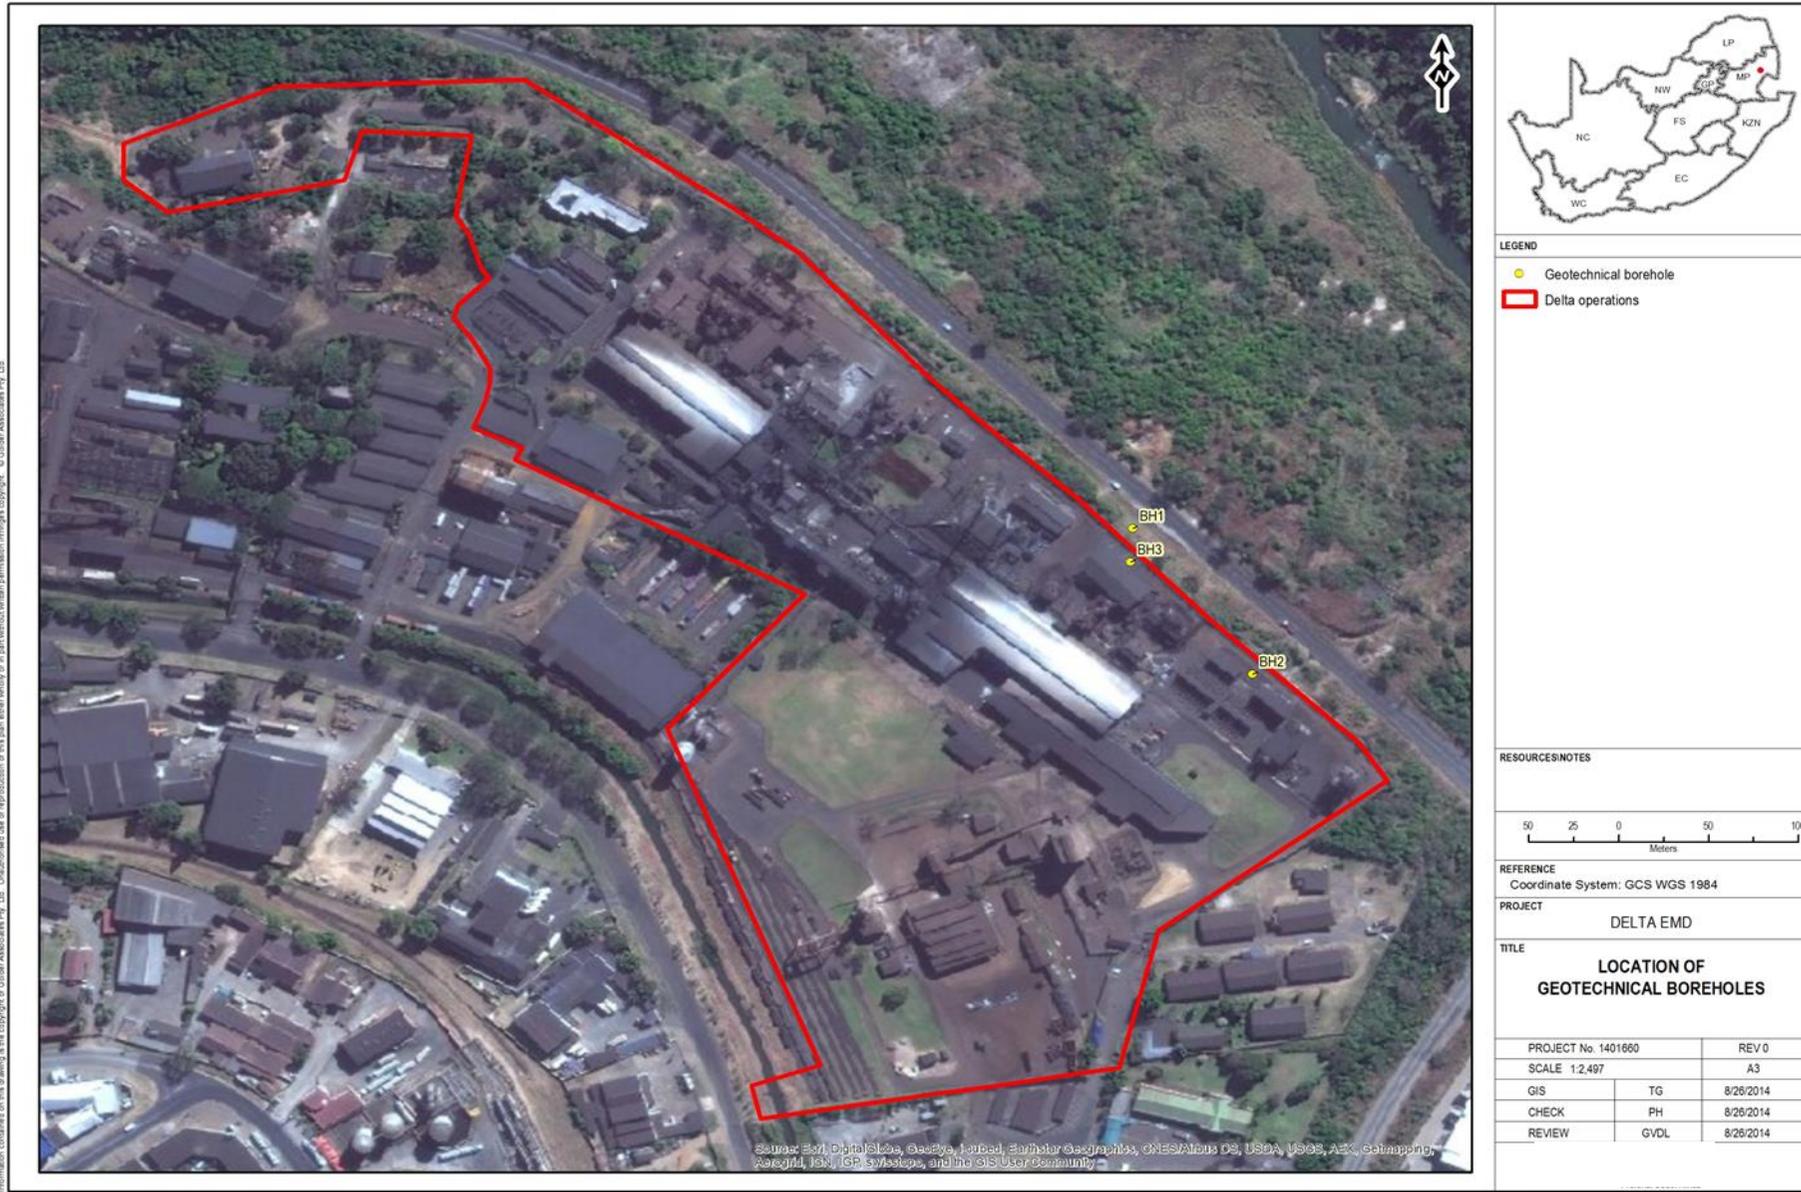
Figure 4-9: Geotechnical Borehole Location Plan (Taken from Hughes, 2014b)

would not extend as deeply as the on-site weathering profile and therefore it would be possible to correlate weathering profiles between the two elevations. Borehole drilling location and construction details are shown in Table 4-2 and a borehole drilling location map is provided as Figure 4-9.

Borehole BH1 was positioned to target a zone of low to moderate apparent resistivity which had been identified to be present between 35 and 100 m from the eastern end of line DE03. Review of the apparent resistivity profile for line DE03 suggested that a change in substantial rock strength may occur at a depth of approximately 6 mbgl coincident with an apparent resistivity reading of 85.9 ohm.m.

Borehole BH2 was located to target the high apparent resistivity zone indicated by the red and orange colours on and what was presumed to represent solid strata with a low FI. Borehole BH3 was positioned to target the low resistivity zone extending to considerable depth and indicated by the blue colours similarly on . Areas of low apparent resistivity were presumed to be indicative of a) fractured strata along which groundwater migrates and/or b) where highly conductive contaminants may be present.

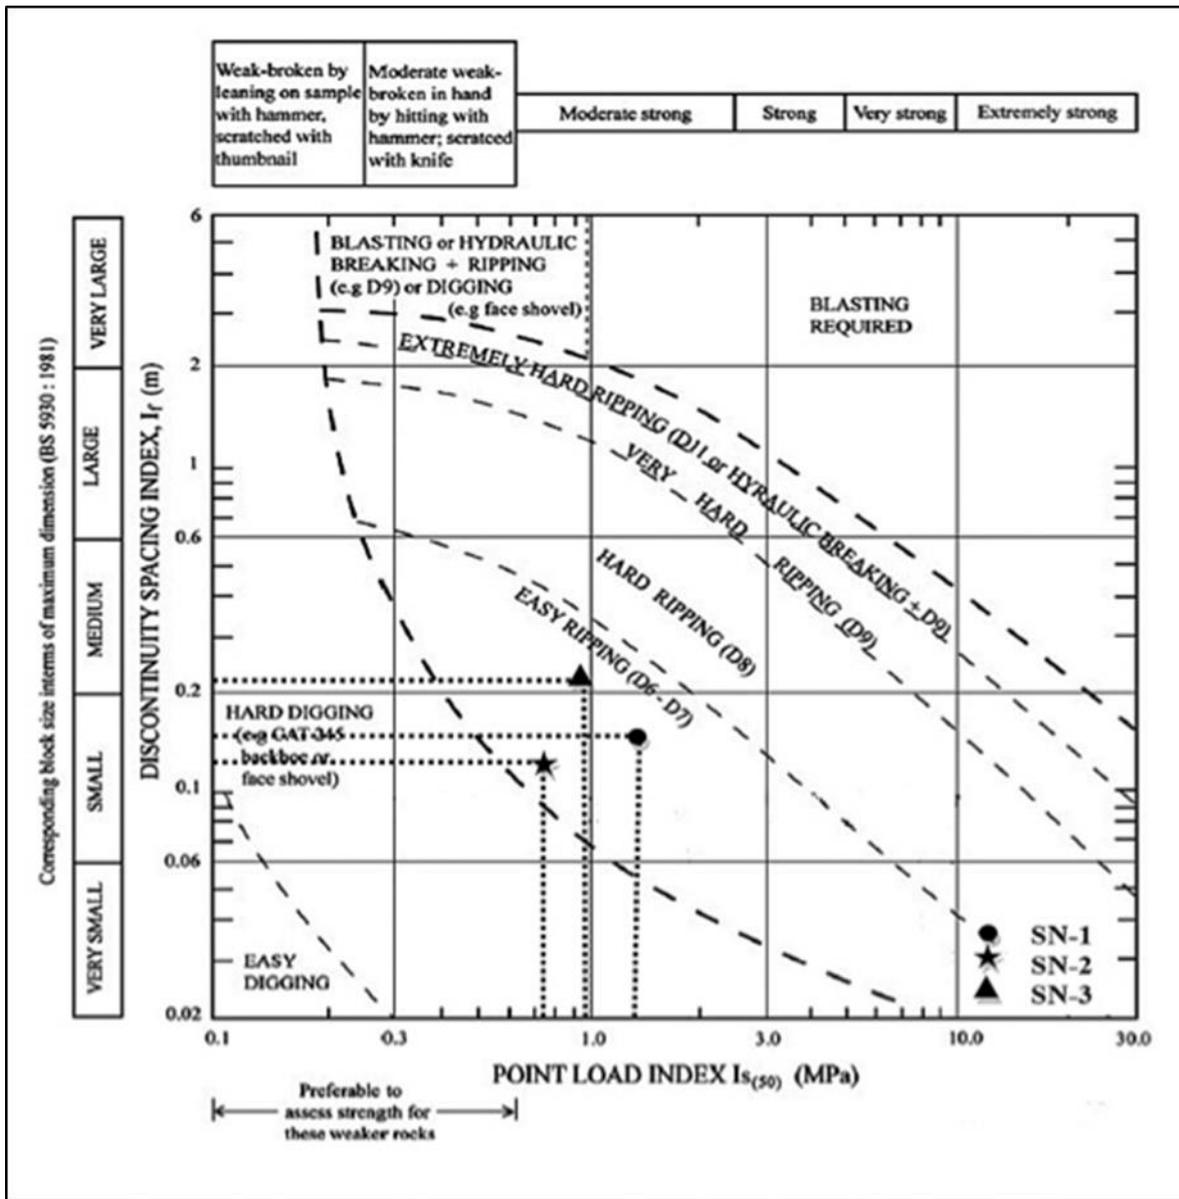
Figure 4-12: Excavatability Assessment (Taken from Pettifer and Fookes, 1994)

One of the goals of the geotechnical assessment was to determine the possible methods by which excavation of the ground along the northern boundary of the site adjacent to the road (R2296) could be undertaken. The assessment of the geotechnical data including: Point Load Index, FI, RQD and rock strength was undertaken by the author in accordance with Pettifer and Fookes (1994) which allows for determination of the type of the method of excavation required based upon the various rock properties of the underlying strata. The chart used in the assessment is provided as Figure 4-12.

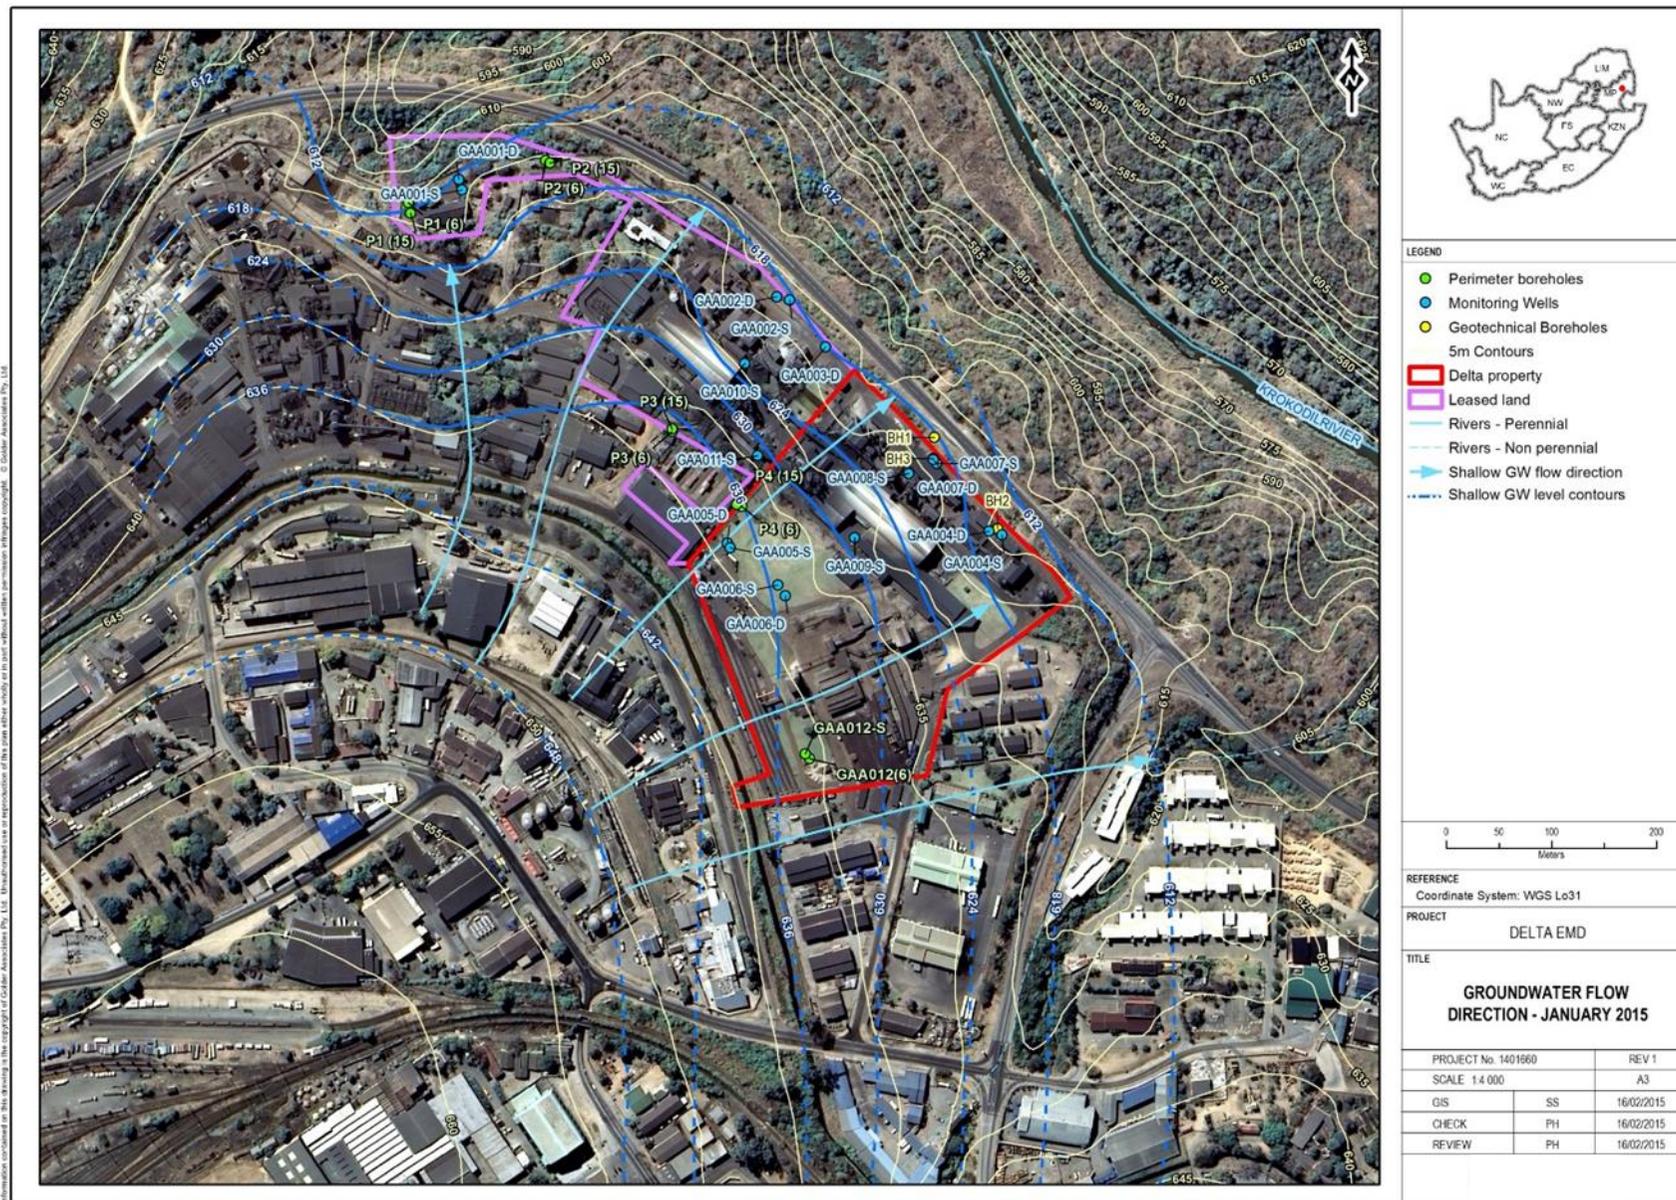
Figure 4-17: Groundwater Flow Direction for January 2015 (Taken from Hughes, 2015)

The groundwater levels have been used to calculate groundwater flow direction for January 2015 which is presented as Figure 4-17. In determining the groundwater contours, the water levels were interpolated using kriging methods to avoid conflict with regard to the close proximity of water levels obtained from groundwater monitoring well pairs. Groundwater flow direction throughout the monitoring period has been confirmed to be in a northerly direction towards the Crocodile River.

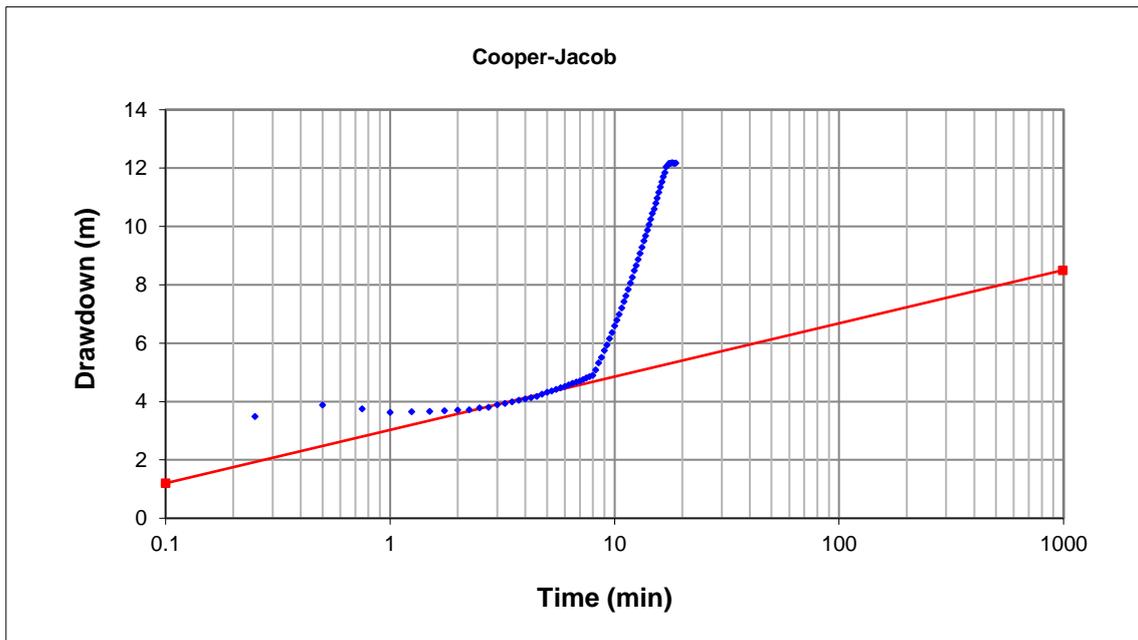
Figure 4-19: Time Drawdowns for GAA009-S (Taken from Hughes, 2014d)

Semi-logarithmic plot of time-drawdown data was produced with FC and is presented as Figure 4-19. An increase in drawdown is noted from approximately 7 minutes into the test which is coincident with a depth of approximately 4.50 to 5.00 mbgl. Review of the time drawdown plot and the derivative plot (Figure 4-20) indicates that dewatering of an upper fracture (4.50 to 5.00 mbgl) is completed by 7 minutes and a second fracture is encountered at approximately 5.50 and 7.00 mbgl.

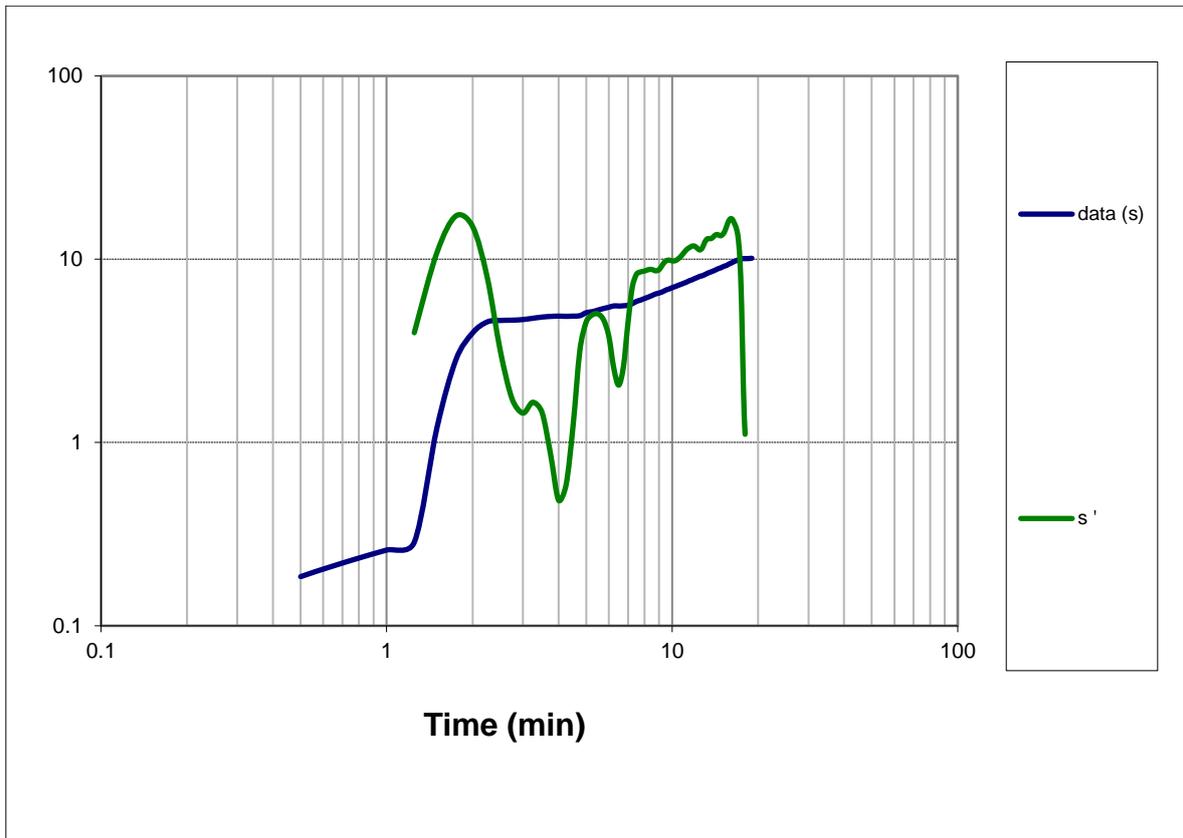
Figure 4-23: Derivative plot for GAA011-S Time Drawdown (Taken from Hughes, 2014d)

Review of the time drawdown plot (Figure 4-22) and the diagnostic plot (Figure 4-23) shows that the first fractures (or upper weathered zone) were dewatering after approximately 5 minutes at a depth of 5.10 mbgl. The second structure was dewatered at 7 minute at a depth of 5.60 mbgl.

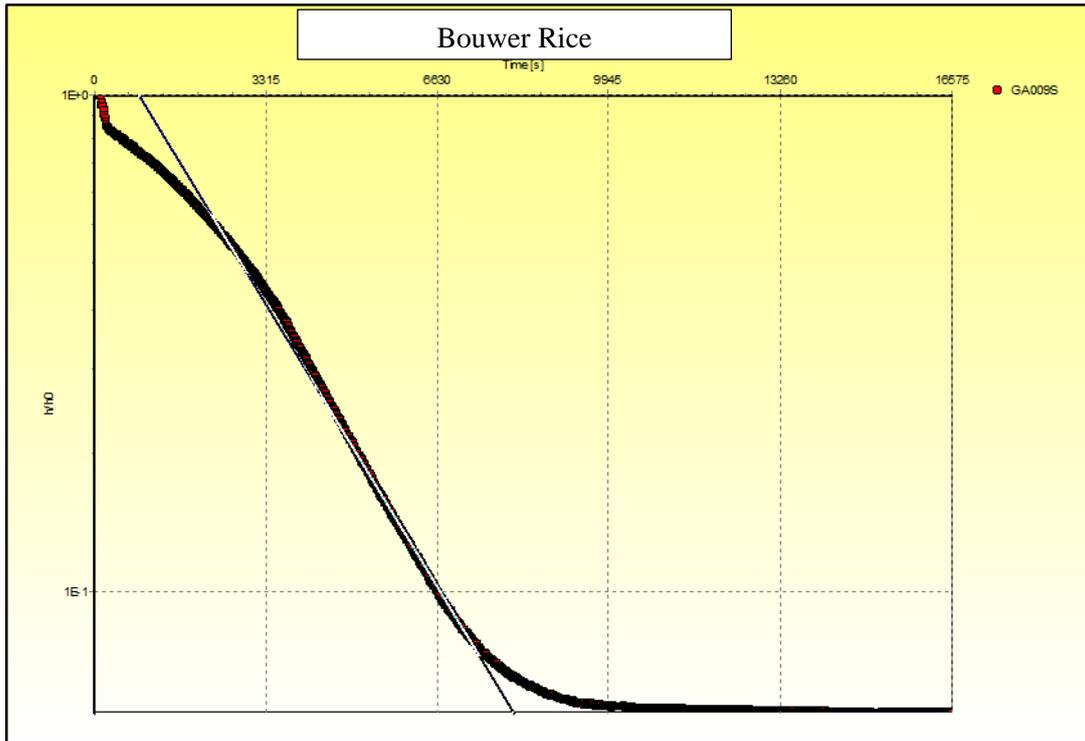
Figure 4-24: Recovery Analysis for GAA009-S (Taken from Hughes, 2014d)

The recovery test data was collected using a solonist data logger and inputted into the Aquifer Test program. The recovery test data was analysed using the Bouwer and Rice method (Bouwer and Rice, 1976). Data plots for GAA009-S and GAA011-S are presented as Figure 4-24 and Figure 4-25, respectively.
