DETERMINATION OF THE POSSIBLE  
REQUIREMENT FOR REMEDIATION OF  
MANGANESE IMPACTED GROUNDWATER AT AN  
INDUSTRIAL FACILITY IN NELSPRUIT

*Magister Scientiae in Geohydrology*

University of the Free State

January 2018

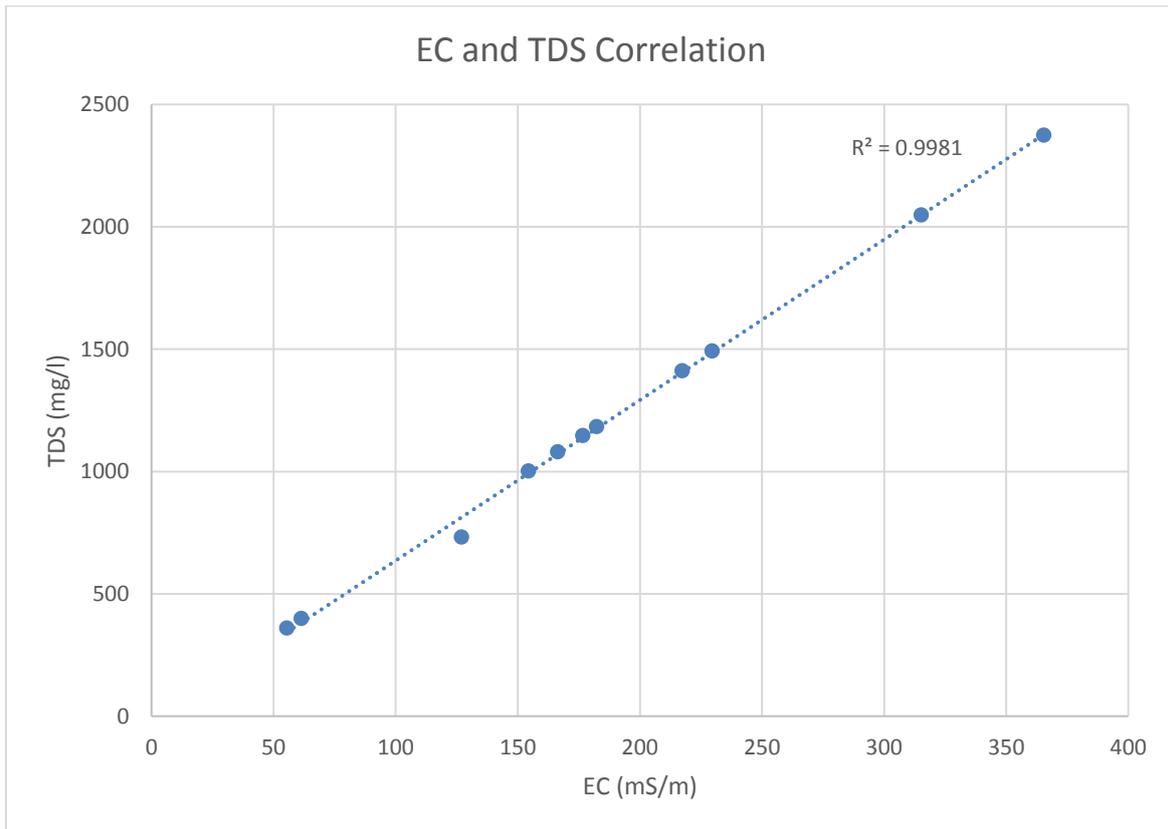
Figure 5-9: EC and TDS Correlation

Monitoring wells GAA002-S, GAA002-D and GAA003-D are located along the northern boundary of the site down-gradient of the various sources of contamination. Low pH values (3.69 to 5) were detected in these monitoring wells along with: a) relatively high ORP (300.90 to 439.90 mV) values; b) relatively high EC values (209.20 to 741.90 mS/m); and c) TDS (1,359 to 4,822 mg/l). A very strong correlation between EC and TDS was determined with  $R^2 = 0.9981$  (Figure 5-9).

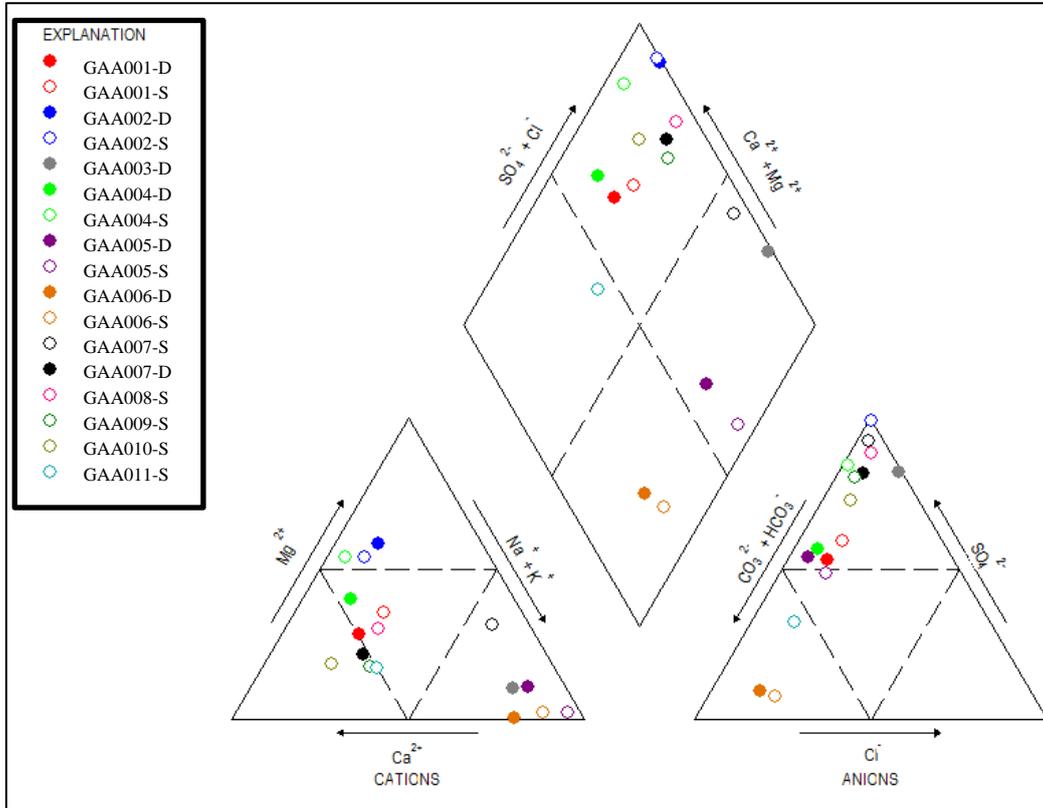
Figure 5-10: Piper Diagram for October 2014 Monitoring Events (Taken from Hughes, 2014d)

The appropriate chemical test data from the October 2014 monitoring event has been plotted as a Piper Diagram using the WISH computer programme and is presented as Figure 5-10.

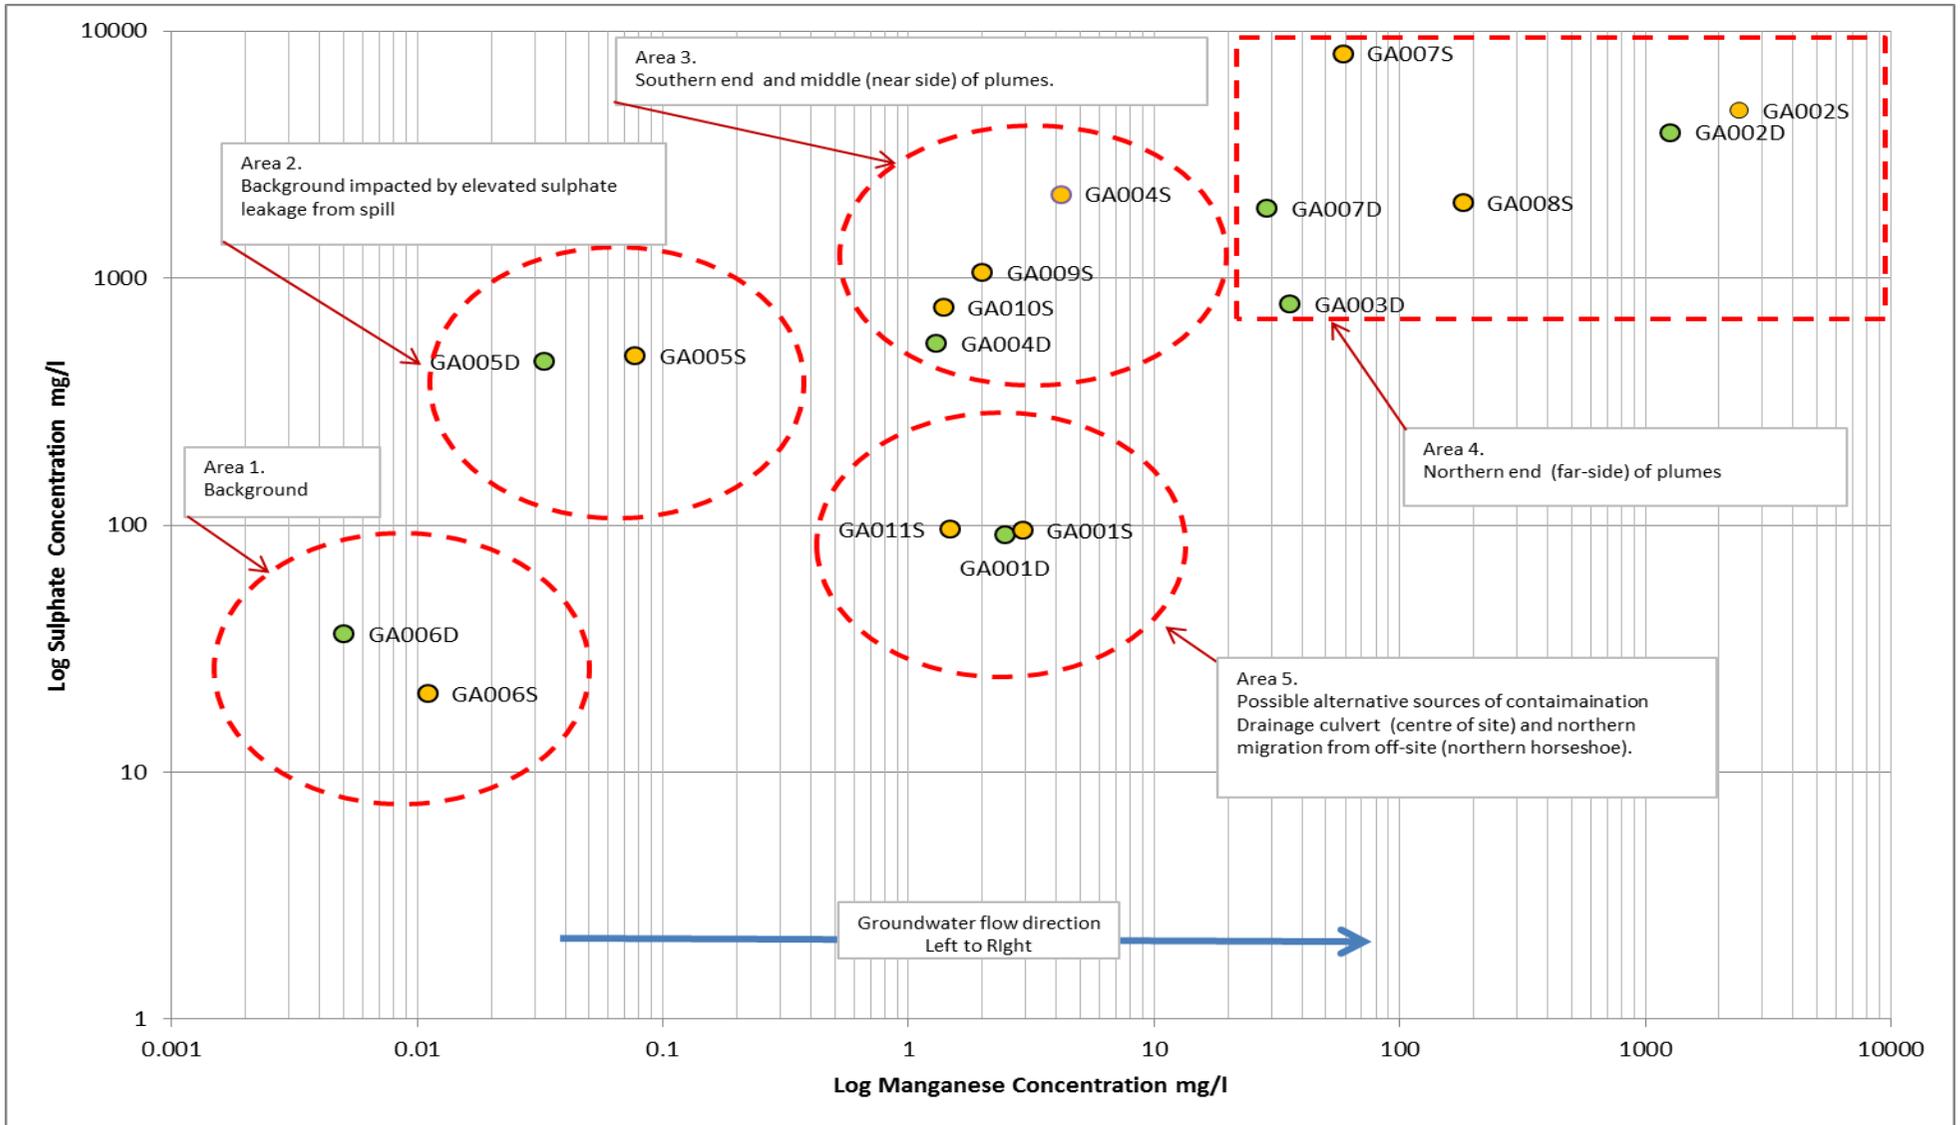
Figure 5-11: Log Manganese vs Log Sulphate (Taken from Hughes, 2014d)

This area is indicative of groundwater that is subject to lower sulphate concentration than other contaminated areas on site whilst maintaining a relatively high manganese concentration. It is possible that the sources of contamination on this area are due to an off-site source (Hughes, 2014d).

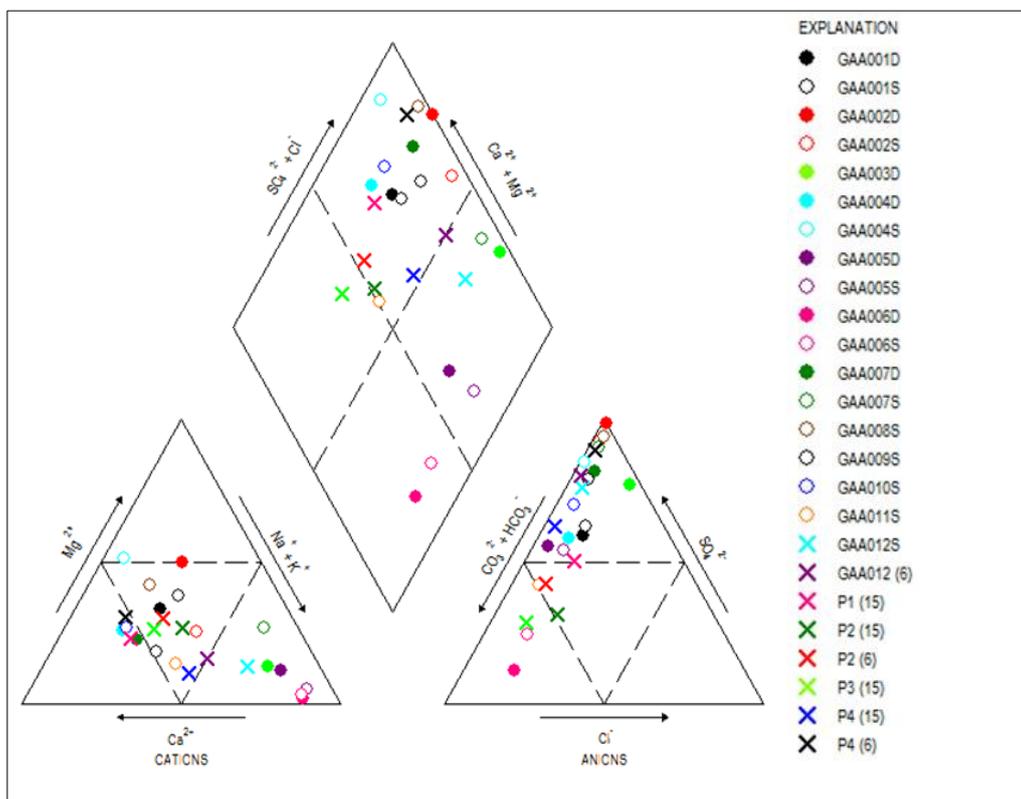
Figure 5-12: Piper Plot for December 2014 sampling event (Taken from Hughes 2015)

The computer programme WISH developed by the Institute for Groundwater Studies (University of Free State) was utilised to characterise groundwater types present on site using a piper diagram. A piper diagram for groundwater samples obtained from the site is provided as Figure 5-12.

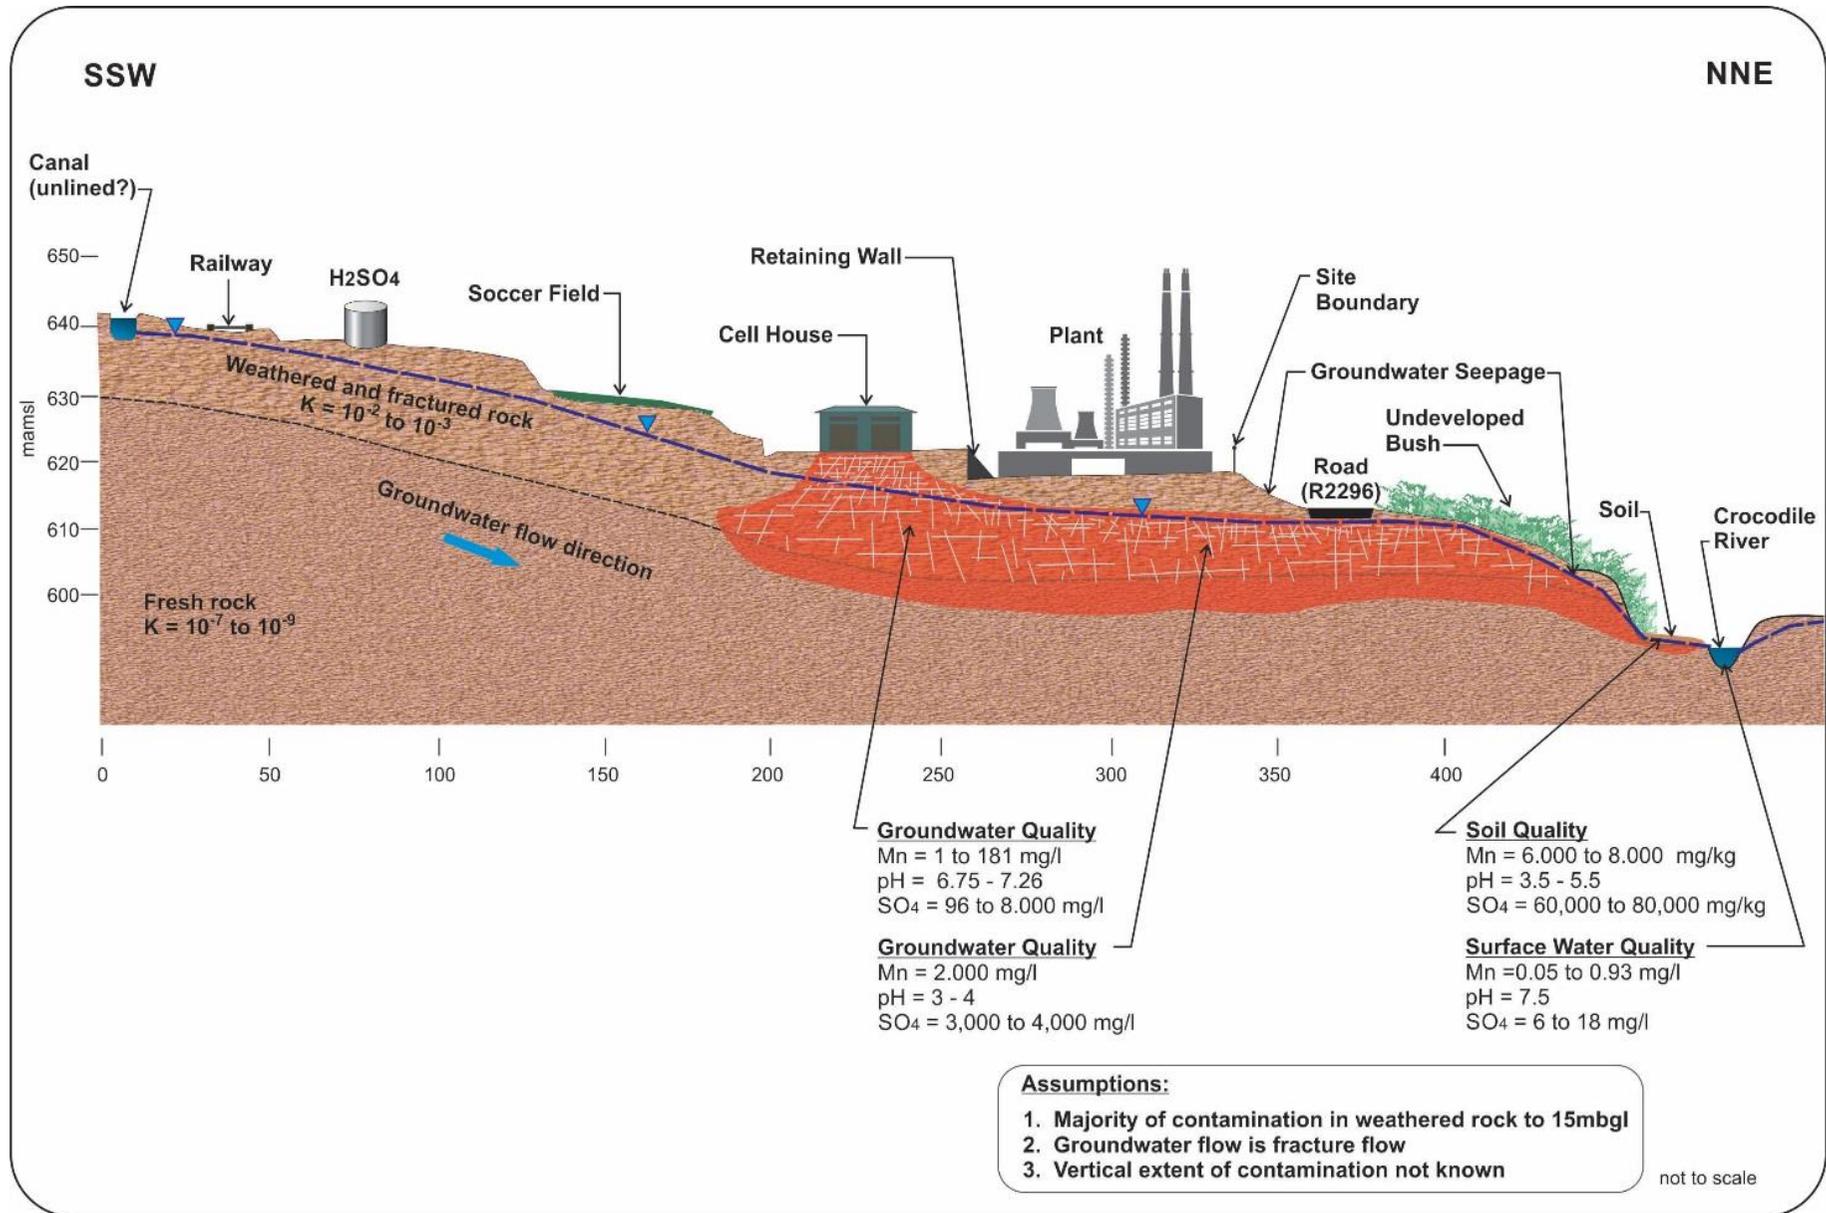
Figure 6-1: Updated Conceptual Site Model (Modified from Hughes, 2014d)

The QRA has determined that low pH and elevated concentrations of manganese represent a high risk to the Crocodile River and that in order to reduce the risk to an acceptable level pro-active intervention is required to improve groundwater quality prior to the groundwater reaching the river.

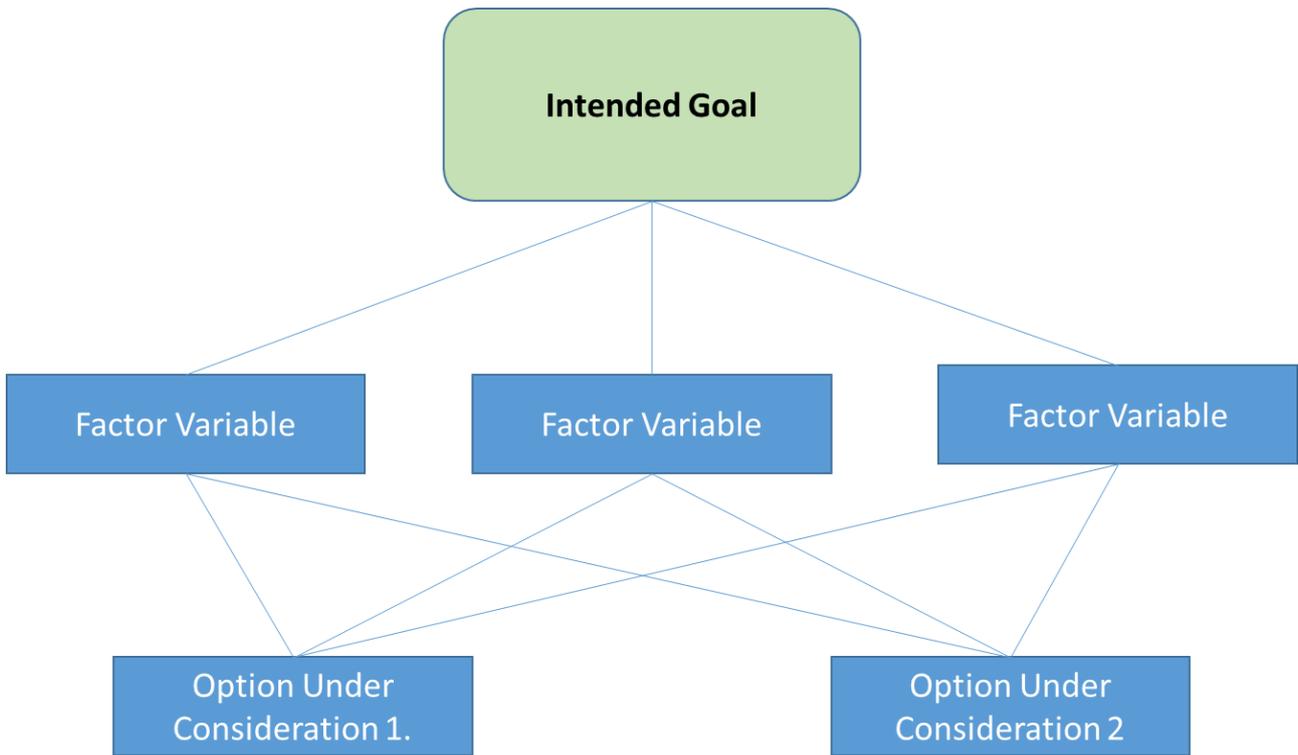
Figure 7-1: AHT Process (Modified after Wollmann et al., 2014)

The AHT was developed in the 1970s by Thomas L. Saaty, an American mathematician. The method represents a tool by which various options can be listed into order of preference based upon consideration of multiple factors affecting the decision making process (Saaty, 2008). The method considers both tangible and intangible factors and the “net-benefit” can be calculated to determine which option is considered to be most favourable to the project in achieving the end goal. The relative importance of each factor under consideration is determined by undertaking “pairwise comparison” by attributing a numerical value to each factor and then applying an appropriate numerical weighting. A figure describing the AHT process is provided as Figure 7-1. The figure shows how each of the various factors that influence the options under consideration are inter-compared.

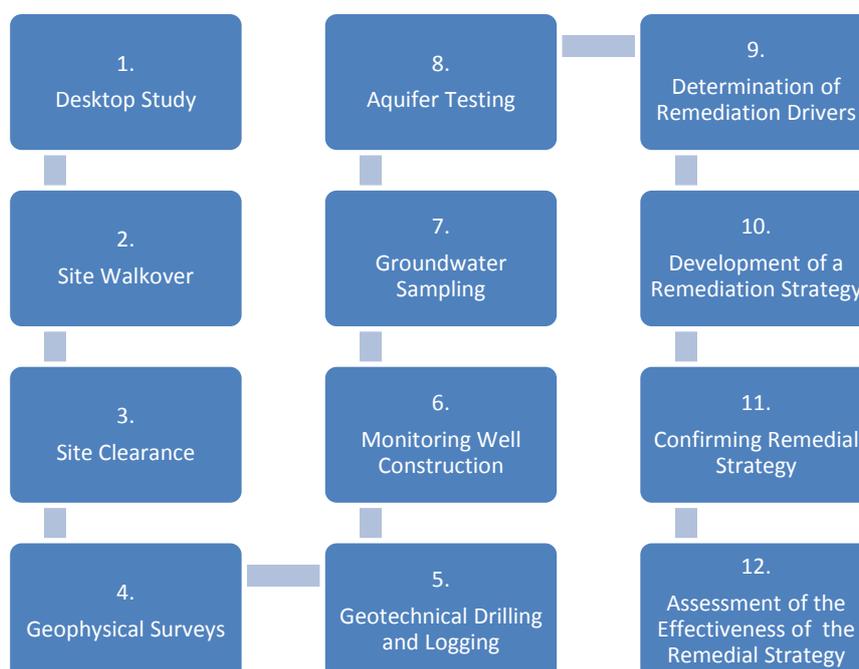
**Figure 8-1: Twelve Step Guide to Detailed Site Investigation for Groundwater Contamination within Fractured Aquifers**

The author proposes that a twelve-step protocol should be followed for most site investigations in South Africa associated with the identification and design of a remedial solution for contaminated

groundwater within shallow weathered/fractured aquifers. The twelve-step protocol is represented as Figure 8-1 with each step being discussed and described in the following sections. During each of the twelve steps the conceptual site model should be revised to ensure it is as up-to-date as possible. After each of the Steps 5 to 11 the user should review the information obtained and loop back into the twelve step guide to Step 4 in an iterative manner to determine if the information obtained is sufficient at that time to move forward or if additional surveys and assessments should be undertaken before moving to the next step. In undertaking this assessment the user must also consider the cost implications that any additional work may impose on the budget and weigh this against the potential benefit to be gained in determining the most appropriate remediation strategy for the site.
