AN EVALUATION OF THE SPATIAL VARIABILITY OF SEDIMENT SOURCES ALONG THE BANKS OF THE MODDER RIVER, FREE STATE PROVINCE, SOUTH AFRICA

Submitted in fulfilment of the requirements for the degree of Master of Science in Geography

University of the Free State

May 2005

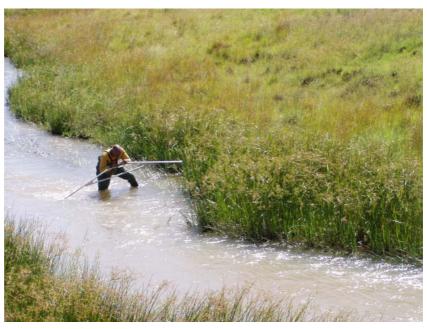
Plate 4.1: Measuring a cross-section using a clinometer and the A-frame (MRS 1)

The cross-sections of ten sites (Figure 5.11) along the Modder River were measured using an A-frame and a clinometer as shown in Plate 4.1.

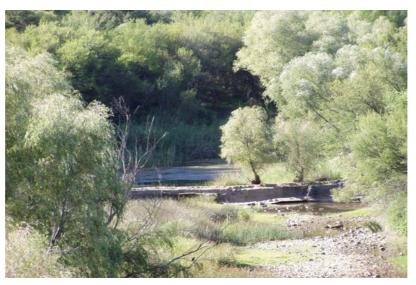
Plate 5.1: Vegetation cover (class 3) classified as *Dense* (grasses, bushes and trees)

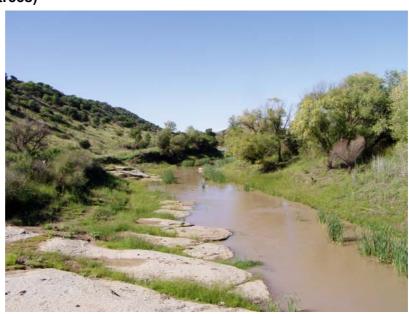
Plate 5.2: Vegetation cover (class 2) classified as Patched (grasses and bushes)

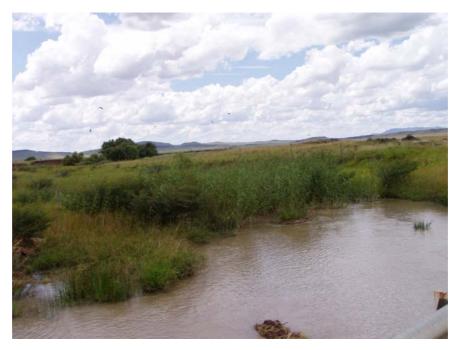
Plate 5.3: Vegetation cover (class 1) classified as *Clear* (grass, with no bushes or trees)

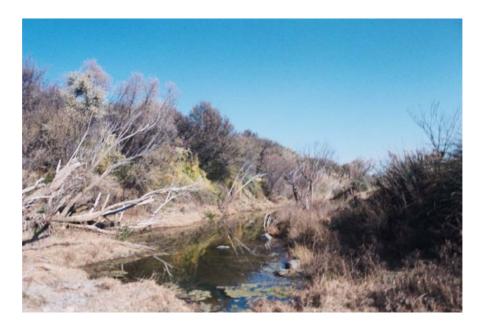
Plate 5.4: Stream channel with dead logs

Fieldtrip, July 2003

With respect to Figure 5.3, there are thirteen segments classified as being congested with vegetation cover. These segments might be source of dropping large woody debris into the Modder River, as shown in Plates 5.4 and 5.5 where dead logs occupying the stream channel cause channel constriction. In segment 4 (Rustfontein Dam), segments 19 and 20 (Krugersdrift Dam) and segments 14 and 30 (presence of weirs) vegetation cover is classified as **2**: *Patched*. As these segments contain a high moisture content, they could be expected to be congested with vegetation, but during high flows, the dams/weirs retreat, possibly destroying vegetation.

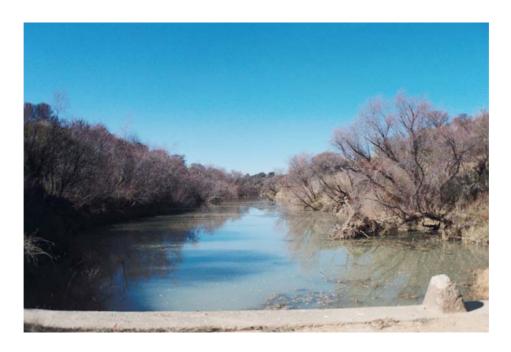
Plate 5.5: Flow of the stream blocked by woody debris in a culvert (MRS 11)

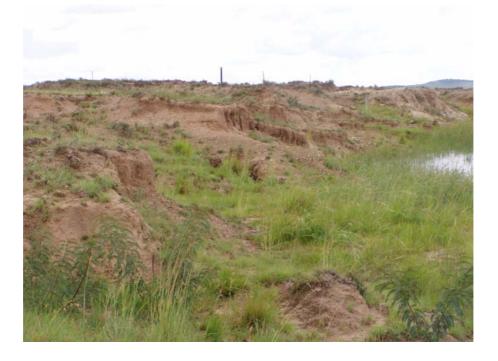
Plate 5.6: Bank erosion on some segments on the Modder River (below MRS 3)

Bank erosion along the Modder River is not particularly active, owing to the effect of high vegetation cover on those banks. Erosion is only minimal along acute bends along the river. Segment 16 has a high potential of becoming a high sediment source because of sand mining in the area (Figues 5.6 and 5.7). In segments 1, 2 and 3 animals trampling the bank sides cause bank erosion. The observations indicate that the most dominant type of erosion along the Modder River is gully erosion.

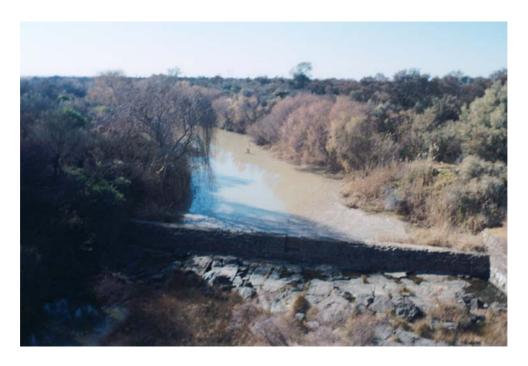
Plate 5.7: Sediment transport restricted by a structure

According to the 2001 report on the state of the Modder River, the morphology of the Modder River has been significantly influenced by artificial structures such as reservoirs, as they considerably affect the fluvial systems by reducing the magnitude and frequency of the runoff, increasing evaporation, restricting sediment transport (Plate 5.7) and increasing scour downstream (Plate 5.8).

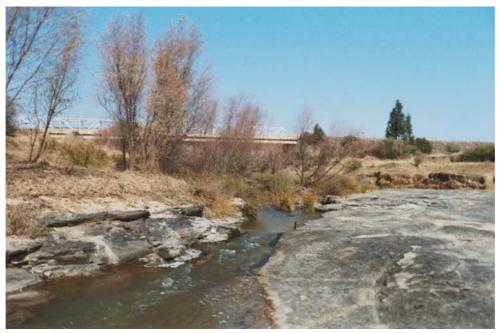
Plate 5.8: Significant changes to the channel below a weir and bridge (MR 3) prevented by lack of sediment inputs

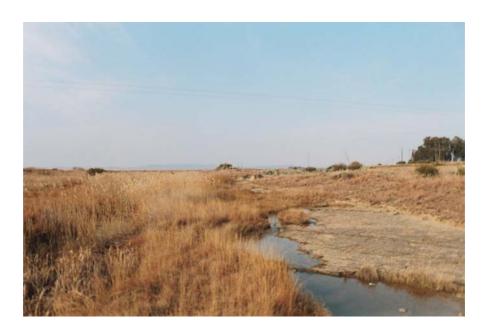
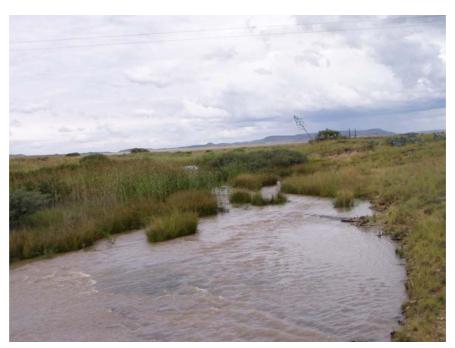
The other possible high sediment source in the upper reaches of the Modder River is the Caledon-Modder (Novo) Transfer Scheme that pumps untreated water from the Caledon River into Knellpoort Dam, then into the Modder River, upstream of the Rustfontein Dam. The transfer scheme has increased the flow of the Modder River in the upper reaches. This implies that the eroding power of the channel has increased; the river now has a higher capability of eroding on its bed and banks. Plates 6.1 and 6.2 show the flow in the Modder River, before and during the Novo Transfer Scheme. The active channel width has increased. Plate 6.2 shows high turbulence on this site, implying an increased flow velocity.

Plate 6.1: Site MRS 3 before the Novo Transfer Scheme

Plate 6.2: Sites MRS 3 during the Novo Transfer Scheme

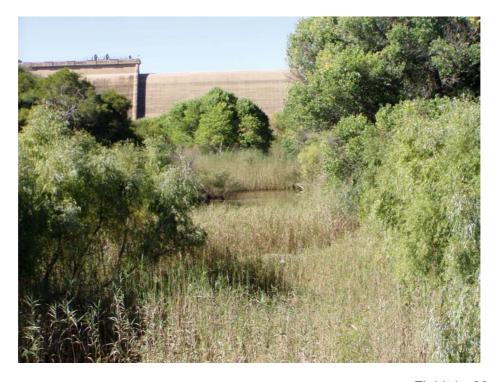
that increase the bank-substrate strength in most the segments. Abemethy and Rutherfurd (2000:921) state, "Vegetated banks in flood-plain reaches can maintain higher and steeper geometries than their vegetation-degraded counterparts." In sections of the river, downstream of the weirs and dams, the common reed is encroaching on the channel owing to a lack of strong current to remove the reed rhizomes, thus reducing the rate of flow and promoting the deposition of sediments (Plate 6.3).

Plate 6.3: Channel encroached by reeds (downstream of Rustfontein Dam)

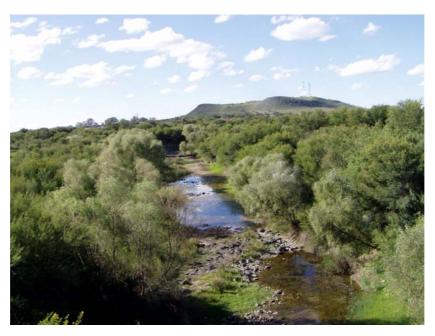
The banks of the Modder River show the luxuriant growth of vegetation. Trees can reduce erosion through mechanical strengthening and binding of the banks by roots. Vegetation protects banks by creating a lower velocity buffer between the soil in the banks and the erosional forces of the main current. The roots of trees and bushes are an important component of the Modder River banks for increasing the bank resistance to erosion and the management of channel width (Plate 6.4). Woody debris in the Modder River acts as a hydraulic roughness element that removes momentum from the flow and reduces the capacity of the channel to transport sediment.

Plate 6.4: Vegetation stabilising the banks of the Modder River (Perdeburg: MRS 19)
