# THE INFLUENCE OF FLOODING ON UNDERGROUND COAL MINES

Thesis submitted in fulfilment  
of the requirements for the degree  
**Magister Scientiae**  
in the Faculty of Natural and Agricultural Sciences  
(Institute for Groundwater Studies)

University of the Free State.

November 2011

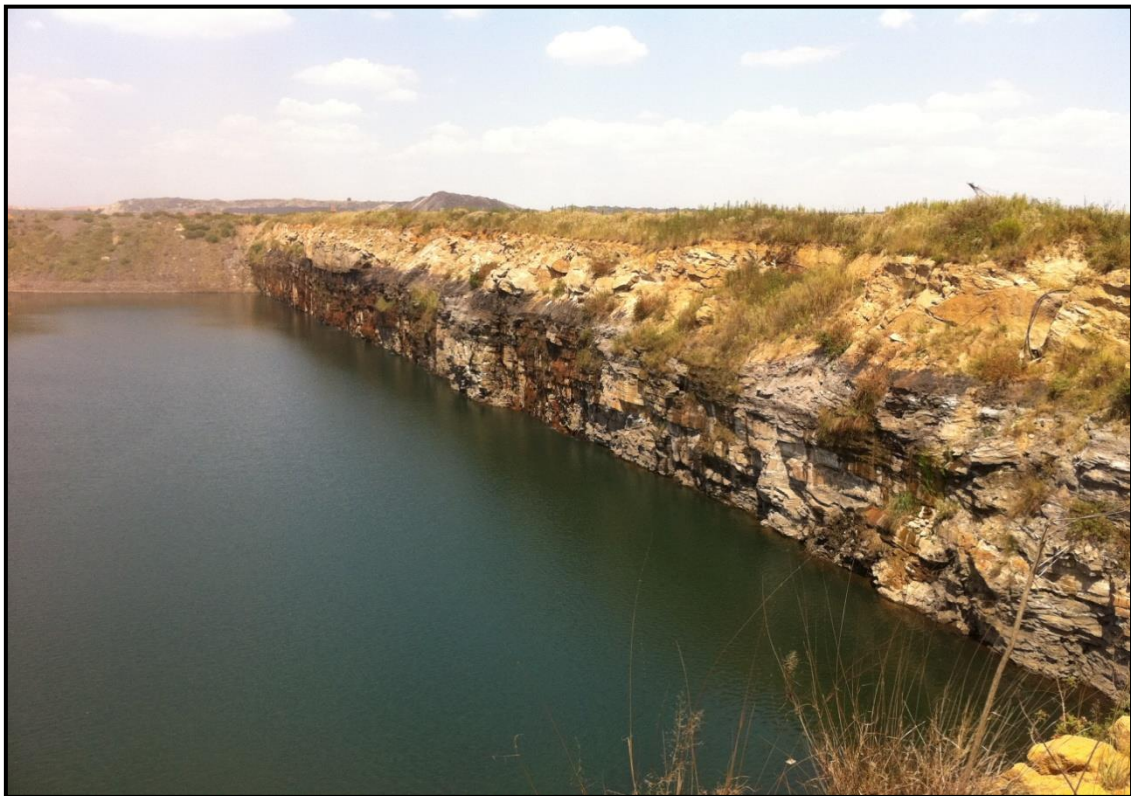
Figure 1: Klipspruit mine pit, where water is seeping into the pit.

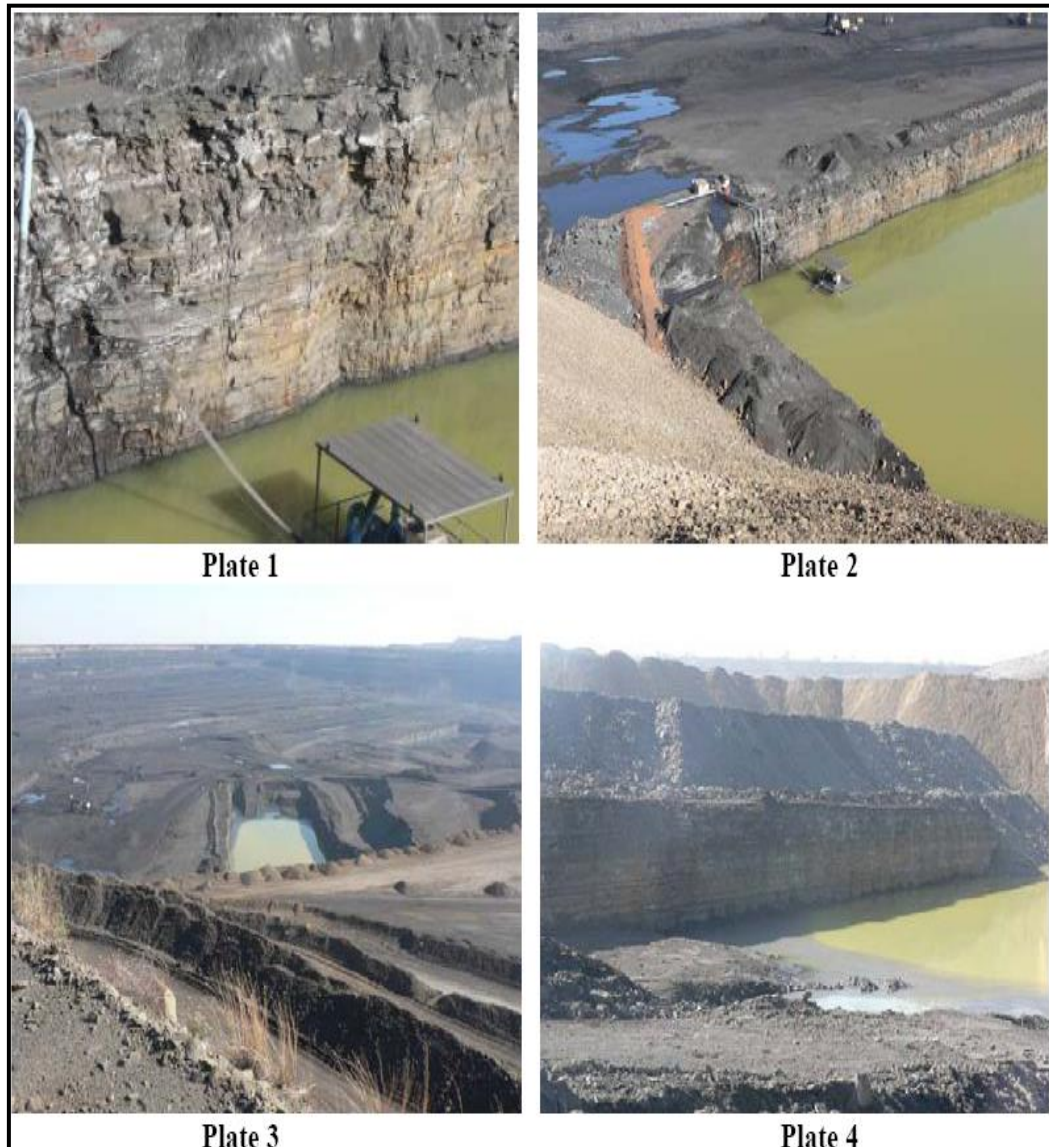
Figure 2 : Plates 1, 2, 3 and 4 area of sump pumping from Grootgeluk coal mine in the North- west of South Africa (Morton, 2009).

Morton (2009) states if water gets in contact with exposed coal not on virgin coal that is not exposed the quality of the water degrades in pH, TDS and colour. This requires that the water should be tested and treated before pumping it into streams and lakes. In open pit mines, the main problem is storm water control. The clean and dirty water needs to be managed. Figure 2 shows plates 1, 2, 3 and 4 in the area of sump pumping from Grootgeluk coal mine in the North West of South Africa.

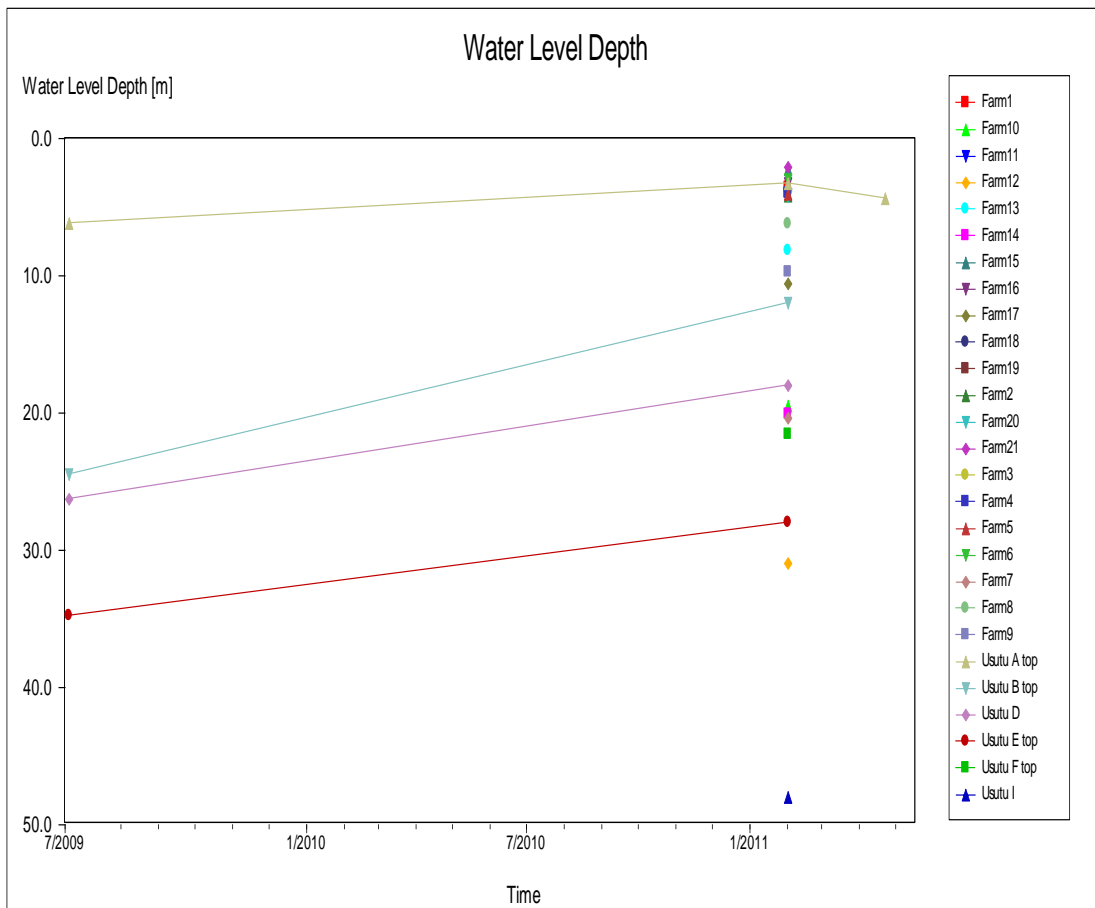
Figure 27: Water level time graph of a few boreholes measured since 2009.

The water levels in the mine were measured in July 2009 and again during the hydrocensus. These levels and all the others from the farm boreholes are presented in the time graph in Figure 27. There has been a definite rise in the water levels since 2009, but this may be attributed to the exceptional rainy season during 2010/2011. These levels should be monitored over time to draw meaningful conclusions as only 4 boreholes water levels were measured previously in 2009 as to mismanagement. These levels should be monitored over time to draw meaningful conclusions. Figure 28 illustrates the proportional water level distribution for February 2011.

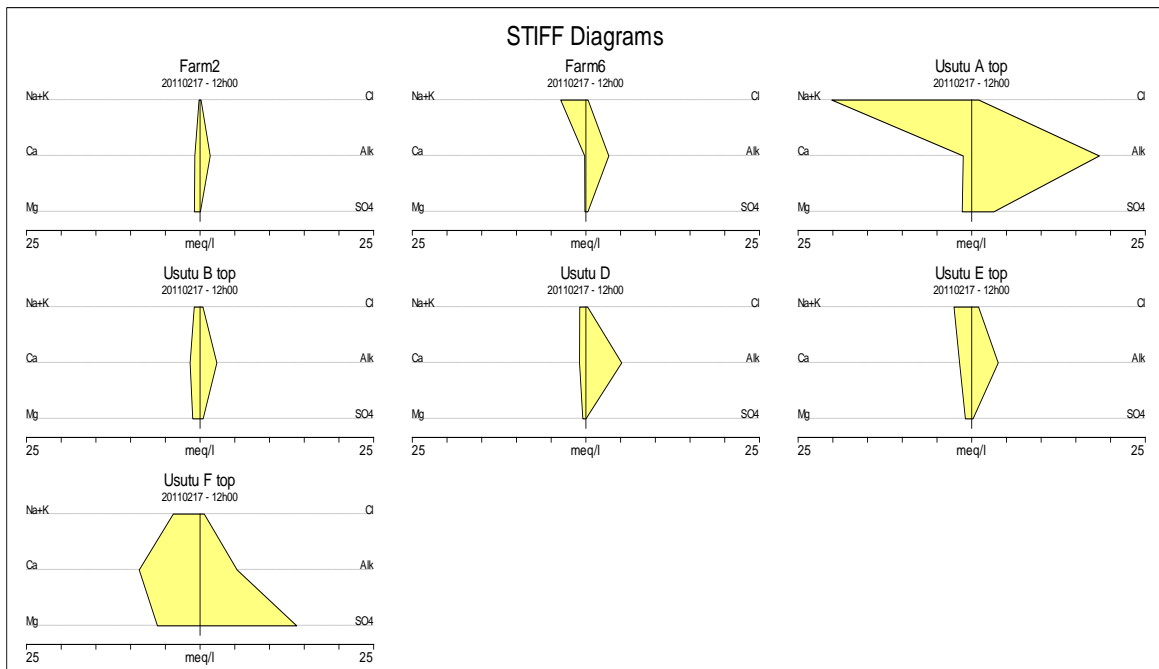
Figure 63: Stiff diagrams of the top mine samples and the farm samples.

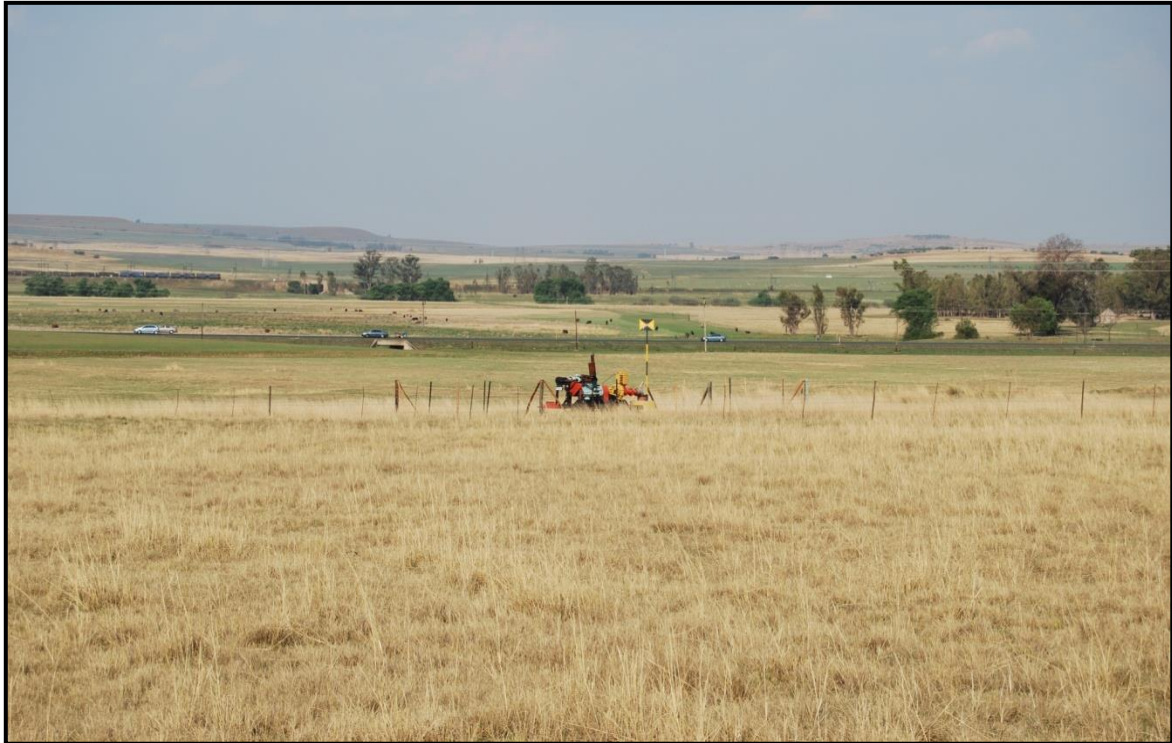
Figure 83: Picture of the mobile pump.

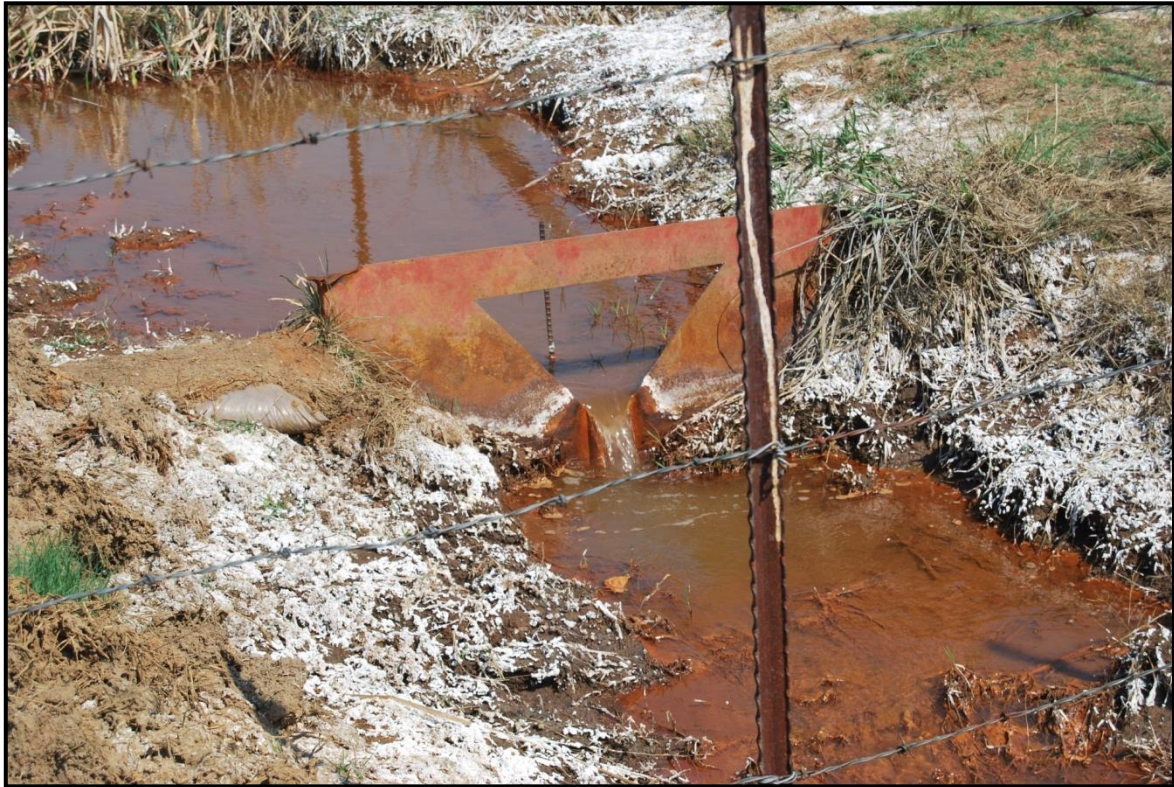
Figure 86: Picture of the V-notch of water decanting out of opencast 1B.

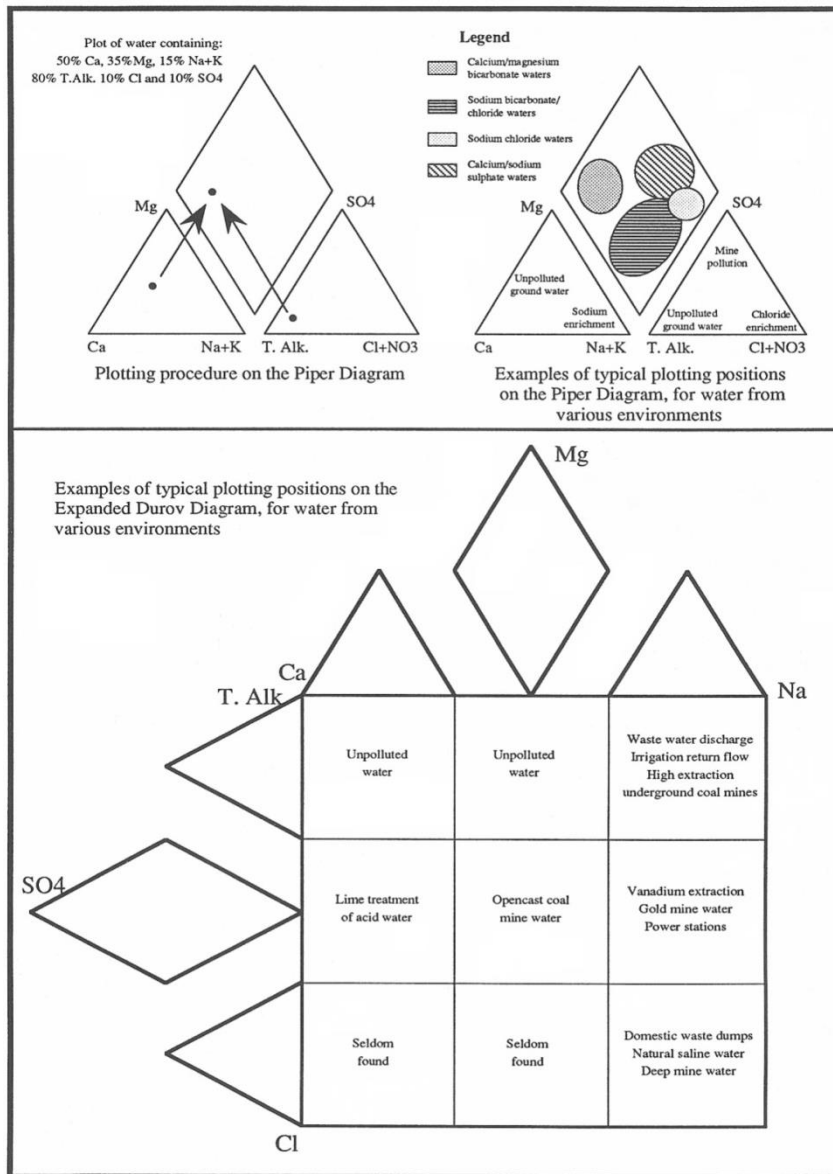
Figure B: Piper interpretation and classes in the expanded durov.

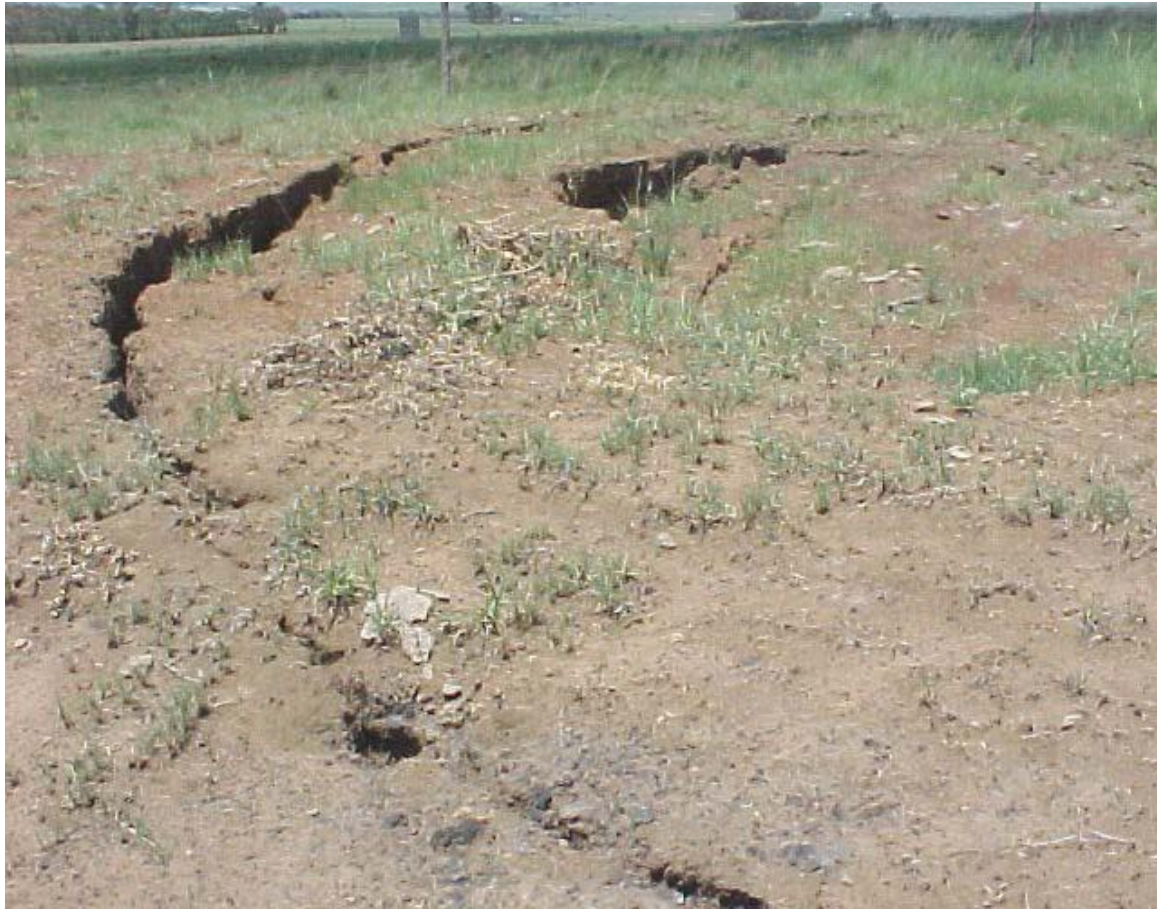
Figure F: Surface subsidence and prior rehabilitation above a stooped area
