The influence of the Irrigation on Groundwater at the Vaalharts Irrigation Scheme

Thesis submitted in the fulfilment of the requirements for the degree of

MAGISTER OF SCIENCE

In the Faculty of Natural and Agricultural Sciences,
Department of Hydrogeology
University of the Free State
Bloemfontein, South Africa

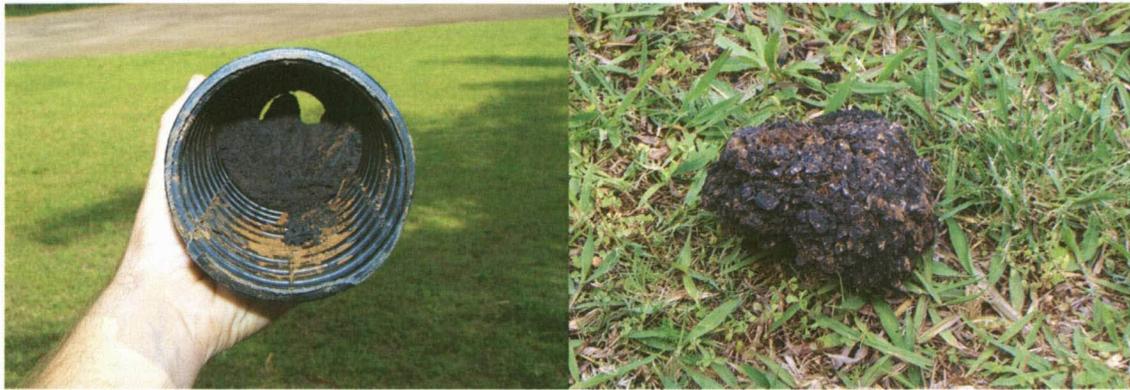
Fig 3: Photo of a blockage recently (May 2009) removed

This study investigated the manganese blockage of drainage pipes. Samples taken at the same spots showed that EC, TDS and total manganese values were much higher in the drainage pipes than that of the irrigation water. The relative high pH (8.2) of the irrigation water makes it corrosive and aggressive. Non liquid fertilizers contain sulphates which precipitated with the positive metal ions in the soil. Salts started to precipitate out of the saturated water was taken up in the solution moving through the soil, the metal salts become hard. This may lead to the magnesium sulphate precipitates in the soil and drainage pipes causing blockages. The lack of drainage capability had a negative influence on height of the groundwater table. This could be rectified by a product called quest but this proved to be too expensive.

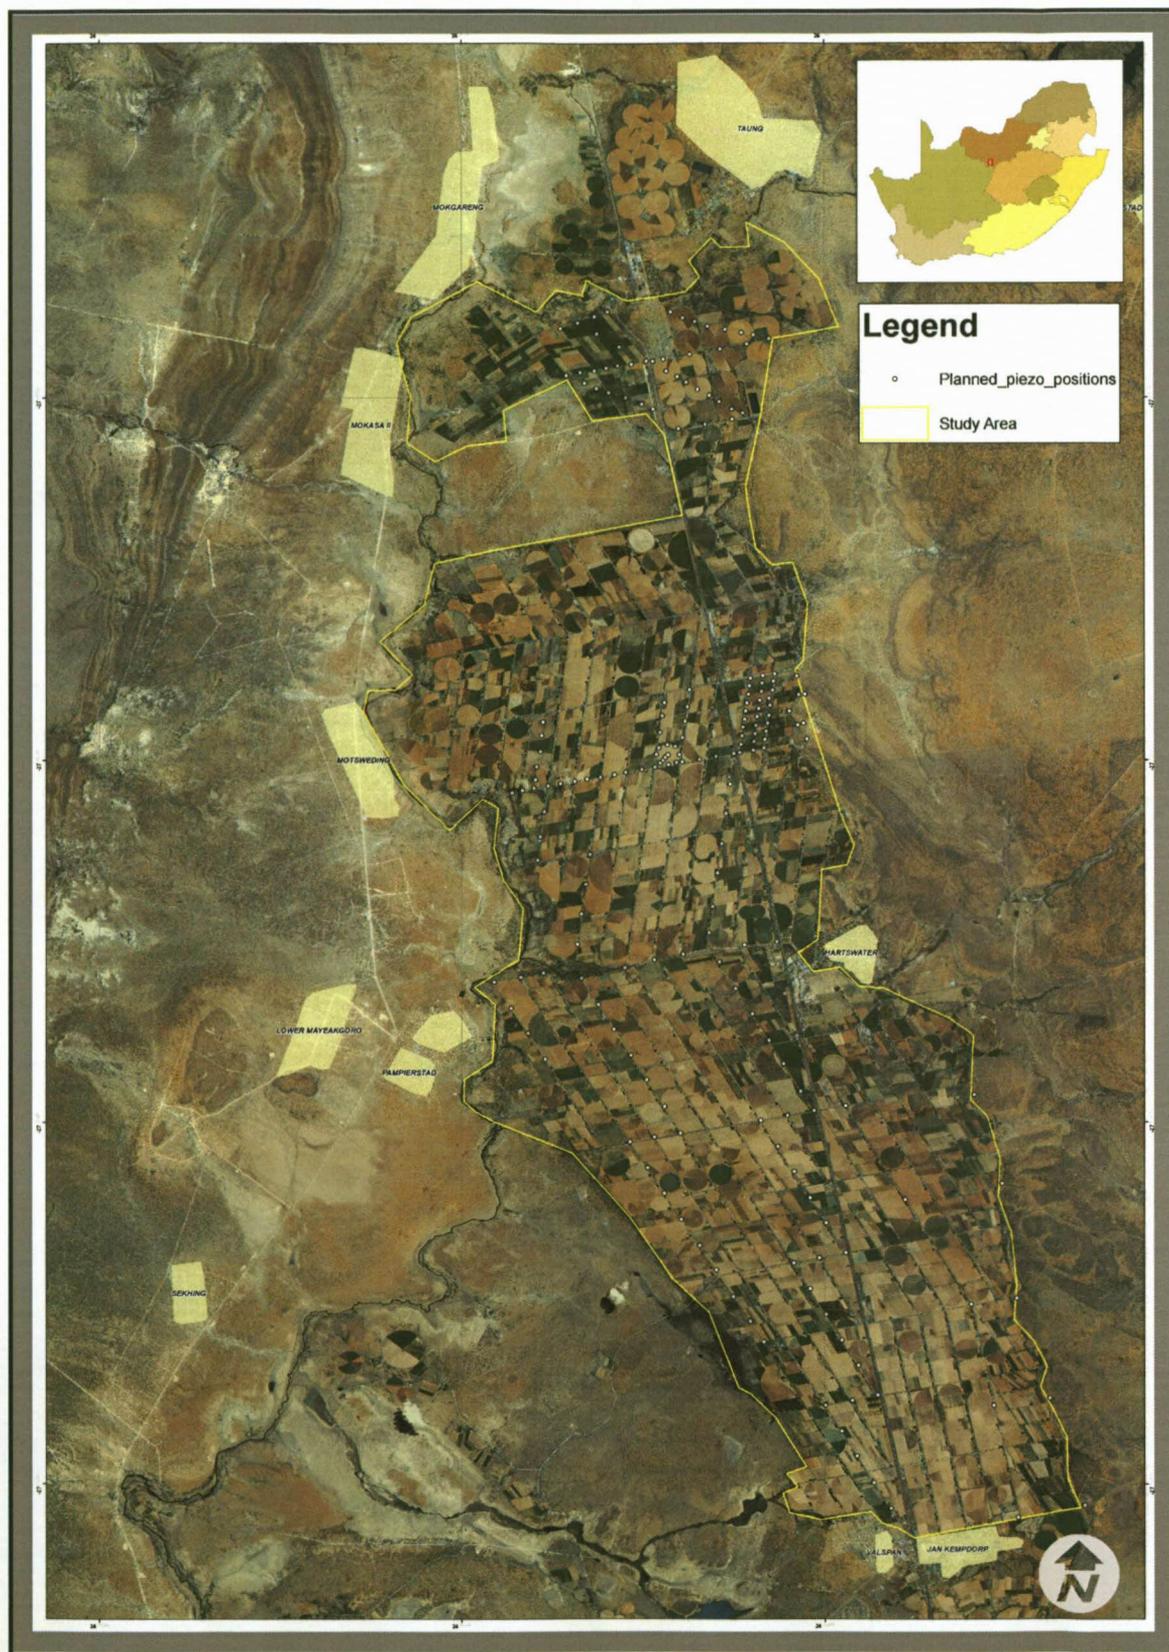
Fig 18: Planned piezometer positions

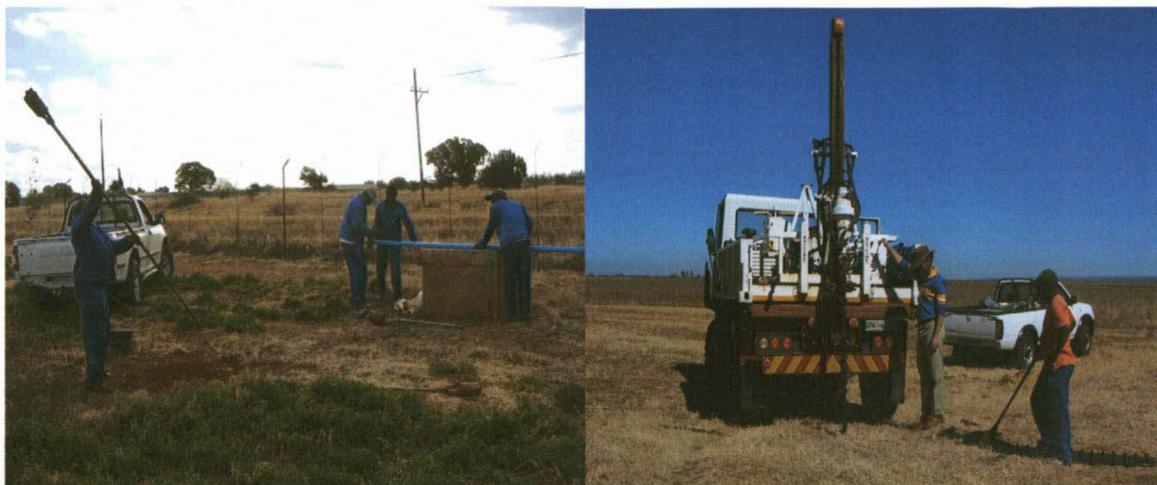
Fig 20: Drilling of the holes

The piezometers consist of a 2.9 m X 63 mm \varnothing , upvc pipe which was perforated at 10 mm intervals, 120 mm from the bottom till 120 mm to the top. To enable measurements up to 3.0 mbgl and to make it visible, a standpipe is screwed on top. These standpipes made field work and finding the piezometer easier. They also enabled the farmers to identify them (Refer to Fig 20 and 21).

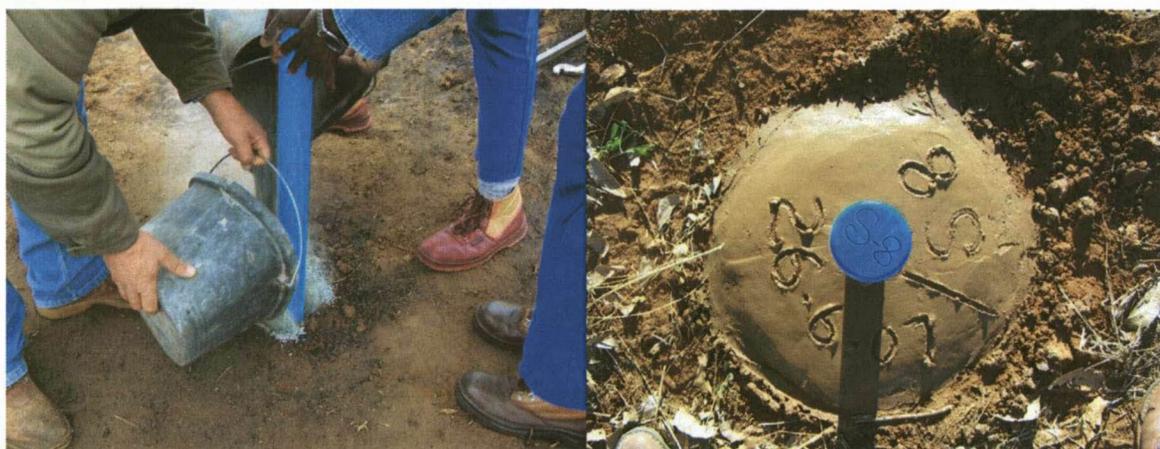
Fig 21: Add filter material and seal the piezometer

A hole was drilled into the soil by means of a 110 mm Ø auger drill. The pipe was then placed in the hole. The 19 mm gap between the soil and the pipe was used for the filter material and filled with 6.7 mm crusher stone. A concrete collar was casted at the top to seal the piezometer and prevent irrigation and other surface water to enter. Each piezometer was fitted with a cap to keep foreign objects out.

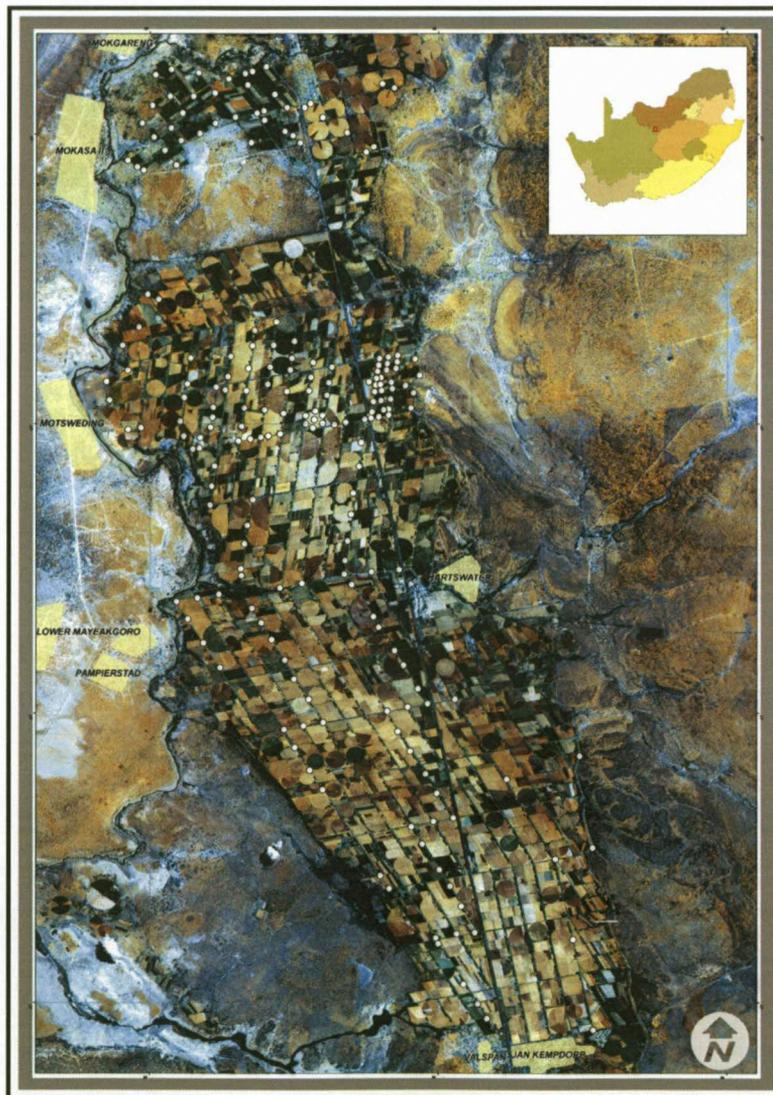
Fig 22: Piezometers with X, Y and Z Coordinates

A sub centimetre global positioning system (GPS) was used to conduct the survey. Firstly, the GPS was calibrated by using 4 trigonometric beacons that is in the area. The best results are obtained if the area of the survey is within the circumference of the beacons. The calibration was necessary to position it on the correct ellipsoid reference. This survey was performed using real time post processing method. The North South direction is X, the East West direction is Y and the height above sea level is Z.

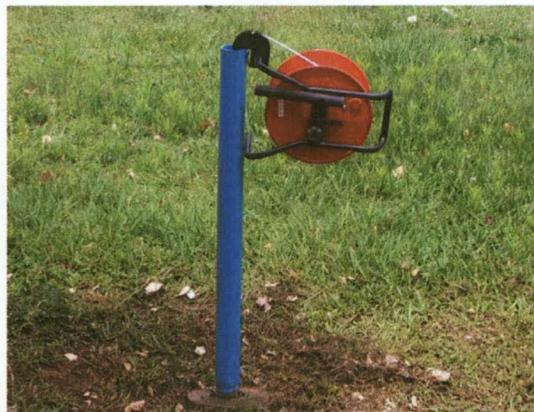
Fig 31: Measuring EC and Water Levels using a TLC meter

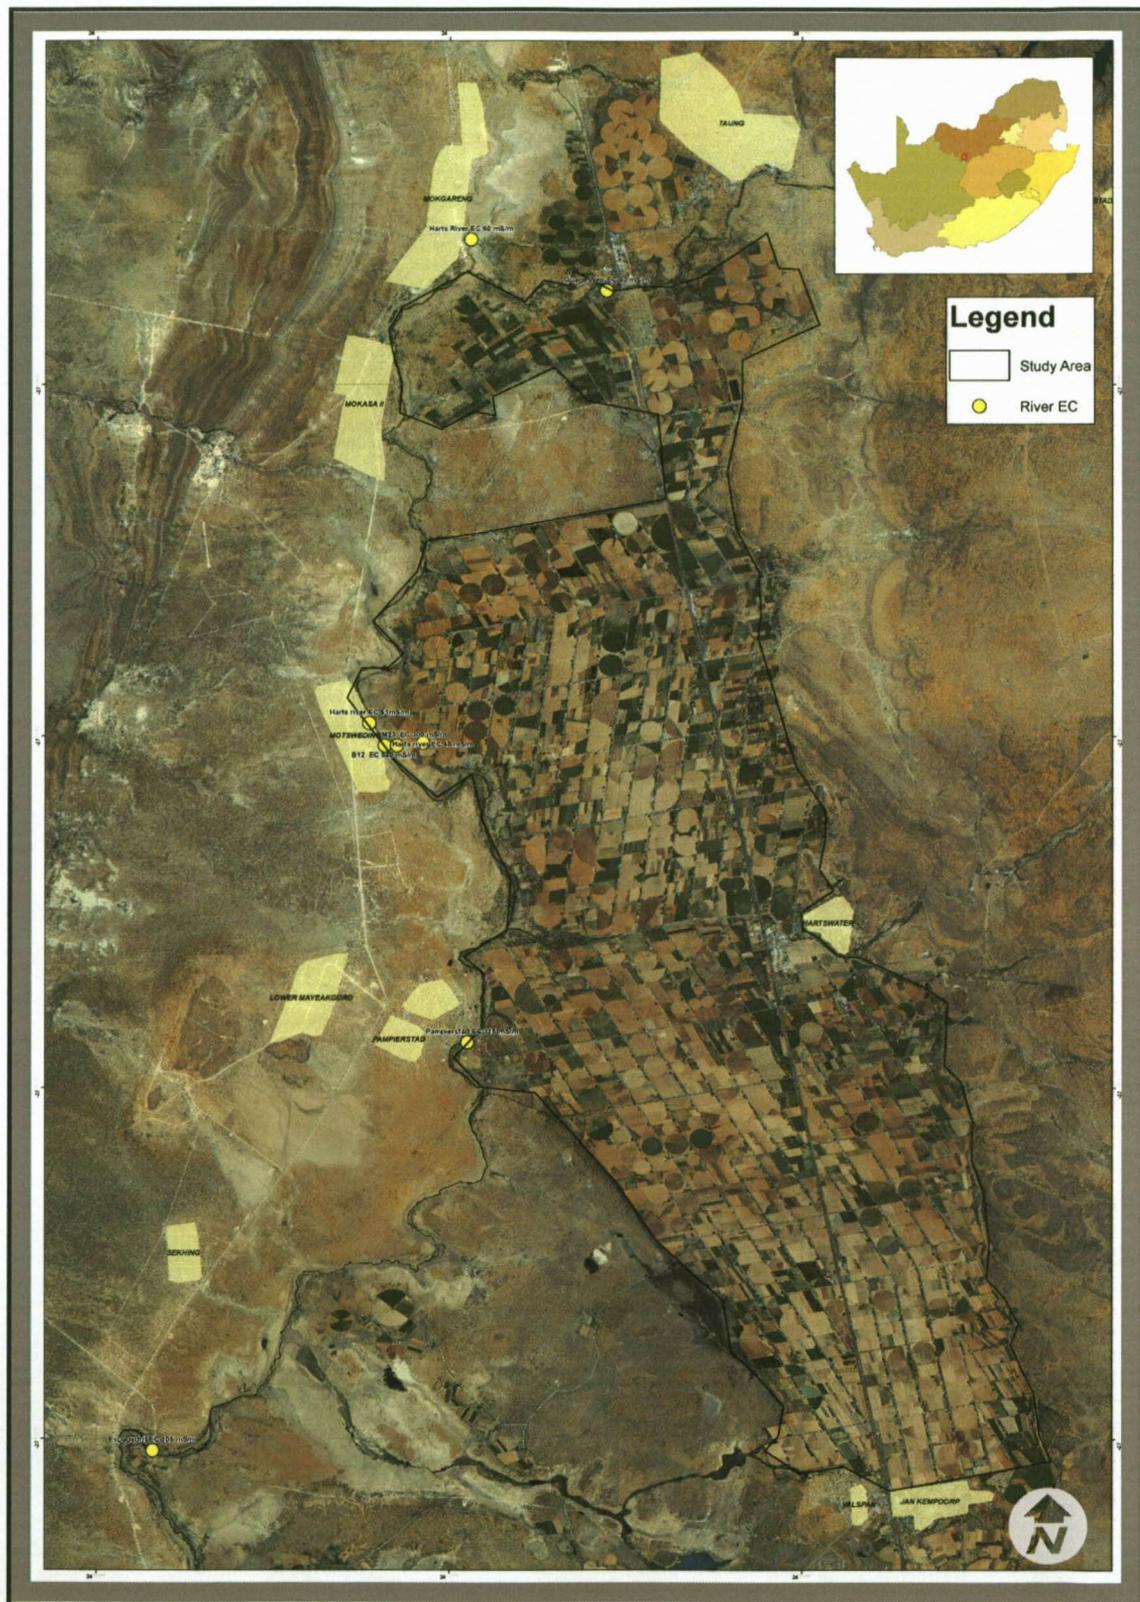
Fig 37: Positions of electrical conductivity measurements in the Harts River

Electrical conductivities were measured at various positions in the Harts River during December 2009 (Refer to Fig 37). The river was dry and the first measurements were only possible at a position 1.2 km north of the junction of the Harts and Dry Harts Rivers. Measurements were taken at four positions up to the Espags Drif gauging station, to cover the influence of the entire research area. Flow measurement were also obtained from Vaalharts Water User Association (Harbron, K 2009) (Refer to Fig 36) There are a correlation between this flow measurements and the rain measurements (Refer to Fig 6).

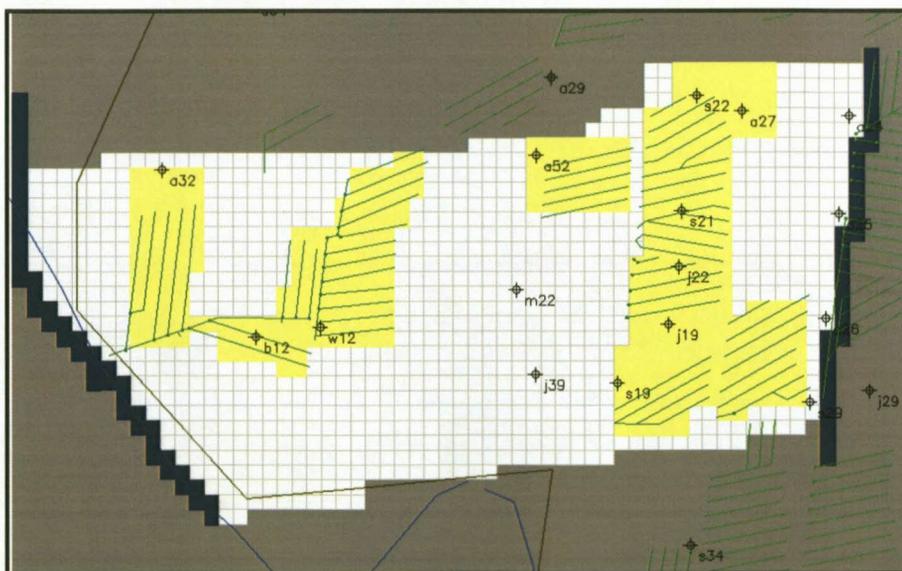
Fig 52: Zones, Block K-Centre as modelled

Fig 53: Zones, Block K-West as modelled

Zones were assigned to 57 areas to simulate the drains by using the zone input method. Different zone numbers, hydraulic conductance and height of the particular drain above the sea level were assigned to each zone. And the values were determined as the drain results representing the sub surface drains in the K block.
