Site Characterisation of LNAPL - Contaminated Fractured - Rock Aquifer

Modreck Gomo

A dissertation submitted to meet the requirements for the degree of

Institute for Groundwater Studies

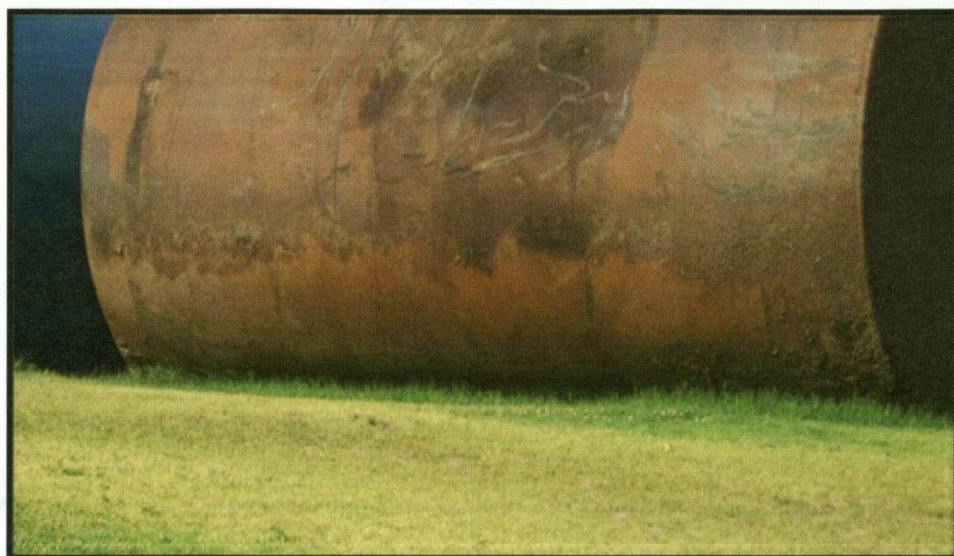
Figure 2-3 Typical petroleum UST installed at the study area's service stations (Taken during the fieldwork).

Petroleum product retail service stations' arrangement in most cases consists of dispenser pumps supplied by USTs (Figure 2-3). According to US EPA (2003), petroleum product leakages from USTs are a worldwide phenomenon as many of them have either leaked or are currently leaking.

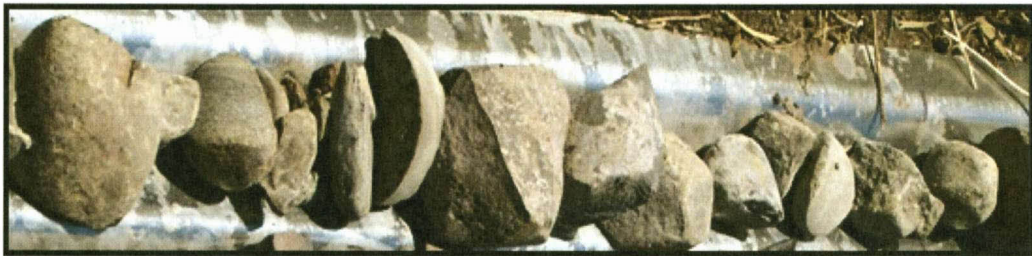
Figure 3-5 Sandstone boulders from core drillings on the study area (Taken during the field work).

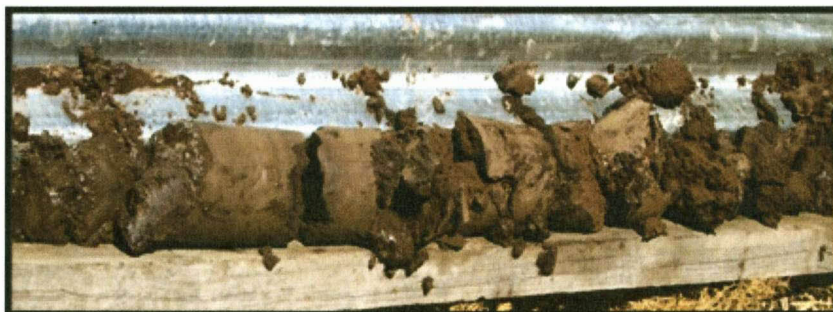
Figure 3-7 River sand deposits from 0 - 3 mbgl on the study area (Taken during the field work).

Alluvial deposits dominate the study area's flood plains with much of the deposits being concentrated along valleys and stream courses of Gamka and Kuils rivers. The nature of these deposits has important implications for recharge and contaminant movement through the unsaturated zone. Boulder alluvium composed primarily of dolerite and metamorphosed sedimentary rocks are found along banks and flood zones of the Gamka River on the upstream of the Gamka dam. Most boulders accumulate in the orders of 1 - 3 meters below ground level (mbgl) in thickness (Campbell, 1980). Thick unsaturated alluvial deposits have great potential to facilitate diffusion of the VOCs. In such environments, precautionary measures has to be taken during air percussion drilling to asses and measure the VOC levels, in order to avoid incidence of fire. The result from the core geological logs (Figure 3-7) confirms the presence of alluvium deposits on the study area where a thickness of 3 m river sand was observed.

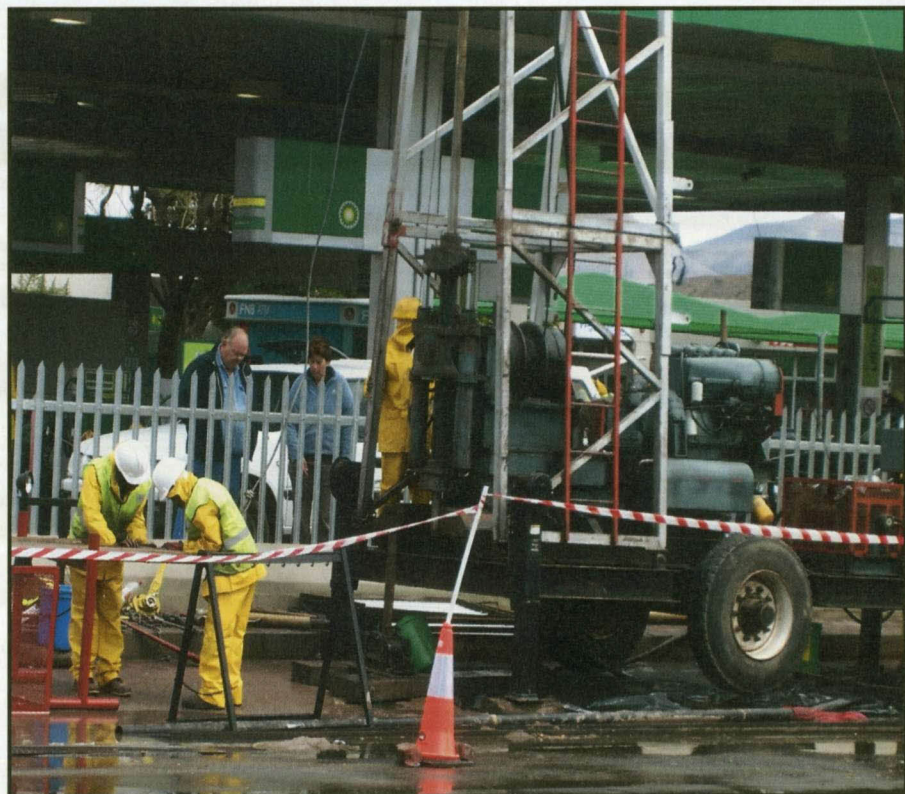
Figure 4-2 Core drilling equipment used at the Beaufort West study area (Taken during the field work).

Core drilling is an effective tool where detailed structural geologic analysis is necessary to identify and quantify contaminant migration pathways (Bunker, 1998). Structural and lithologic information obtained from oriented cores provide an understanding of migration pathways, more importantly with regard to fracture networks which are hydraulically very conductive. Core drilling technology is widely used in the petroleum, mining exploration and engineering geology construction industries, but can also yield valuable information for groundwater exploration and contamination studies.

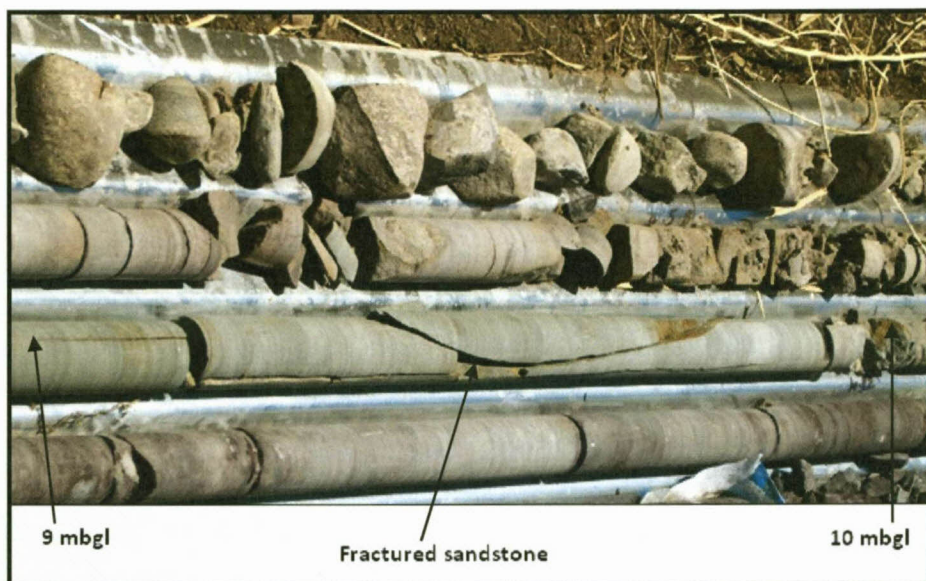
Figure 4-4 Fractured sandstone between 9 - 10 mbgl in MW6 core borehole (Taken during the field work).

pathways. In this situation, the fracture is possibly conveying contaminated groundwater or naturally high TDS groundwater as indicated by elevated EC.

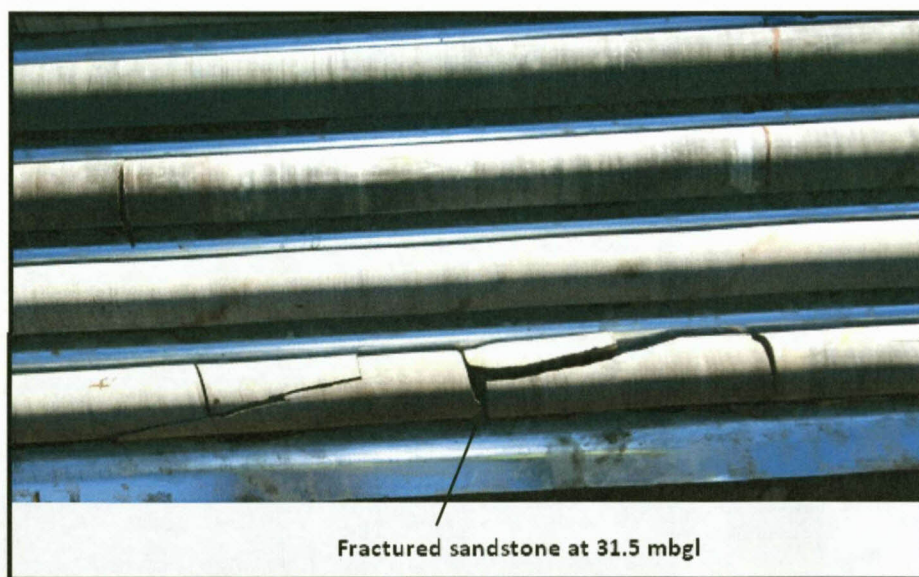
Figure 4-5 Fractured sandstone at 31.5 mbgl in MW6 core borehole (Taken during the field work).

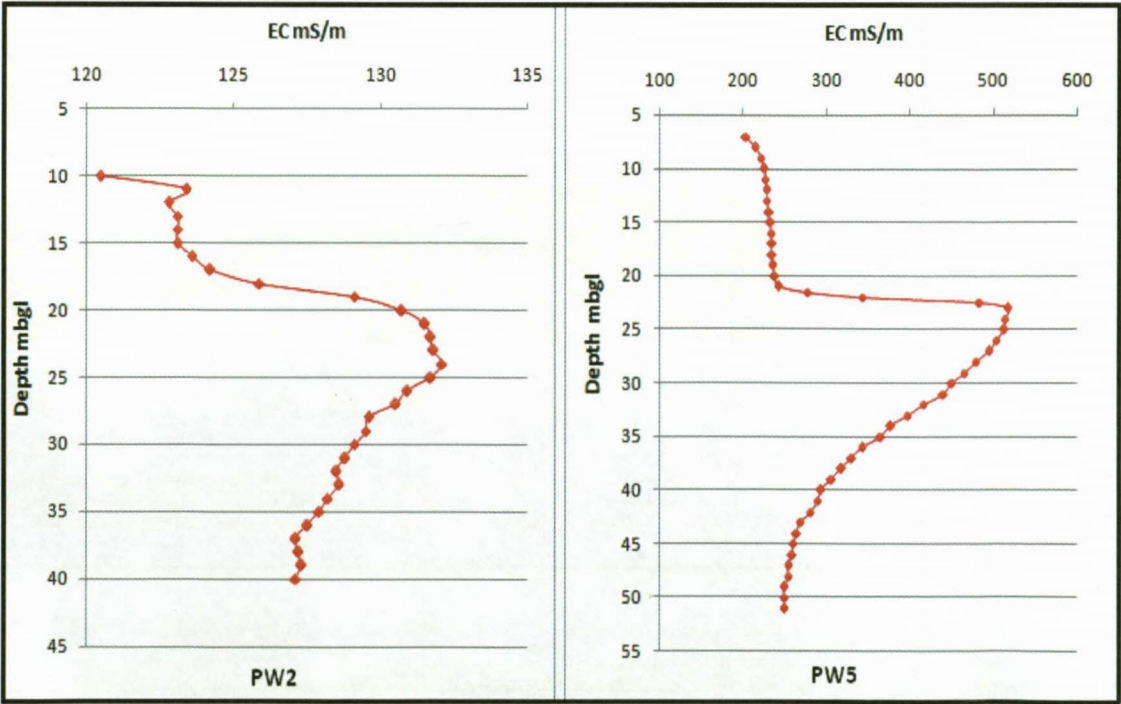
Figure 5-1 EC profile in PW2 and PW5 private boreholes.

For instance EC logging in PW5 (Figure 5-1) revealed an elevated EC at 23 mbgl. The observed anomaly at 23 mbgl was linked to a high hydraulic flow zone conveying degraded diesel product which according to (Hiebert *et al*, 1995) has the potential to generate carbonic acid during the biodegradation process. Electrical conductivity logging in PW2 private borehole (Figure 5-1) also indicated elevated EC values between 19 - 28 mbgl and the zone was targeted for the tracer tests.

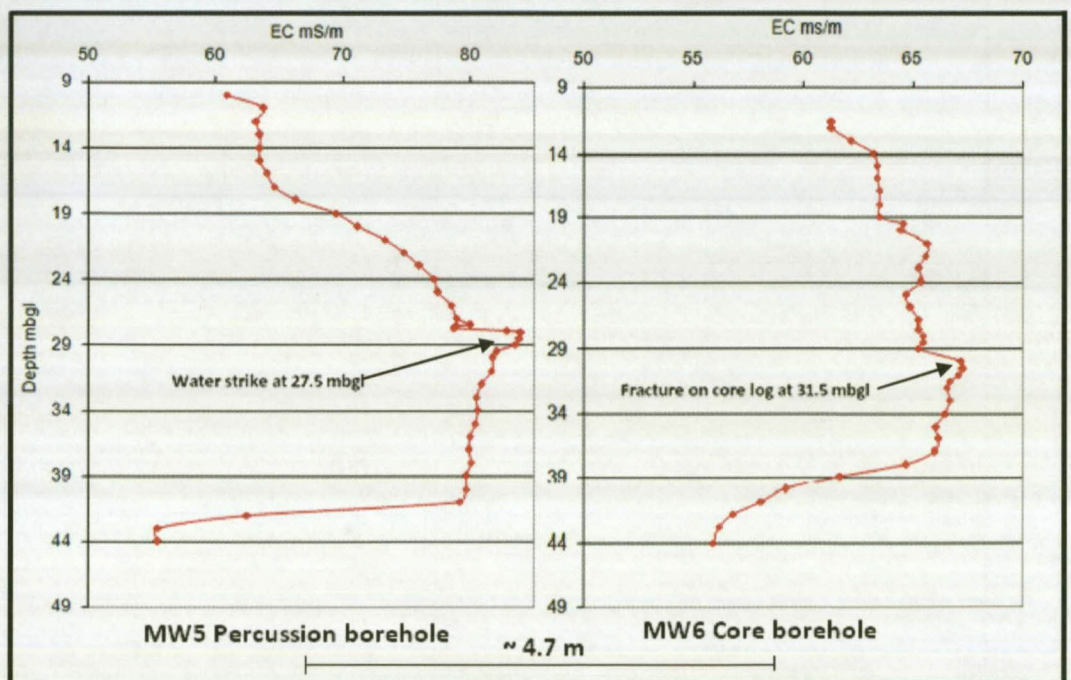
Figure 5-2 EC profiling in MW5 (Percussion) and MW6 (Core) boreholes.

Figure 5-2 shows the EC profile in core borehole MW6 and percussion borehole MW5 which are only 4.7 m apart. The profiles depict anomalies at 27.5 mbgl and 31.5 mbgl in MW5 and MW6 respectively. The EC anomaly in MW5 is attributed to the existence of a preferential flow path conveying LNAPL - contaminated groundwater. The preferential flow path being intersected in MW5 is most likely to be part of the fracturing system detected in MW6 core borehole which is evident on the core log at 31.5 mbgl (Figure 4-5, Section 4.1.1.1). It can be concluded from the two EC profiles that the two boreholes intersect the same fracture preferential flow path but at different depths. This conclusion however needed to be verified through the use of other complimentary tools for optimum subsurface understanding.

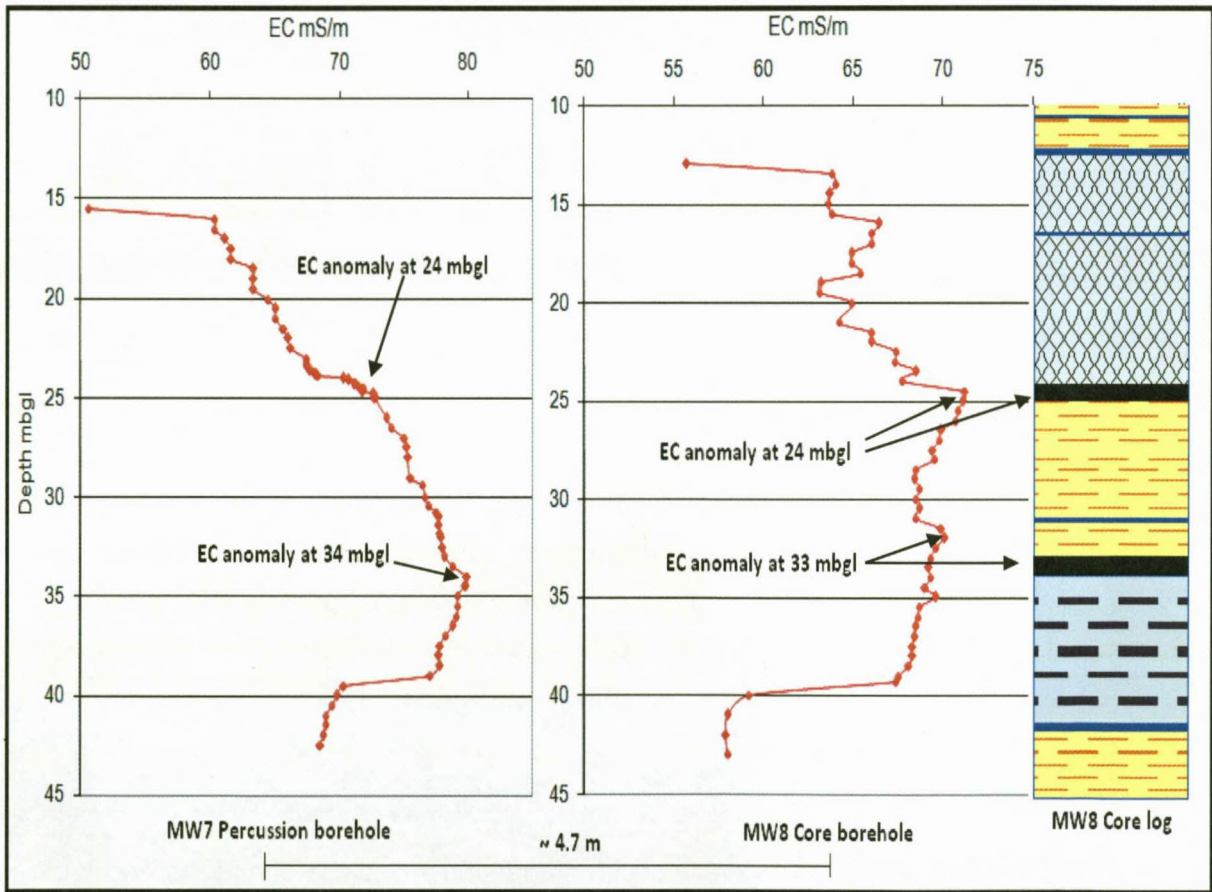
Figure 5-3 EC profiling in MW7 and MW8 boreholes and MW8 core geological log.

Figure 5-3 shows EC profiles in MW7 percussion and MW8 core boreholes. Displayed in both profiles are EC anomalies at 24 - 25 mbgl and 34 - 35 mbgl. The anomalies are most likely due to the weathering on the shale and sandstone contact areas, leading to the formation of a bedding plane fracture preferential flow path. MW8 geological core log also confirms the existence of shale and sandstone contact area as shown besides MW8 EC profile (Figure 5-3). It is most likely that that the two boreholes are intersecting the inferred bedding plane fractures at 24 - 25 mbgl and 34 - 35 mbgl. FWS, AV and conventional borehole geophysics logs (Section 5.2.2 and 5.2.3 respectively) also indicated clearly the existence of bedding plane fracture feature at those depths.

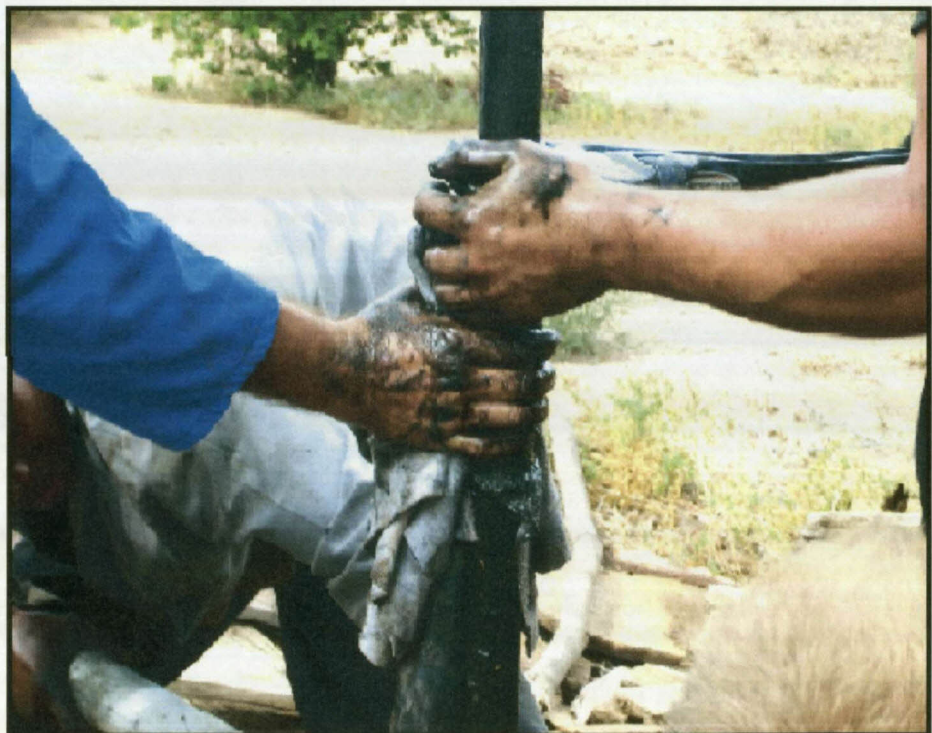
Figure 6-2 Contaminated pumping equipment on PW5 private borehole (Taken during the fieldwork).

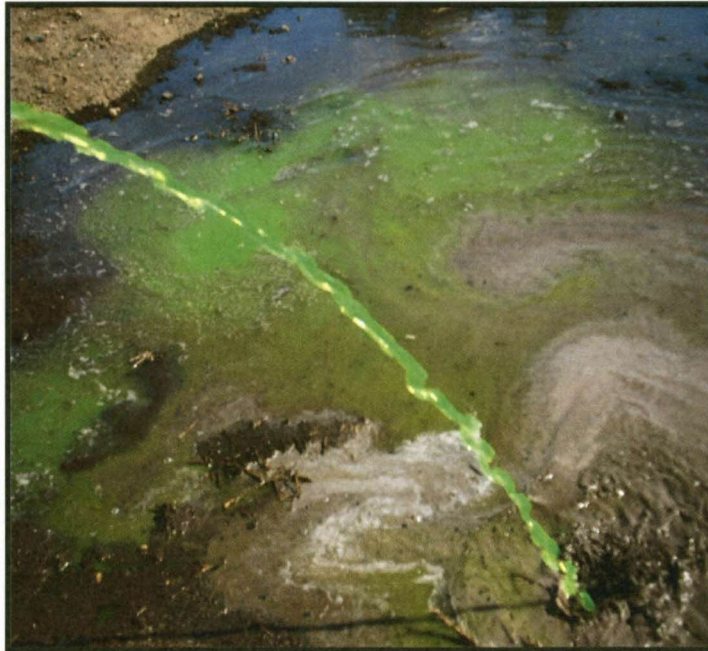
Figure 11-2 Pumping out injected tracer after the tracer tests (Taken during the field work).
